Report of  
**Preliminary Investigation for  
Determination of an Area in Need of Redevelopment  
without Condemnation**

Block: 1207, Lots: 8, 9 10 & 11; Block: 1208, Lots: 1, 2, 3, 4 & 5; Block: 1209, Lots: 2, 3, 4, 5 & 6;  
Block: 1210, Lots: 6, 7, 8, 9, 10 & 11; Block: 1211, Lots: 1 & 2; Block: 1212, Lot: 13.

**Prepared By:**  
DMR Architects

**Prepared For:**  
Borough of Hillsdale  
Bergen County, New Jersey

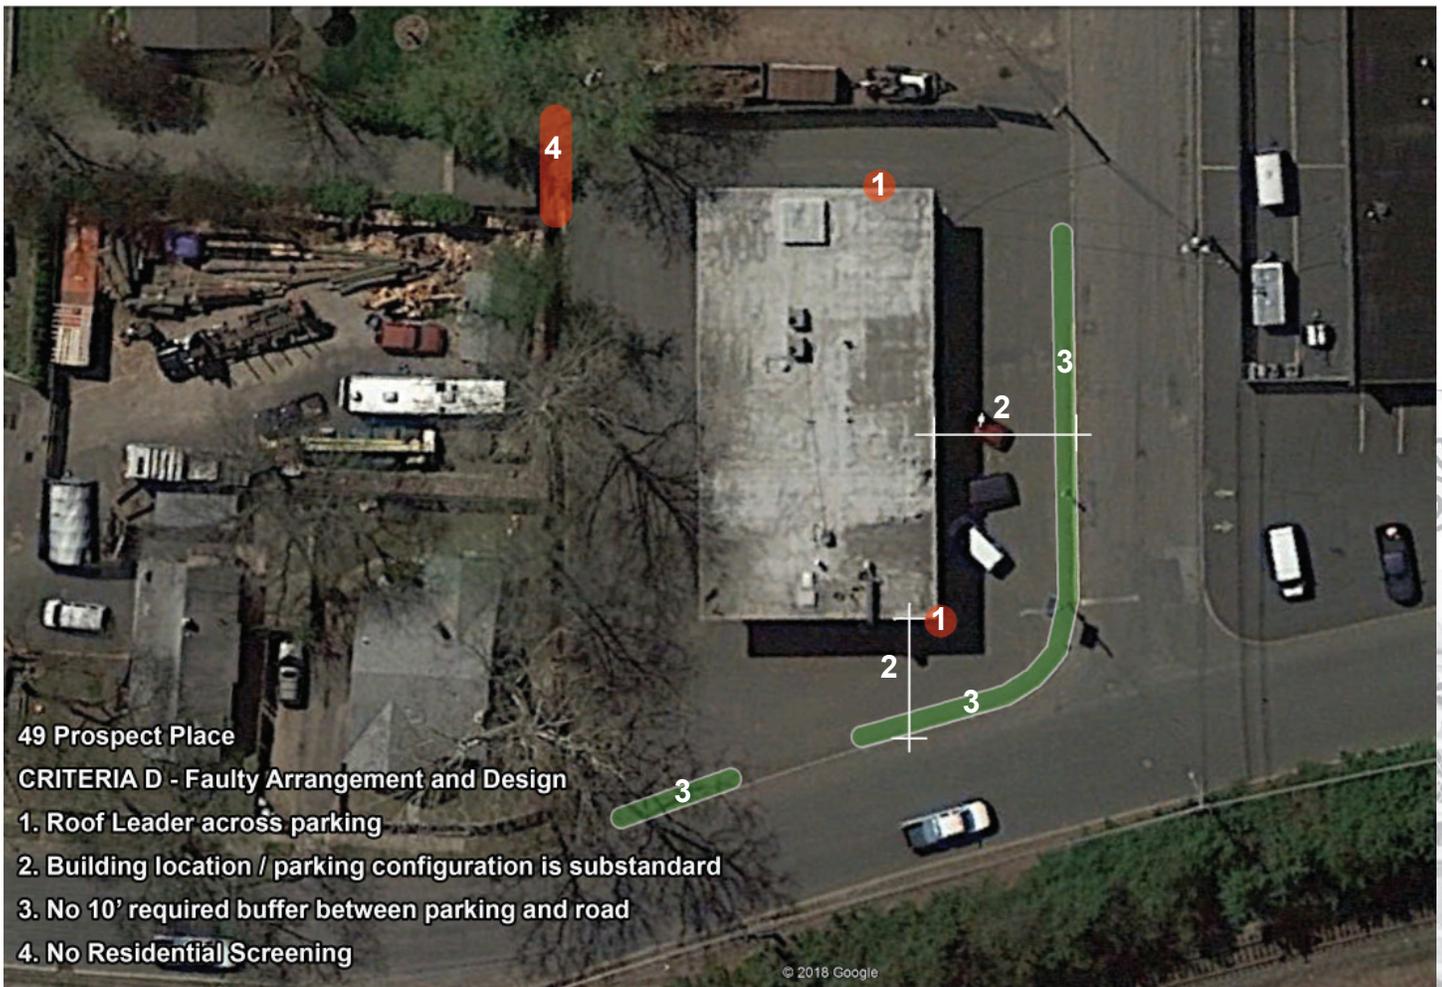
- 1) The roof leaders drain water across the asphalt parking areas and drive aisles into the public right of way. During rain and freezing events this condition is detrimental to the safety, health and welfare

- 2) The portion of the property adjacent to the residential zoning district at the rear does not provide the required minimum landscape buffer strip with planted evergreens or other natural foliage, that is not less than six feet in height, and of such character as will effectively screen such use from the abutting Residential District. (*Existing Zoning - Other Required Conditions and Supplementary Notes*). This condition has a detrimental impact on the adjacent property owner as it does not block the industrial use from the residential zoning district;

- 3) The area between the building and the public streets are insufficient to allow both parking and drive aisles in such a manner as to meet the requirements of the Hillsdale Zoning Ordinance (Section 310-58). This deficiency creates a dangerous condition in that vehicles have to back into the public right of way, which is detrimental to the safety, health and welfare of the community. The existing dimension between the building and Prospect Place is approximately 27 feet. The zoning states, "Parking areas shall not be closer than 10 feet from any street line" (Section 310-58). As noted the asphalt parking goes directly to the back of curb along both streets, which does not meet this requirement.

Image 1: Google Aerial Map depicting the site, locations of the roof leader drains, lack of the 10 foot required buffer, distance between the building and the back of curb as well as the area at the rear that lacks the required screening.

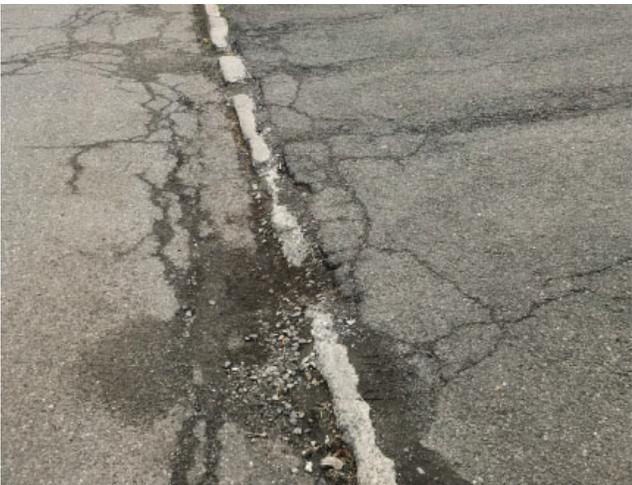
Image 13: View at drive entrance depicting damage to asphalt in the public right of way.

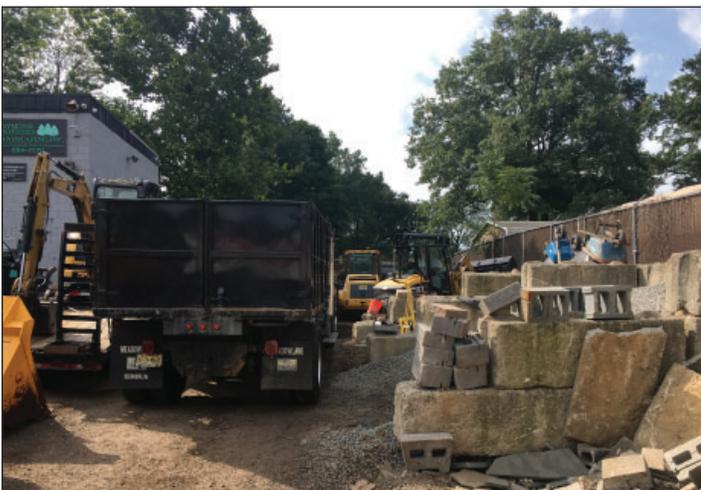
**Image 1:** Construction bins located where parking was identified in the site plan application.

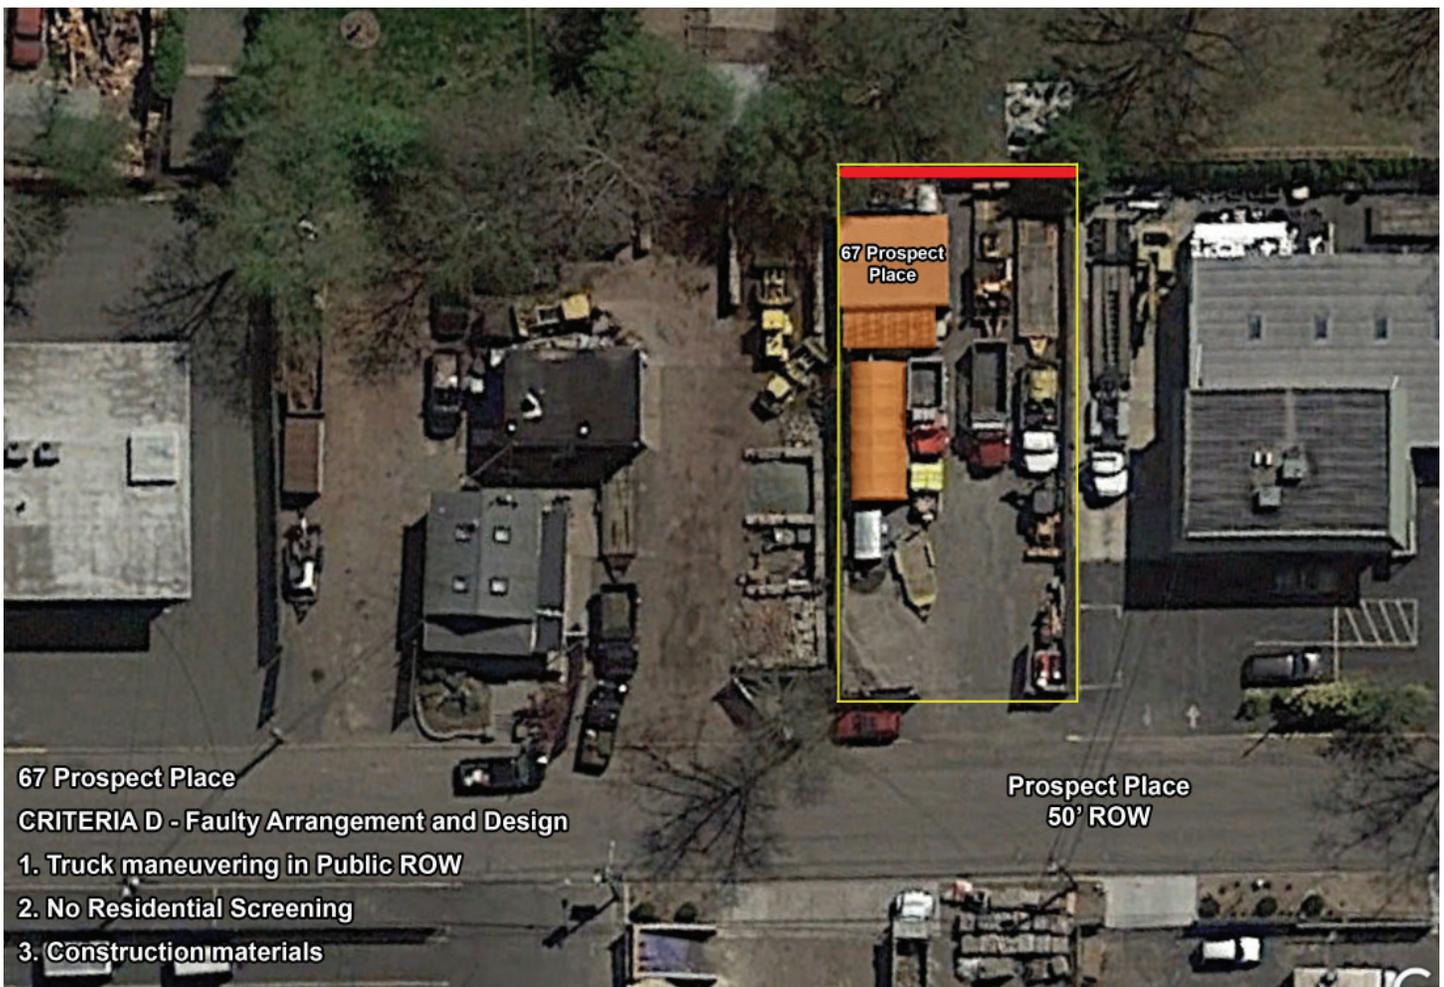
**Image 1:** Google Aerial Map which depicts the two sheds on the site, the lack of required screening along the rear property line and the construction materials located adjacent to the Prospect Place Right of Way.

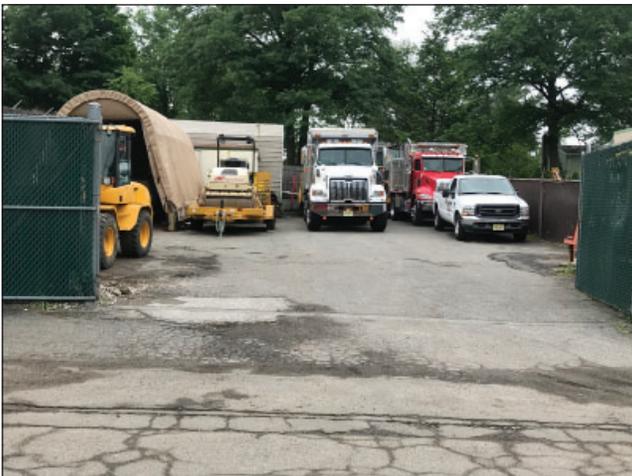
**Image 4:** Damage to the driveway apron area. Water run off with sediment in the public right of way. Commercial vehicles backed into the property. No required landscape screening at the rear property line.

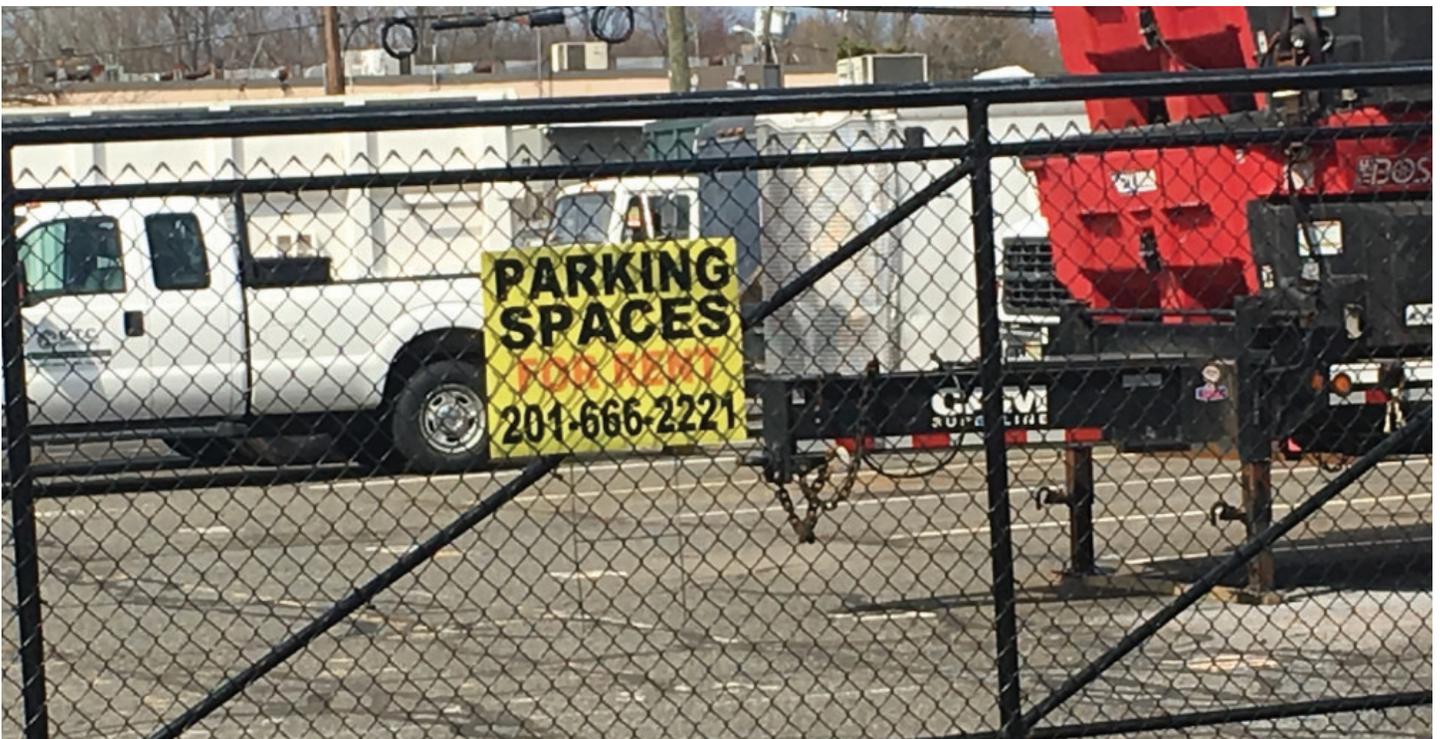
**Image 1:** Street view from Prospect Place depicting the six foot chain linked fence, with commercial vehicles and trailers stored on site without screening or shielding the vehicles from public view.

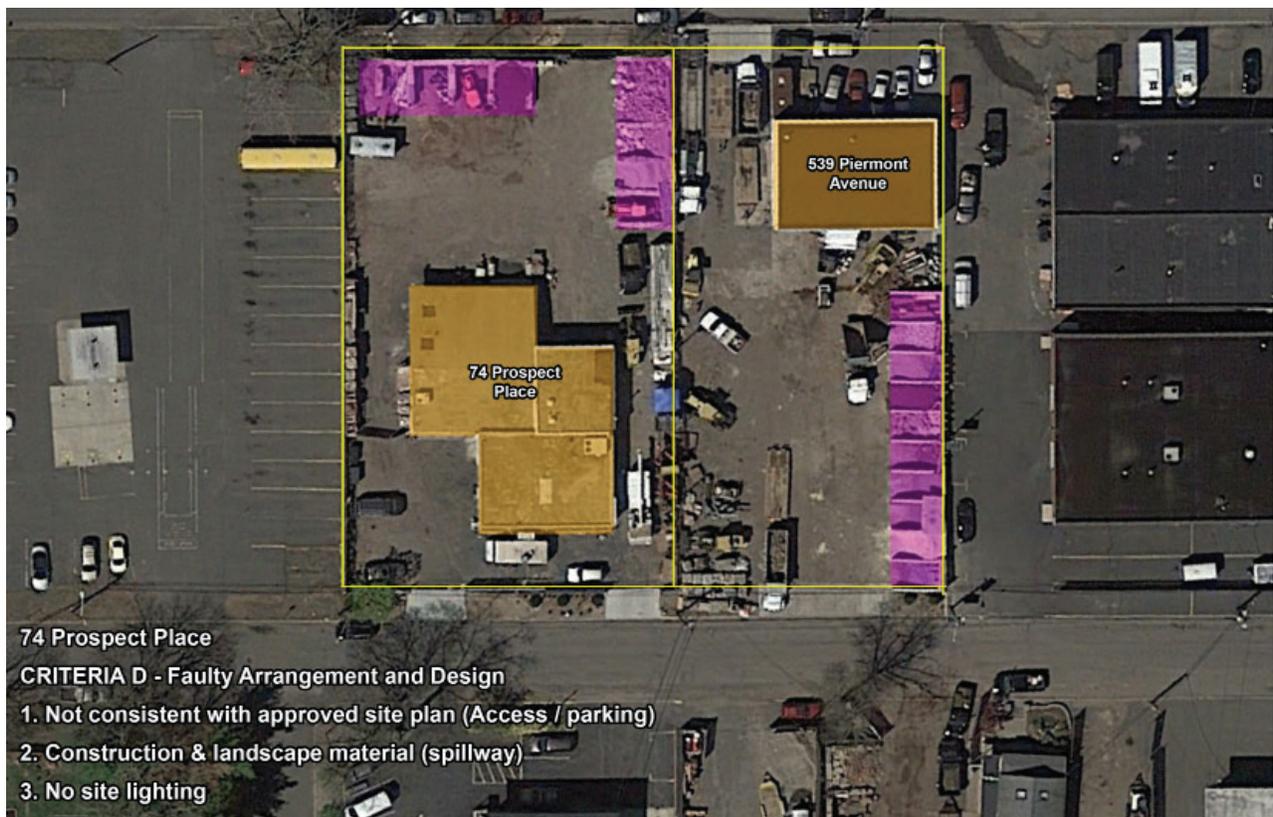
**Image 1:** Google Arial Map depicting the buildings, outdoor storage bins, one access point from Piermont Avenue, construction storage materials in the identified fire lane and a lack of delineated parking

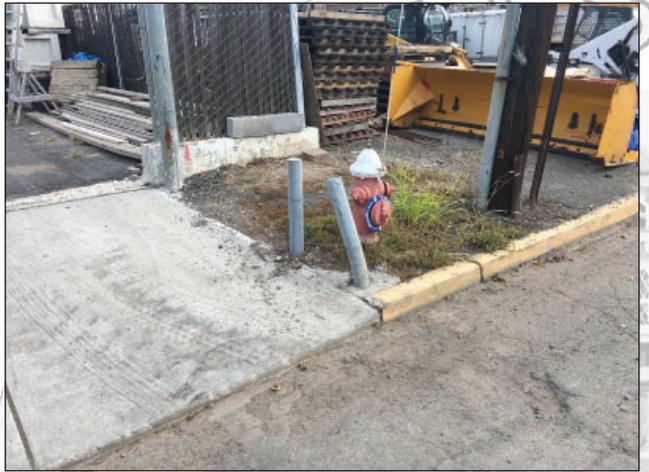
**Image 6:** Construction materials located directly on the asphalt area. Damage to protective bollard in the public right of way. Sediment and gravel in the street.

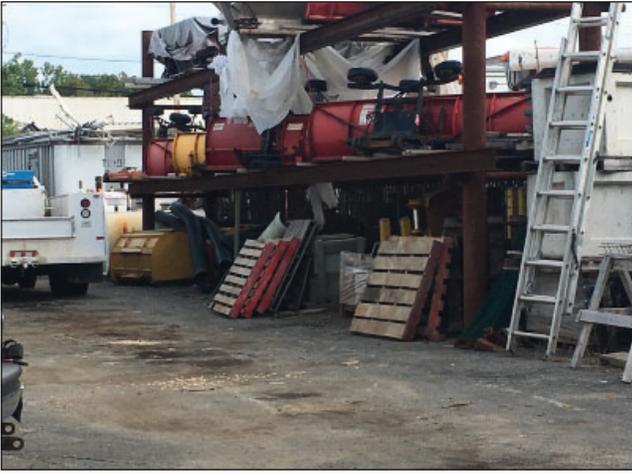
**Image 7:** Storage of materials on asphalt area. Sediment, gravel and potential chemicals visible on asphalt.

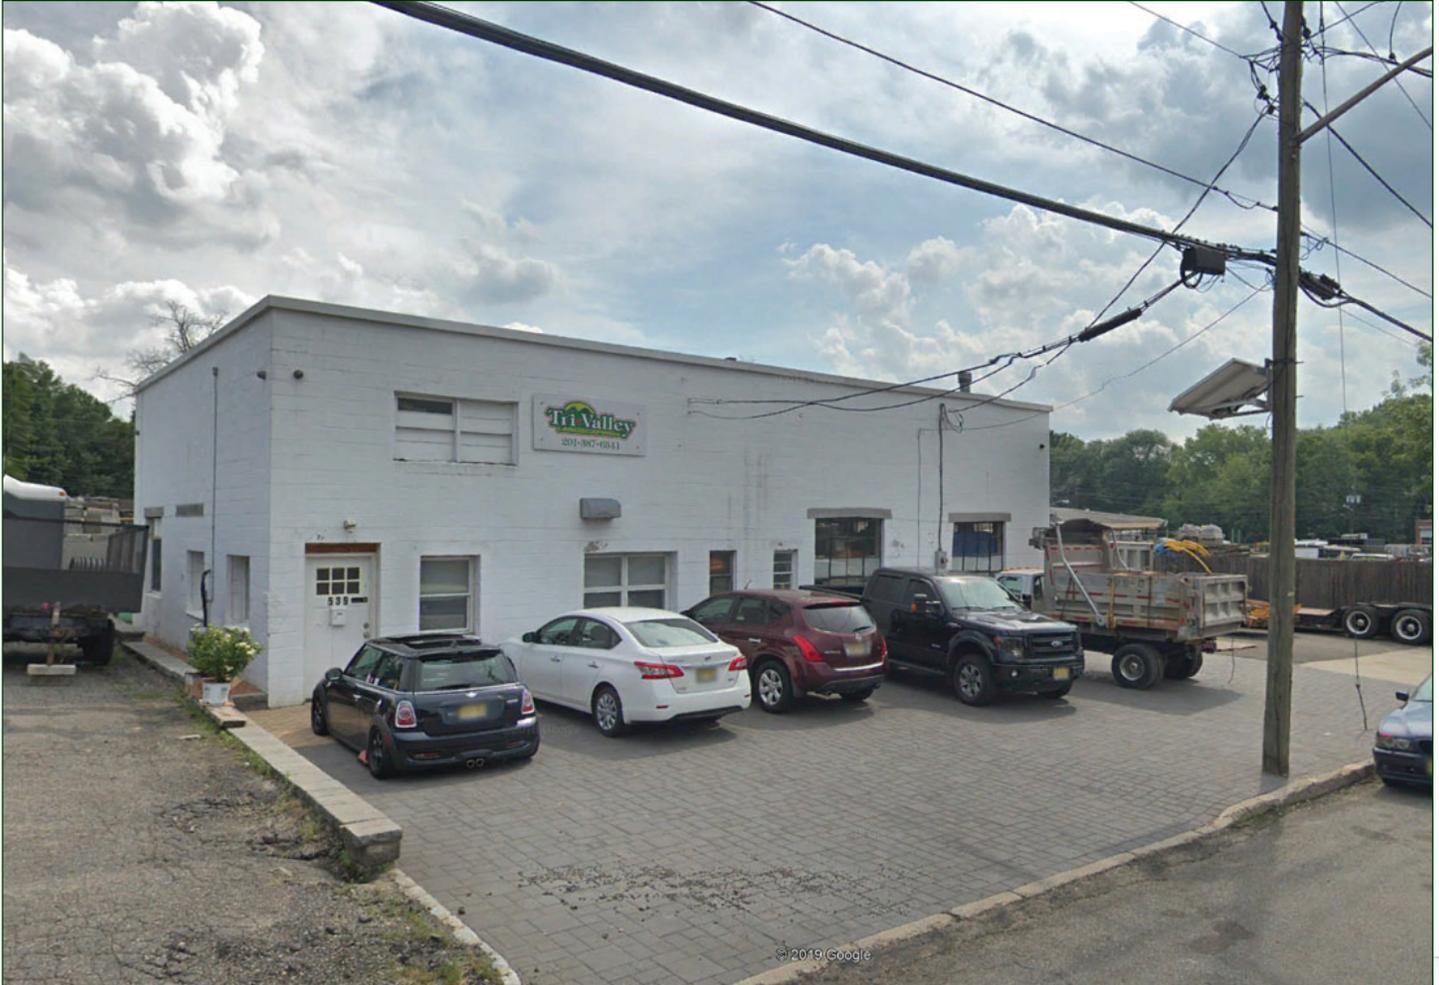
**Image 1:** Head in parking along Piermont Avenue with not enough depth to allow vehicles to maneuver within the right of way. Includes the utility pole and guy wire.

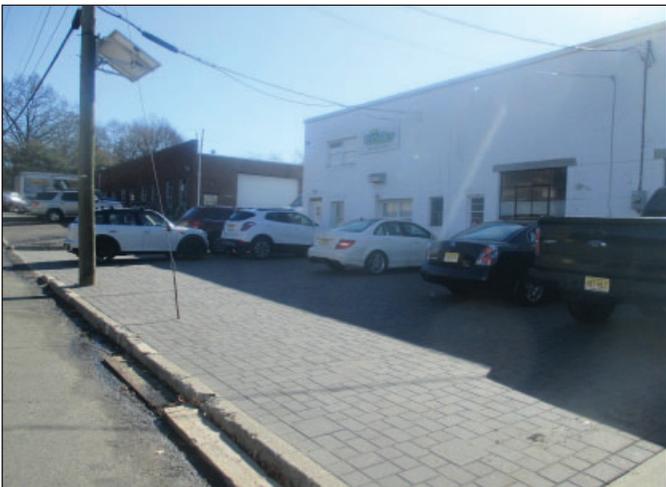
**Image 5:** Head in parking along Piermont Avenue with wood placed in the public right of way to encourage vehicles to drive over the existing curb which has visible damage.

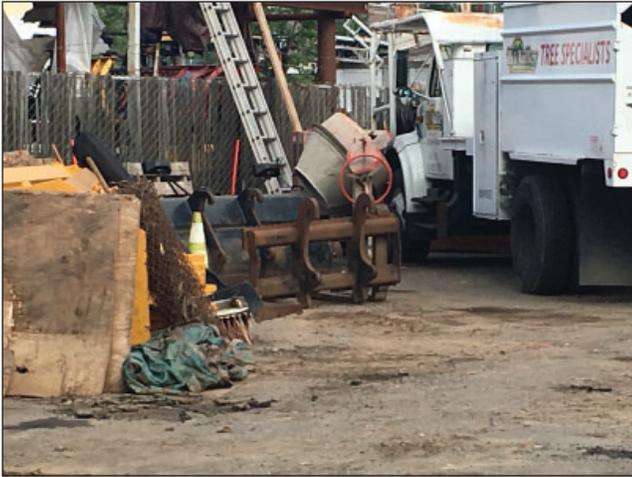
Image 13: Rusting construction materials and damage to the existing asphalt.

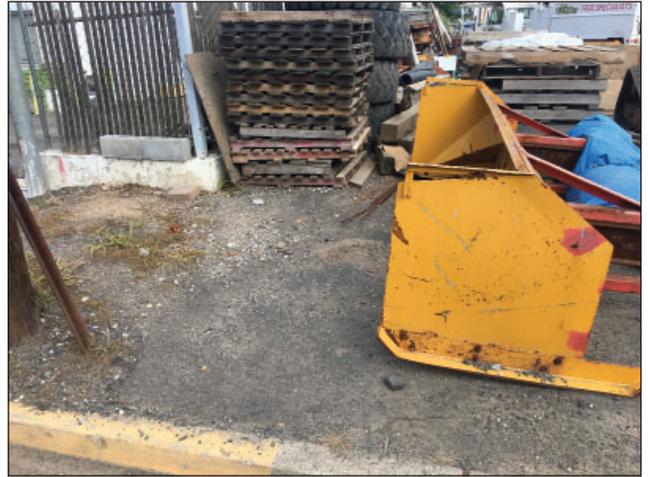
Image 14: Construction debris in the public right of way with sediment and gravel run off in the public right of way

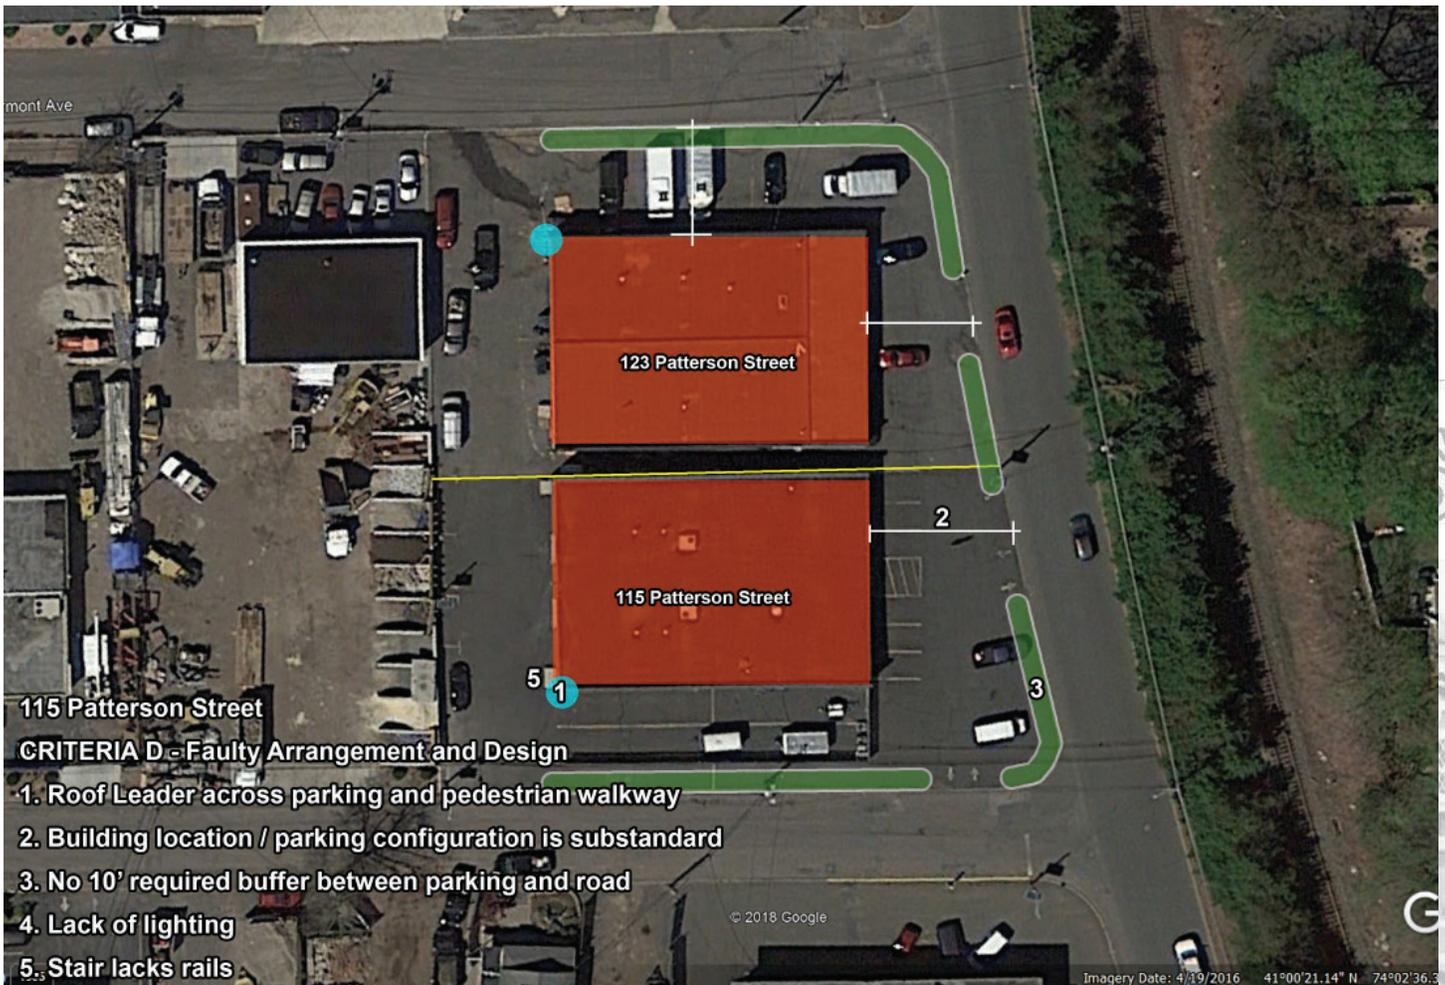
Image 1: Google Aerial Image depicting the location of the building, lack of depth between the building and Patterson Street, lack of 10 foot buffer between parking and the street, location of the roof leader drain and the location of the rear stair with the lack of handrails.

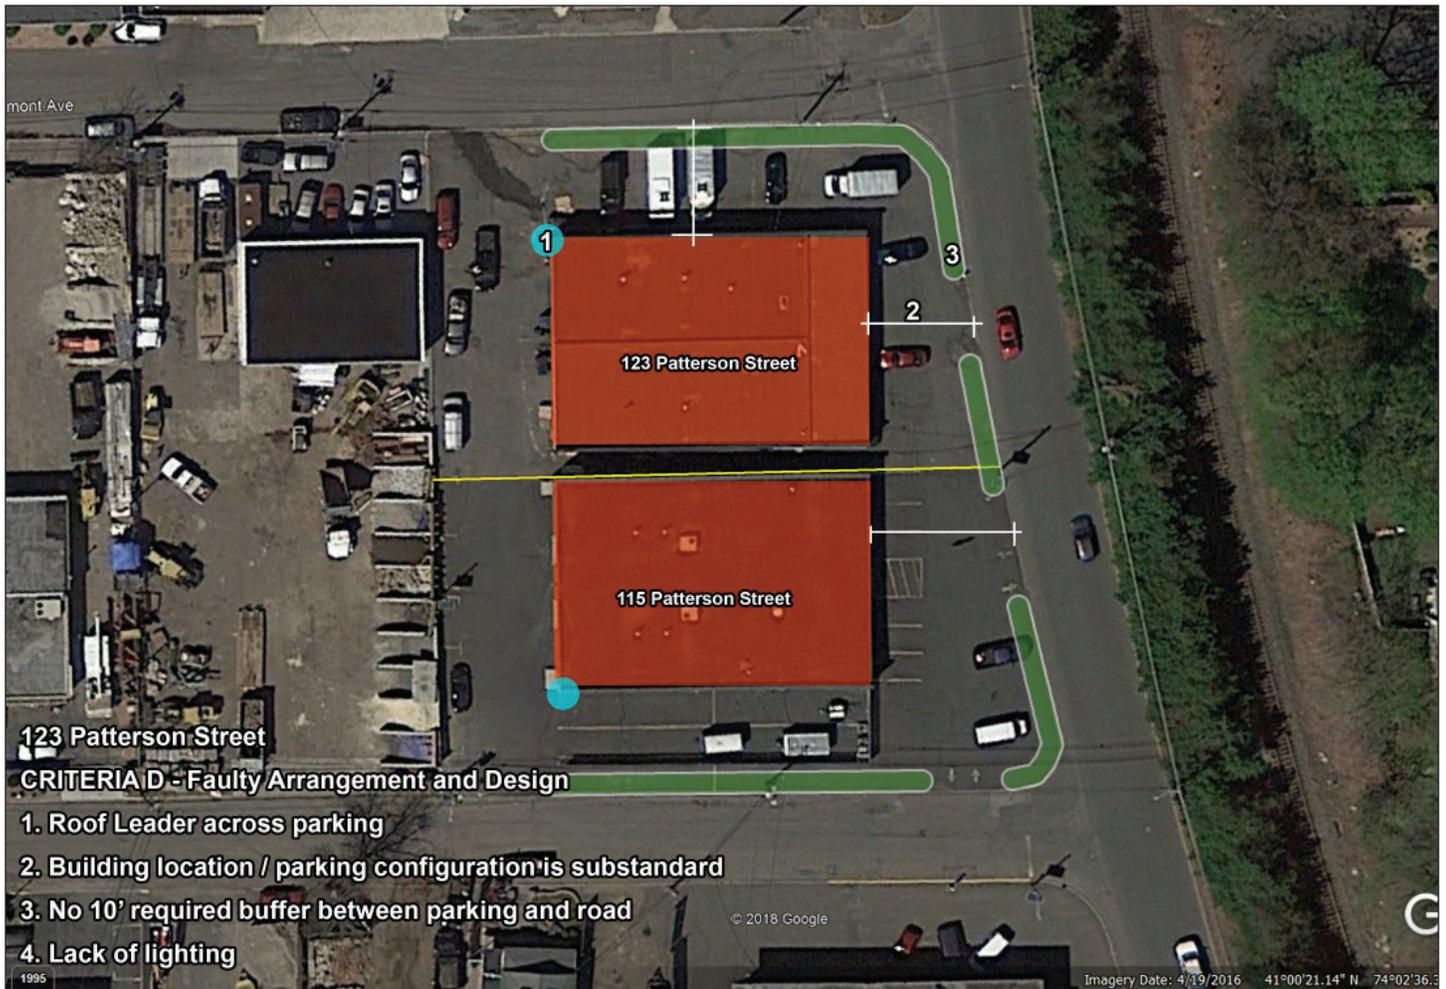
Image 4: Google Aerial Map depicting the location of a roof leader drain, lack of dimension between the building and the back of curb, and a lack of the 10 foot required buffer along the street frontages.

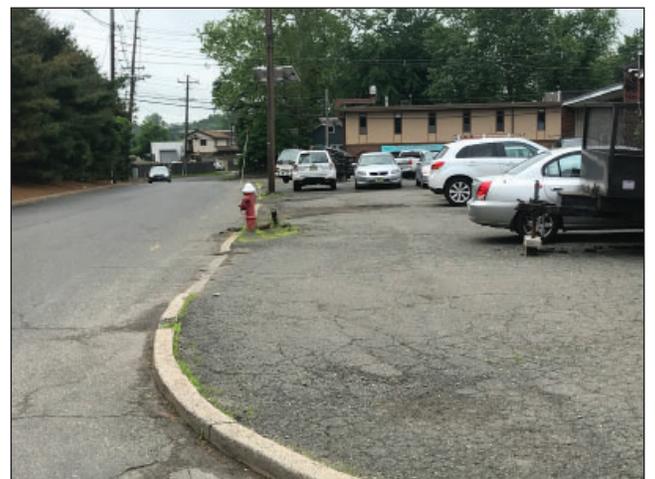
Image 6: Parking area along Patterson Street with vehicles in the public right of way. No sidewalks or pedestrian safety measures. Damage to bollard protecting the fire hydrant.

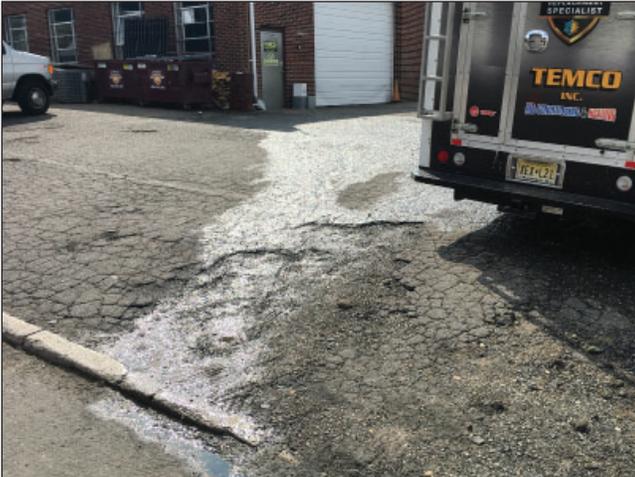
**Image 7:** Roof leader draining across asphalt area into the public right of way into Piermont Avenue.

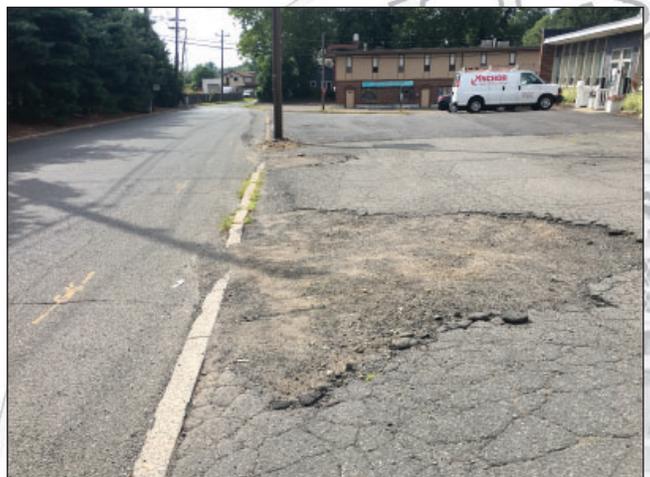
**Image 12:** Drainage toward Patterson Street with deterioration of asphalt and sediment.

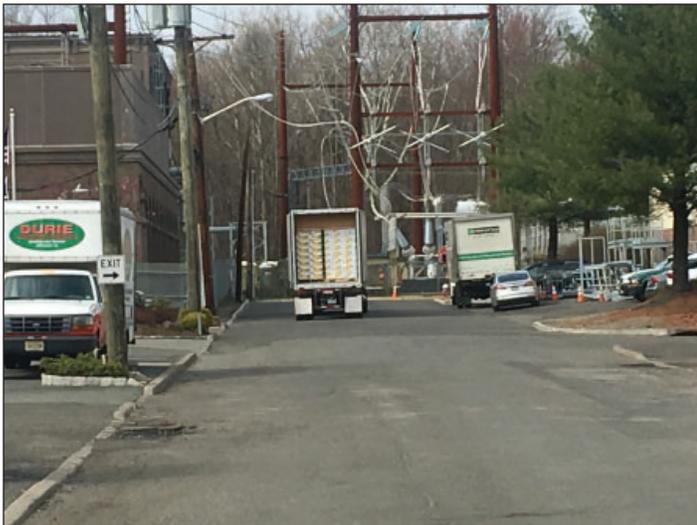
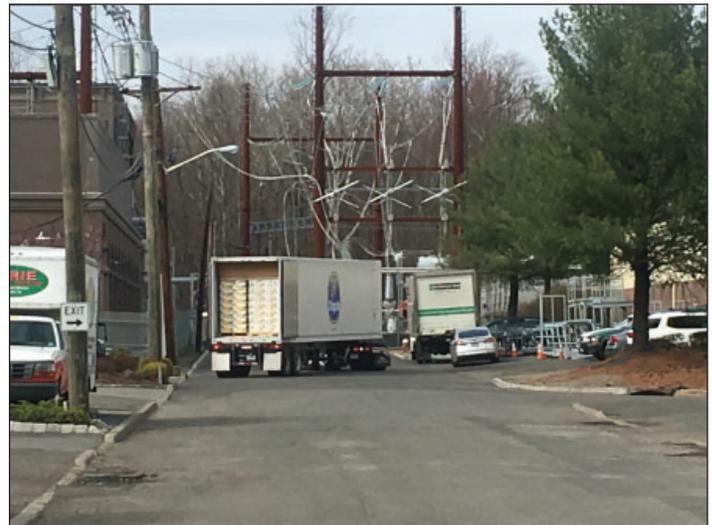
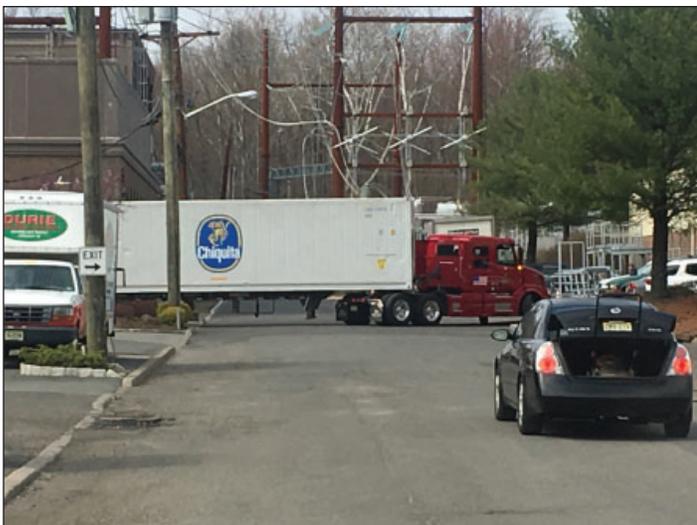
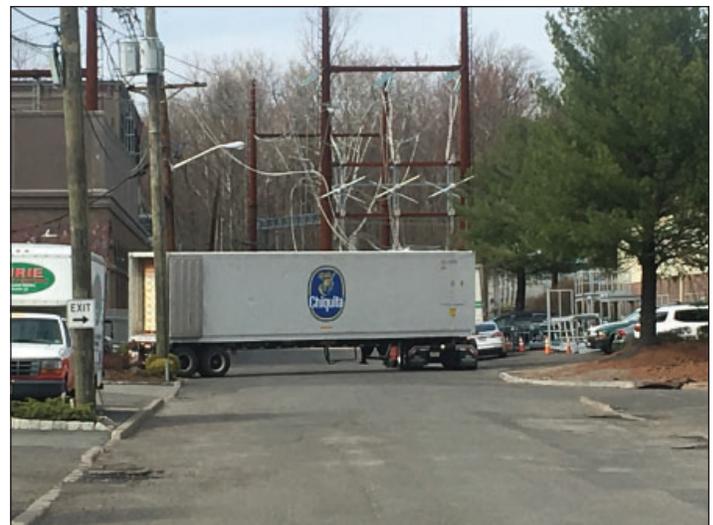
**Image 1:** Series of photographs depicting an 18 wheeler backing into the property from Prospect Place during business hours.

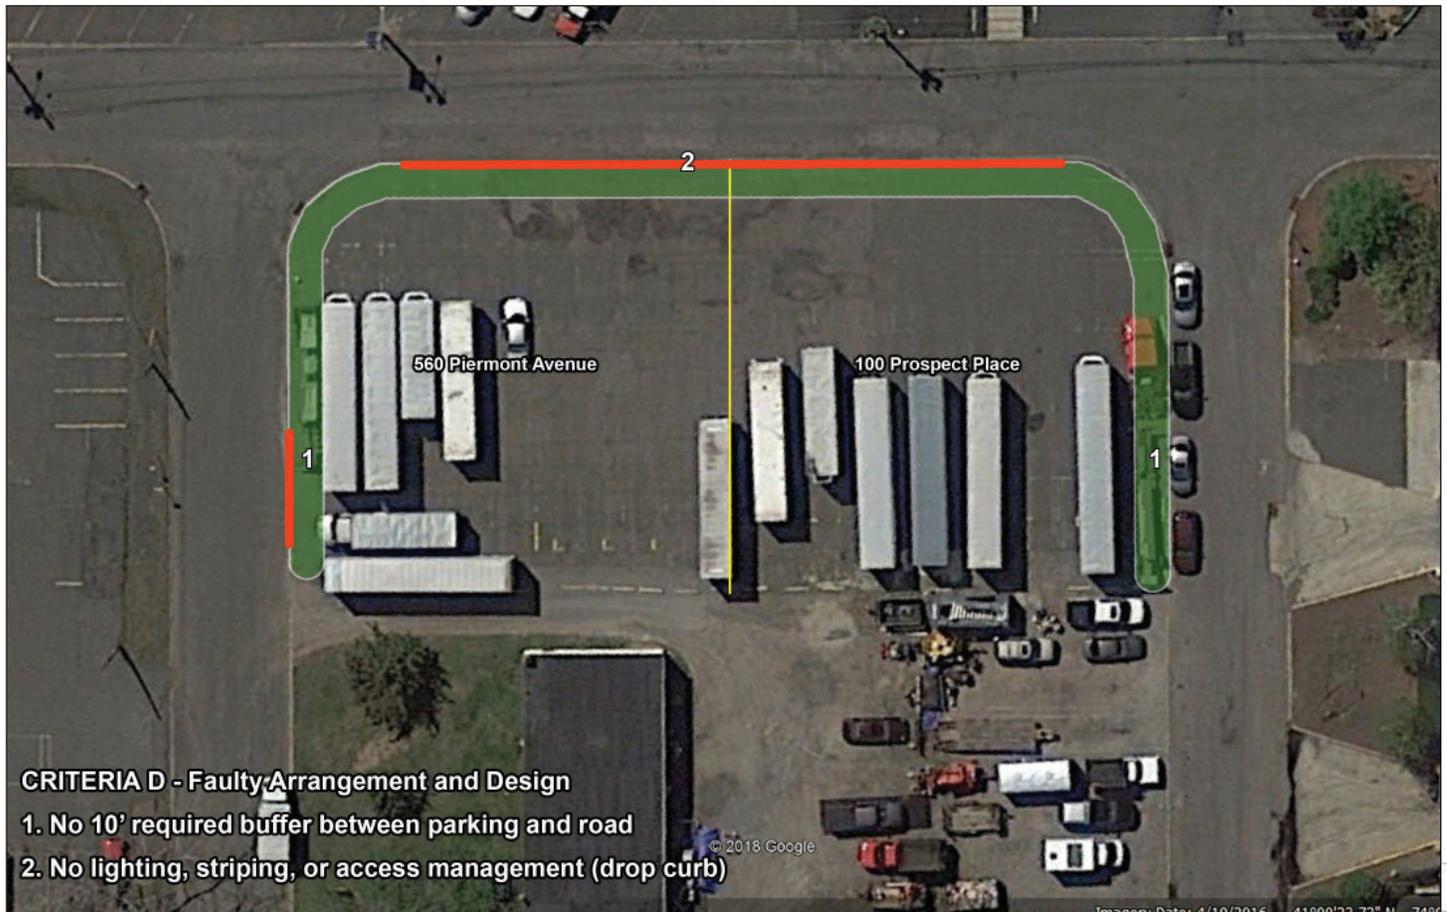
Image 1: Google Aerial Map depicting impervious parking area with no sidewalks, lighting, pedestrian safety measures and the drop curb locations.

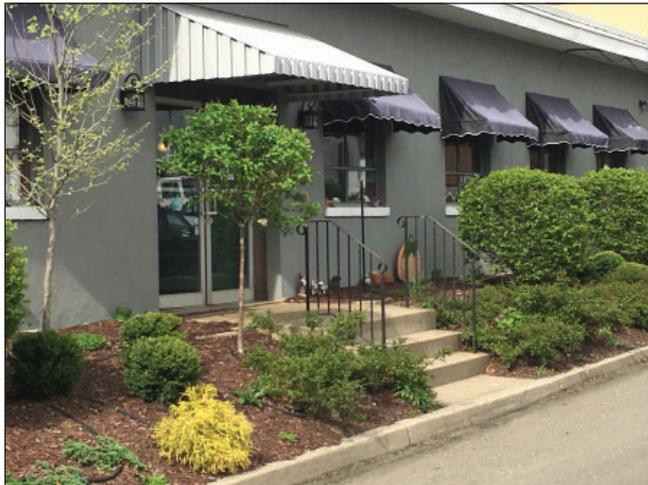
Image 2: Damage on building along roof line

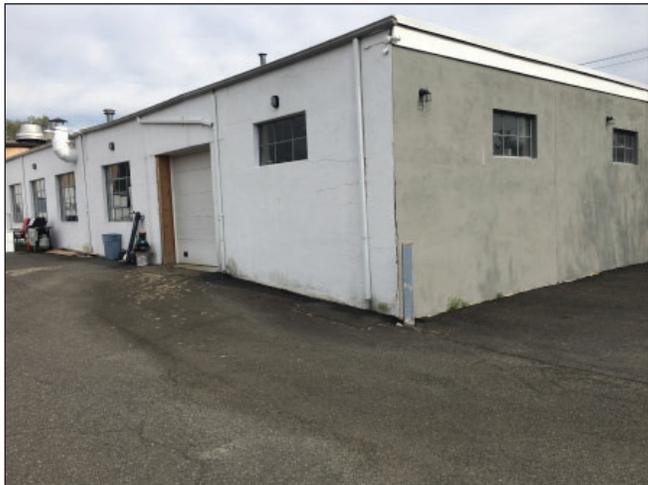
Image 2: Damage on building along roof line

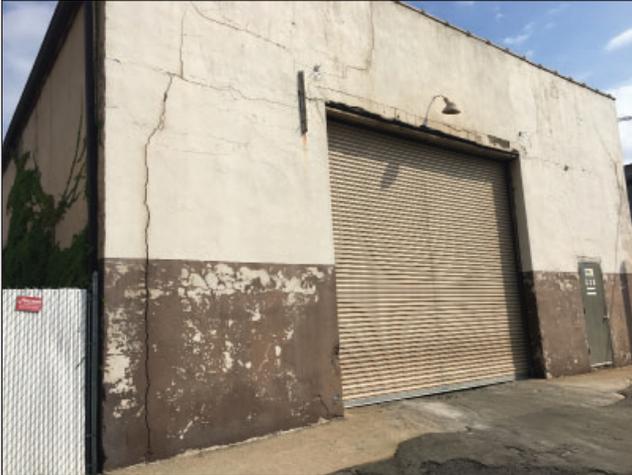
**Image 1:** Building at west edge of property facing interior property depicting large cracks along the facade.

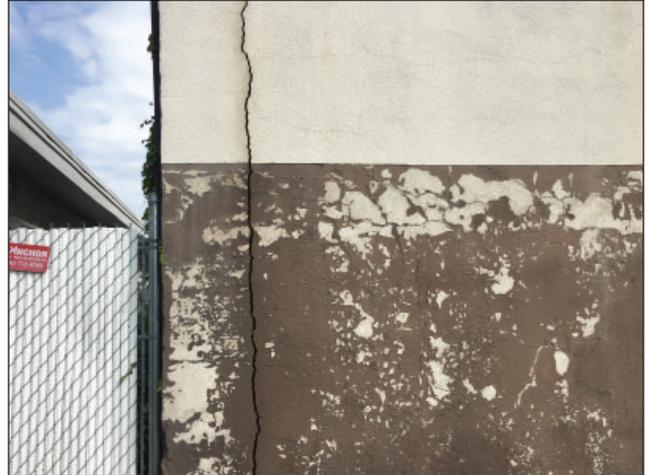
**Image 2:** Building at west edge of property facing interior property depicting large cracks along the facade.

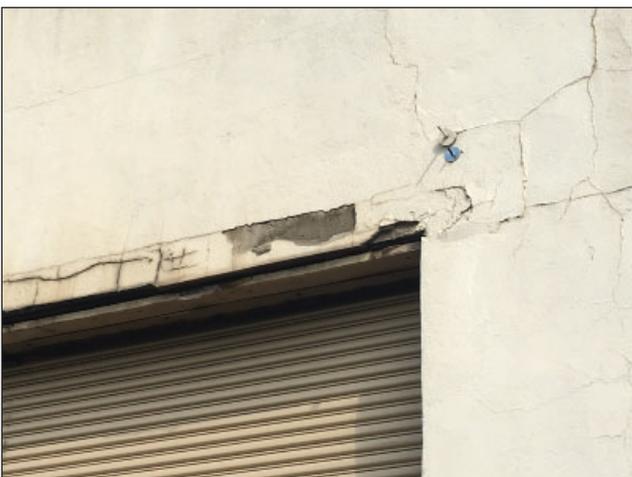
**Image 5:** Building at west edge of property facing interior property depicting large cracks and missing construction materials along the facade.

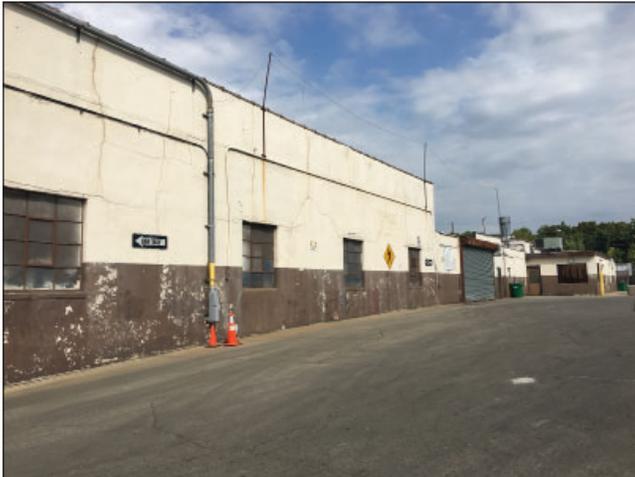
**Image 7:** Building at west edge of property facing interior property depicting large cracks along the facade.

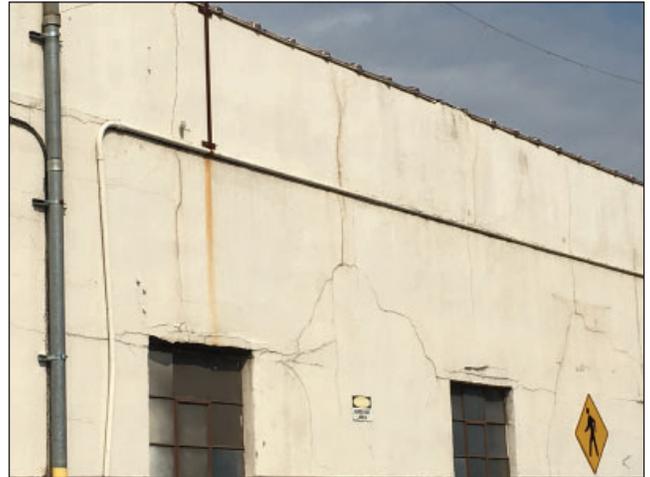
**Image 8:** Building at west edge of property facing interior property depicting large cracks along the facade.

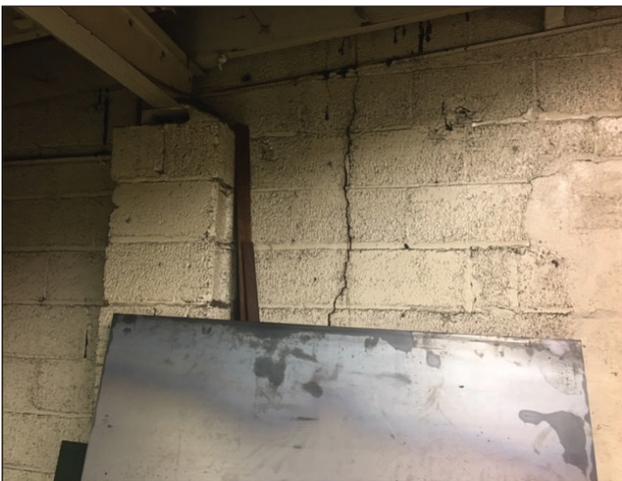
**Image 9:** Building at west edge of property facing interior property depicting large cracks along the interior walls.

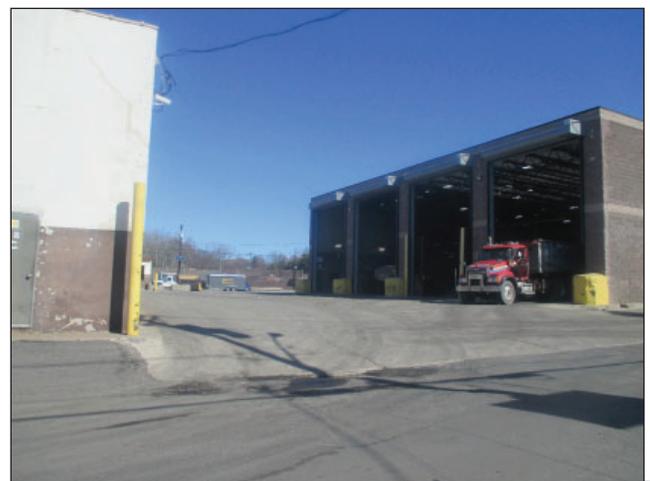
**Image 10:** Two story building with four garage bays depicting impervious area and grading toward the public right of way. No sidewalks, lighting or access control measures.

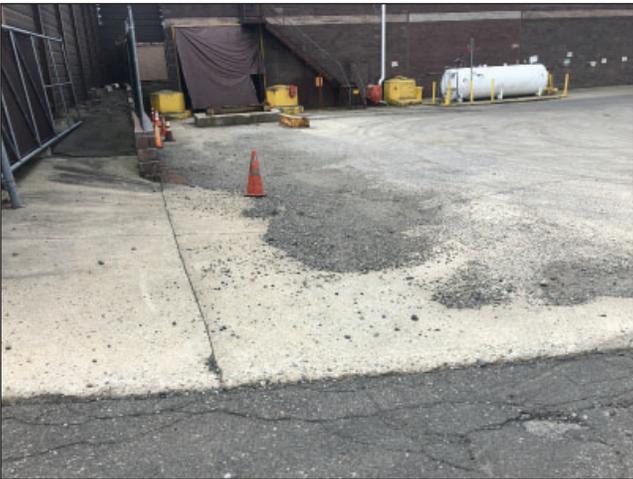
Image 27: View from Brookside Place across impervious lot to the building depicting roof drain, sediment and fuel tank with missing bollards.

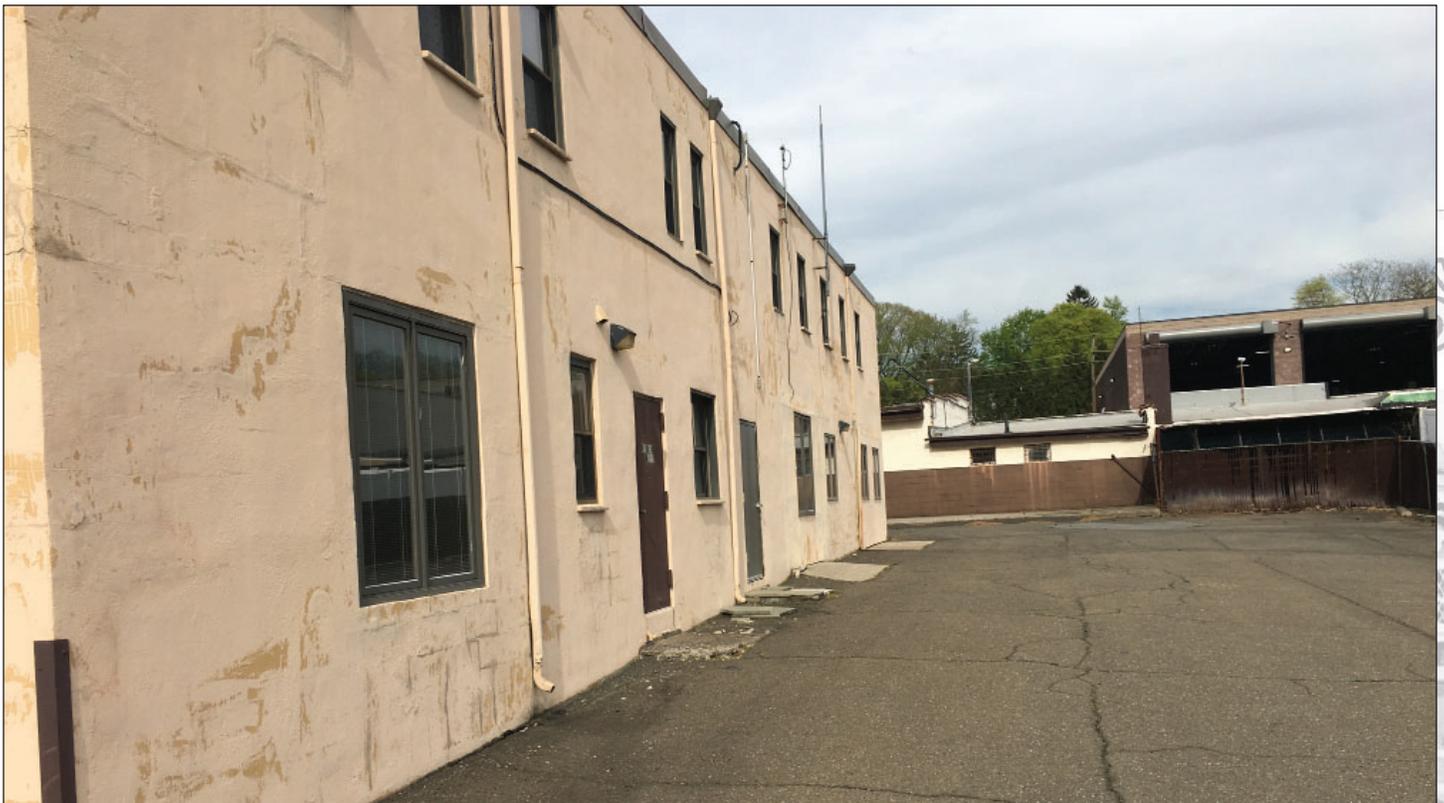
**Image 1:** View of the rear facade and parking area depicting the roof leader drains directly onto the asphalt, doorways raised above the parking area.

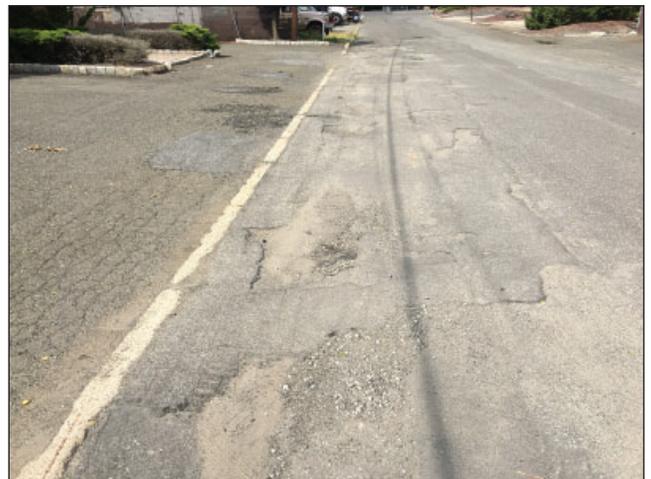
**Image 11:** View of parking area in front of the building along the drop curb depicting sediment and damage to the asphalt.

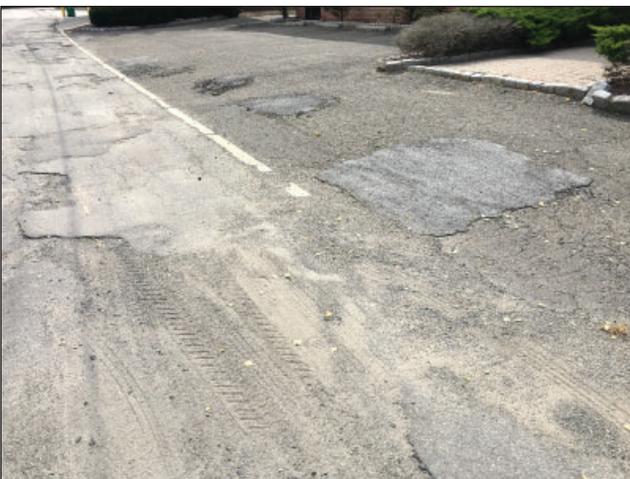
**Image 12:** View of asphalt parking with no access control measures and significant sediment across the public right of way.

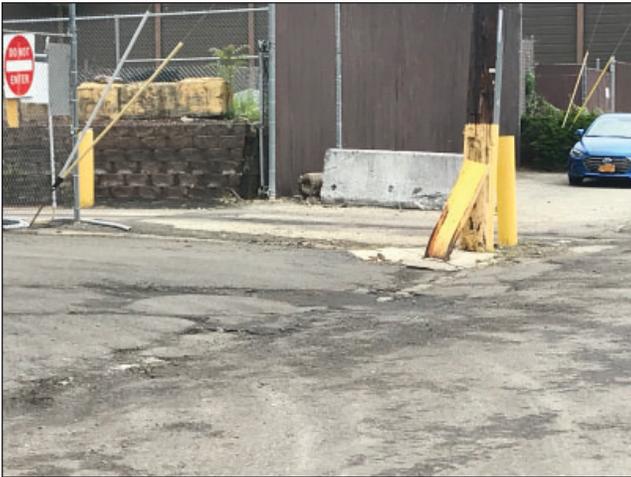
Image 17: View of entrance into the asphalt parking area with damage to utility pole protection.

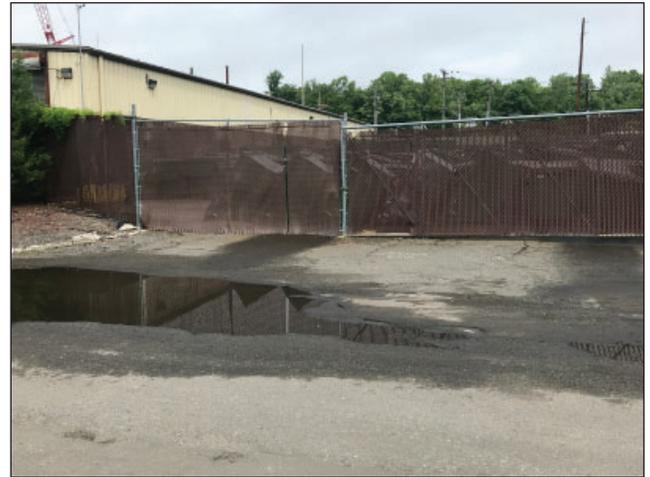
Image 18: View along Brookside Place depicting no curb, sidewalk, street lighting or pedestrian safety controls.

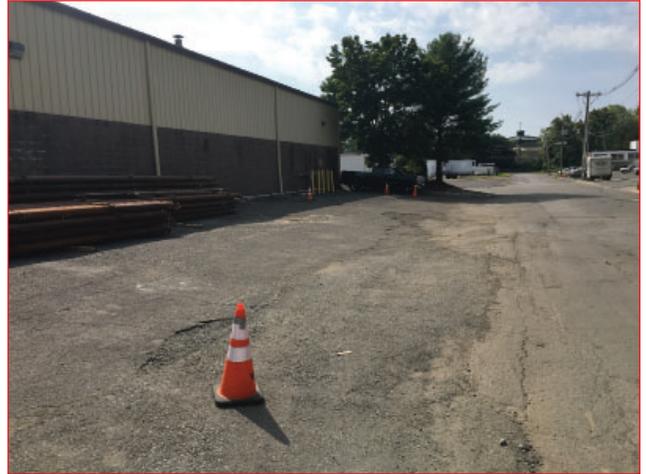
**Image 2:** View of parking area on Prospect Street with rusting construction materials. Grades toward the street with sediment and debris in the public right of way.
