Report of  
**Preliminary Investigation for  
Determination of an Area in Need of Redevelopment  
without Condemnation**

Block: 1207, Lots: 8, 9 10 & 11; Block: 1208, Lots: 1, 2, 3, 4 & 5; Block: 1209, Lots: 2, 3, 4, 5 & 6;  
Block: 1210, Lots: 6, 7, 8, 9, 10 & 11; Block: 1211, Lots: 1 & 2; Block: 1212, Lot: 13.

**Prepared By:**  
DMR Architects

**Prepared For:**  
Borough of Hillsdale  
Bergen County, New Jersey

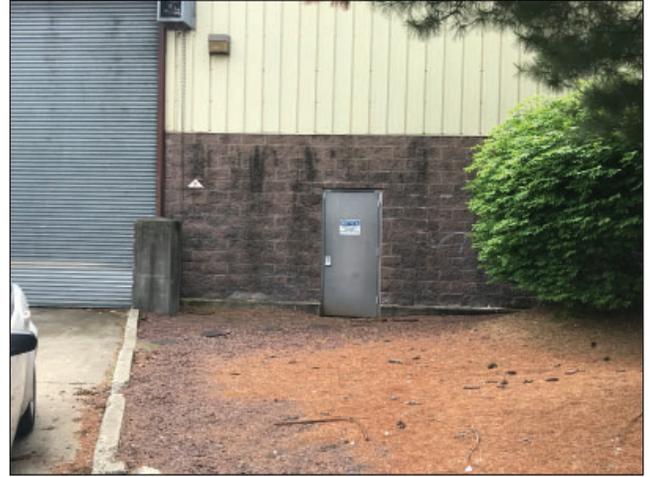
**Image 8:** View of Knickerbocker entrance with no sidewalk or safety lighting.
