Report of  
**Preliminary Investigation for  
Determination of an Area in Need of Redevelopment  
without Condemnation**

Block: 1207, Lots: 8, 9 10 & 11; Block: 1208, Lots: 1, 2, 3, 4 & 5; Block: 1209, Lots: 2, 3, 4, 5 & 6;  
Block: 1210, Lots: 6, 7, 8, 9, 10 & 11; Block: 1211, Lots: 1 & 2; Block: 1212, Lot: 13.

**Prepared By:**  
DMR Architects

**Prepared For:**  
Borough of Hillsdale  
Bergen County, New Jersey

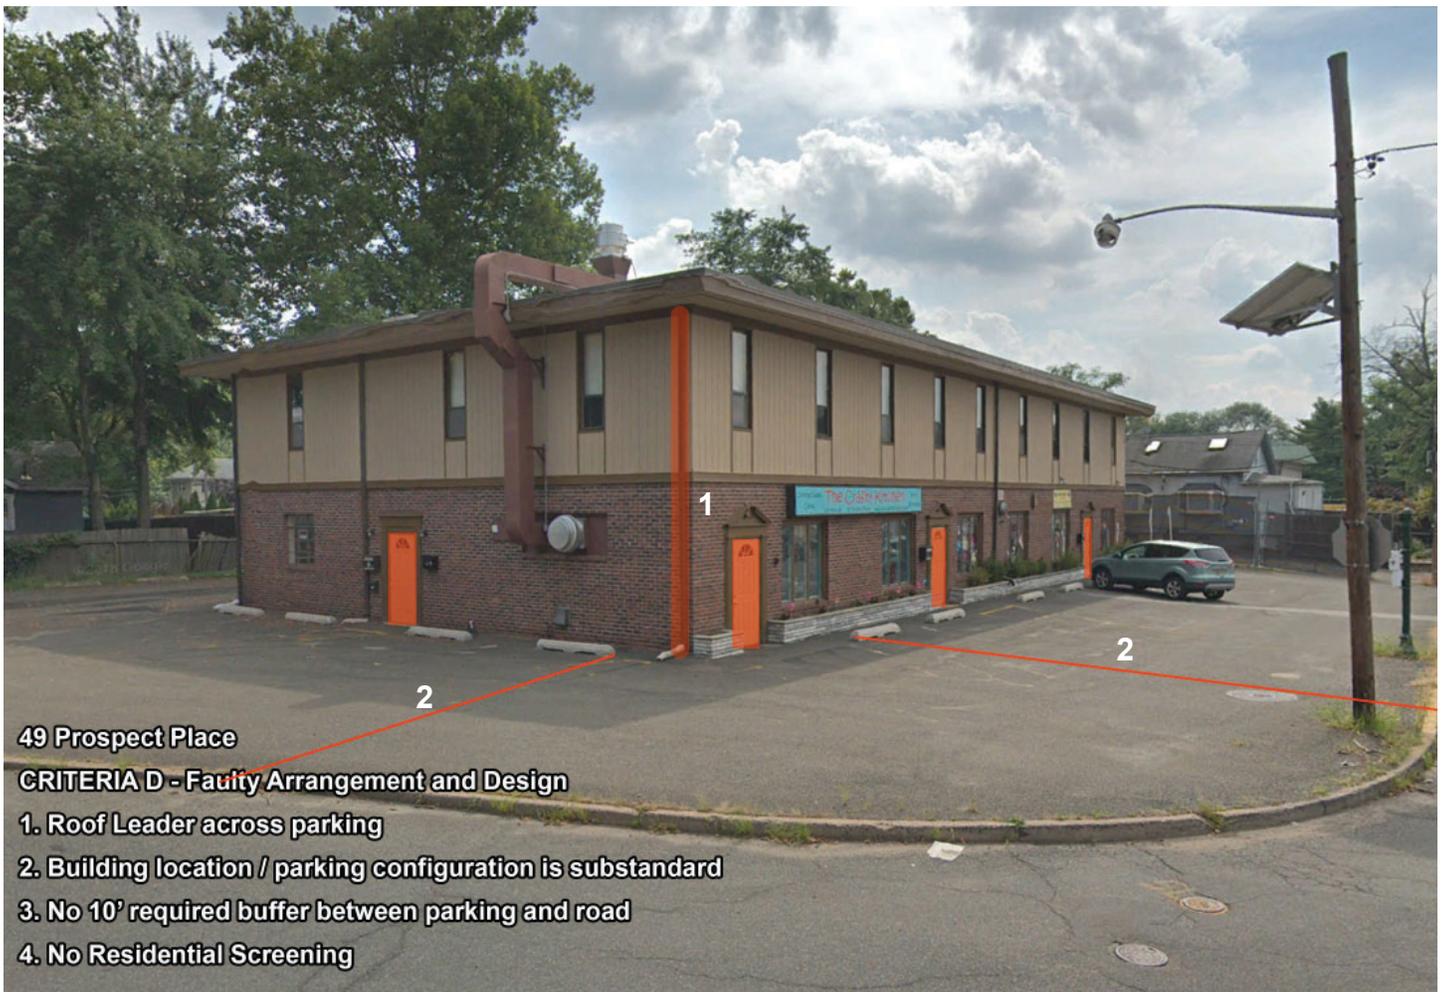
**Image 2:** Google Street View Map depicting the site, location of one of the roof leader drains, lack of the 10 foot required buffer, distance between the building and the back of curb.

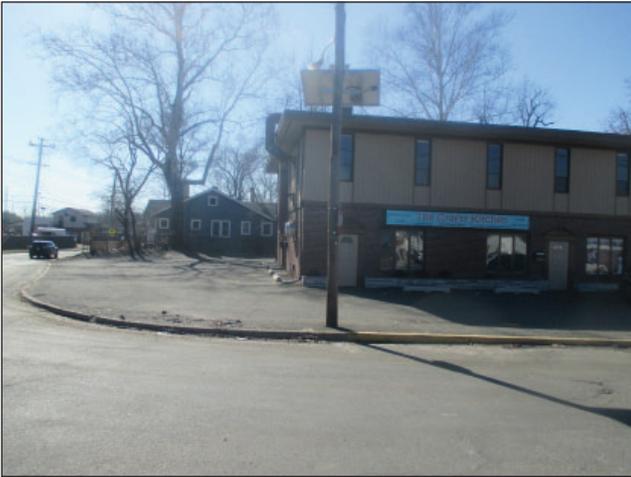
**Image 3:** View from the corner of Prospect Place and Patterson Street with no sidewalks, lighting and asphalt to the back of curb.

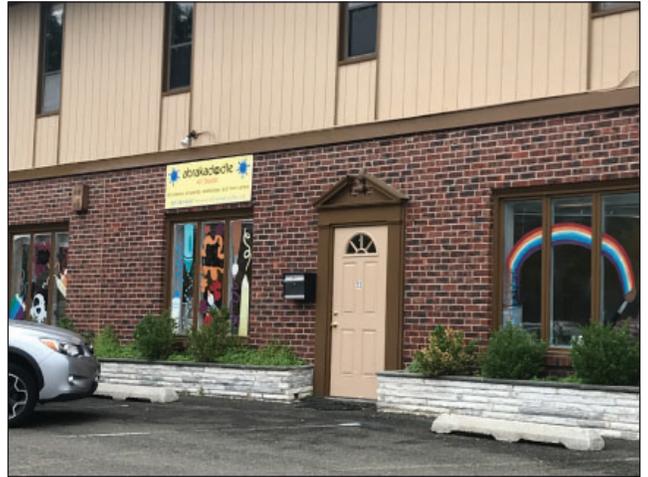
**Image 4:** Front door opening onto asphalt parking area.

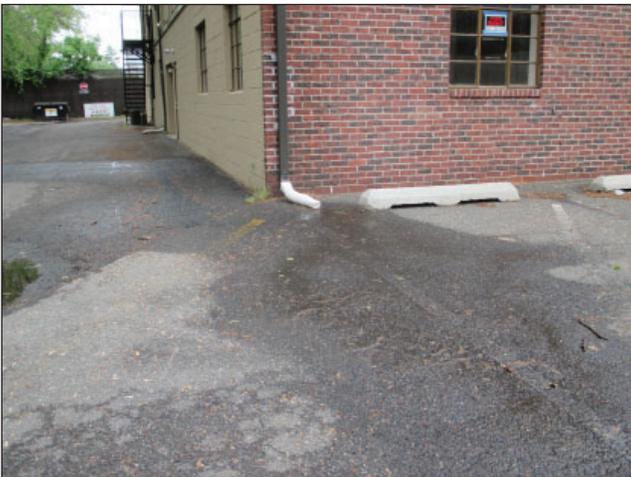
In addition, the existing building has multiple roof leaders that are concentrated and spill onto the asphalt parking and across drive aisles. Water running across the asphalt into the public street was observed during several visits to the site.

- 1) The roof leaders drain water across the asphalt parking areas and drive aisles into the public right of way. During rain and freezing events this condition is detrimental to the safety, health and welfare

**Image 5:** Roof leader draining across asphalt drive to public right of way.

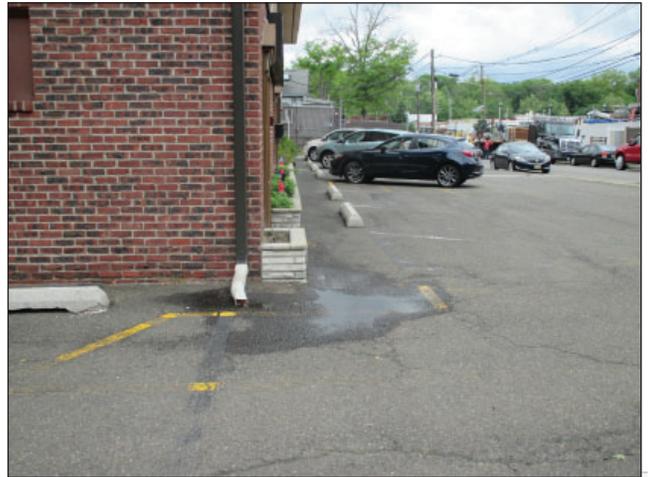
**Image 6:** Roof leader draining across asphalt drive to public right of way with angled parking in front of building.

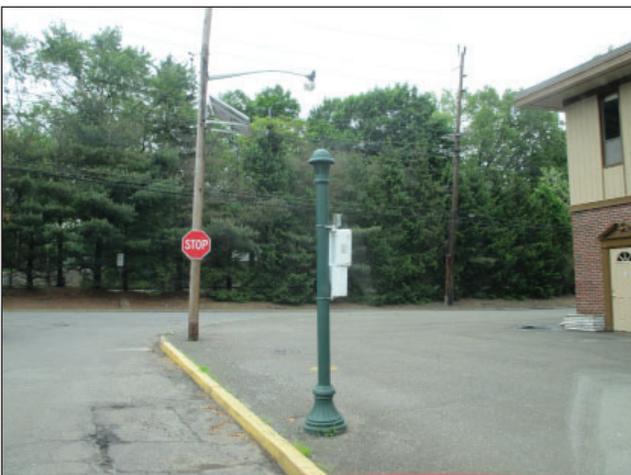
**Image 7:** Asphalt from building to the back of curb with no sidewalk and limited dimension for vehicles to maneuver.

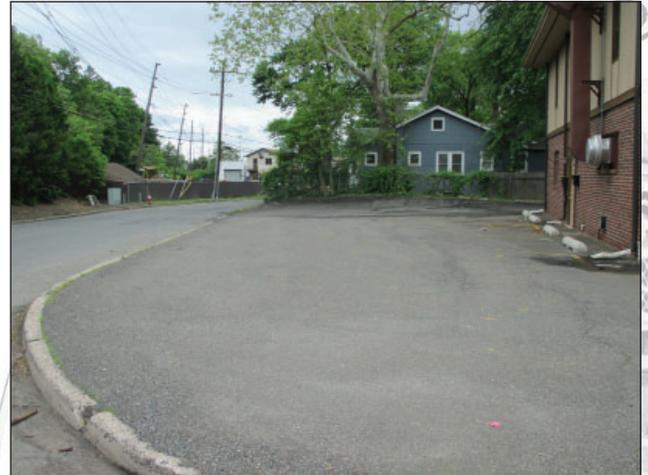
**Image 8:** Patterson Street with no sidewalk, parking against building, limited dimension for vehicular maneuvering.

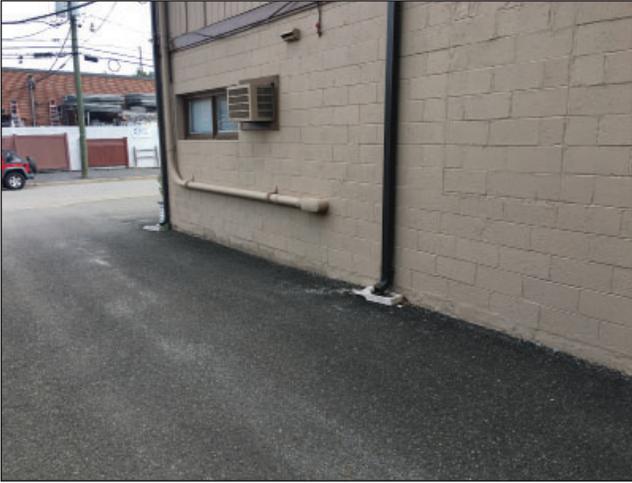
Image 9: Side of the building with roof leader draining on the asphalt parking

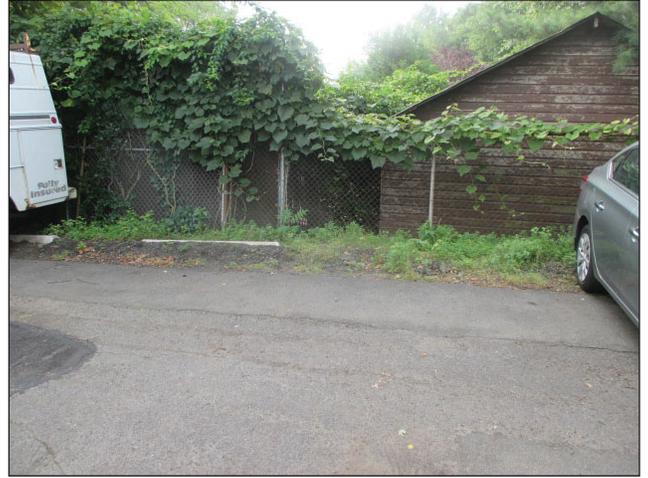
As indicated, a portion of the property abuts a the R-4 (residential zoning district), which requires, a minimum landscape buffer strip with planted evergreens or other natural foliage, not less than six feet in height, and of such character as will effectively screen such use from the abutting Residential District (*Existing Zoning - Other Required Conditions and Supplementary Notes*). The property does not conform to the required landscape buffer as noted in the attached images.

Image 10: View of rear portion of property adjacent to residential without required buffer

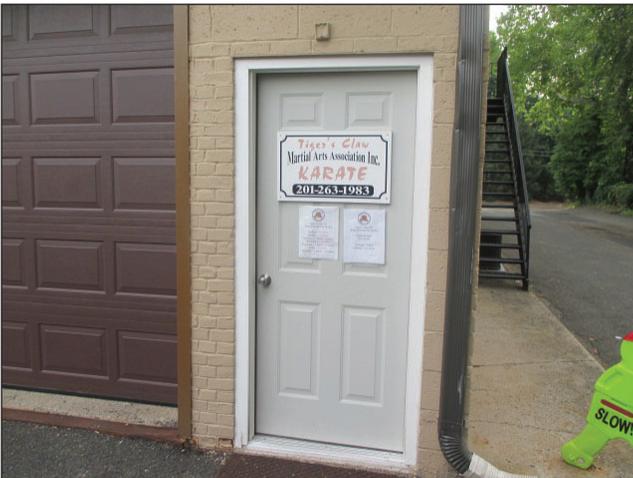
Image 11: Exterior door without light, threshold not flush and existing directly onto asphalt parking

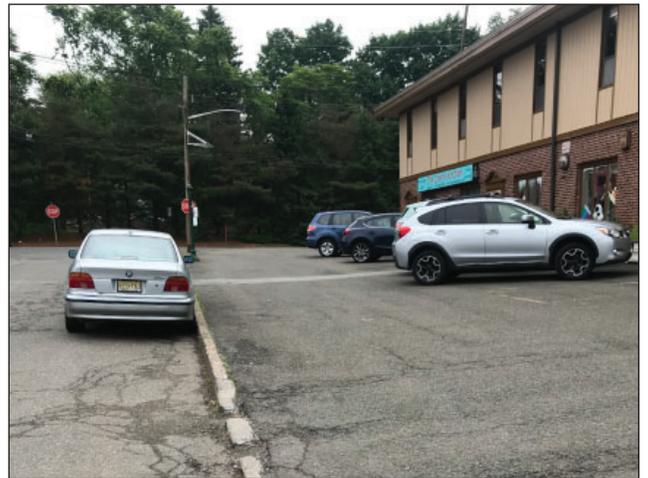
Image 12: View along Prospect Place with angled parking and limited space for maneuvering. No sidewalks or pedestrian safety measures.

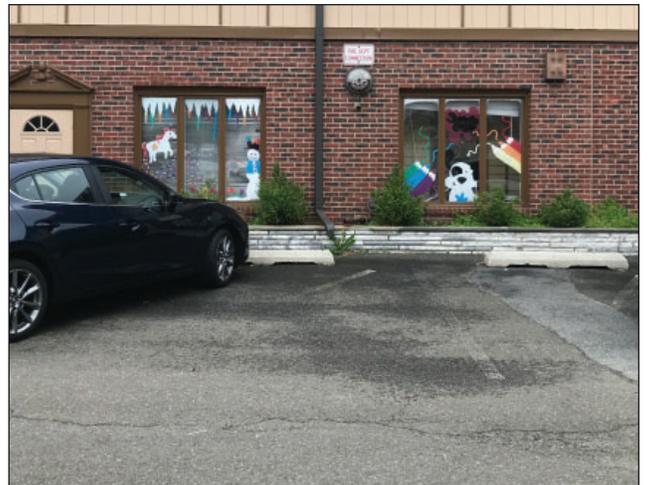
Image 14: Angled parking in front of the existing building along Prospect Place.

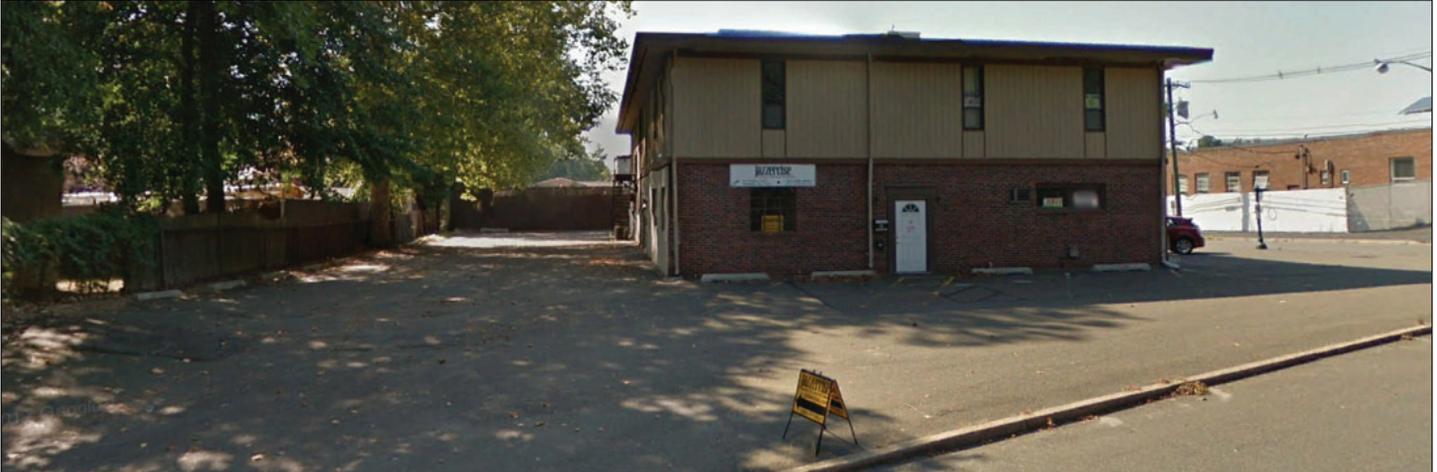
**Image 15:** View of rear portion of the building along Patterson Street depicting asphalt around the building, angled parking along the side with limited area for vehicular maneuvering, no required landscape buffer along the rear adjacent to the residential zone and no sidewalks.

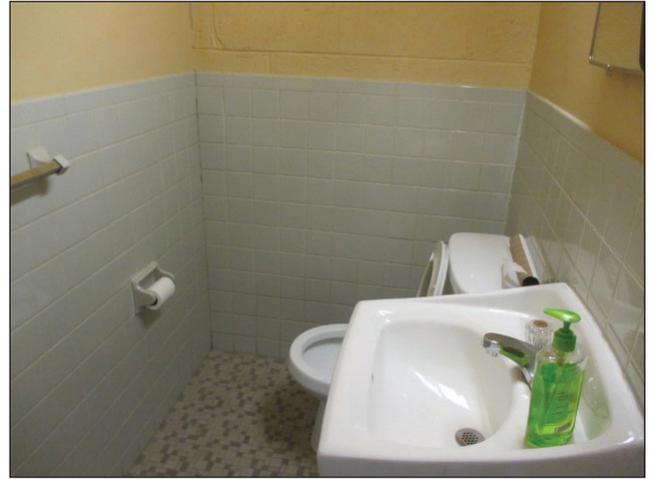
**Image 21:** Example of interior bathroom which is not ADA compliant.

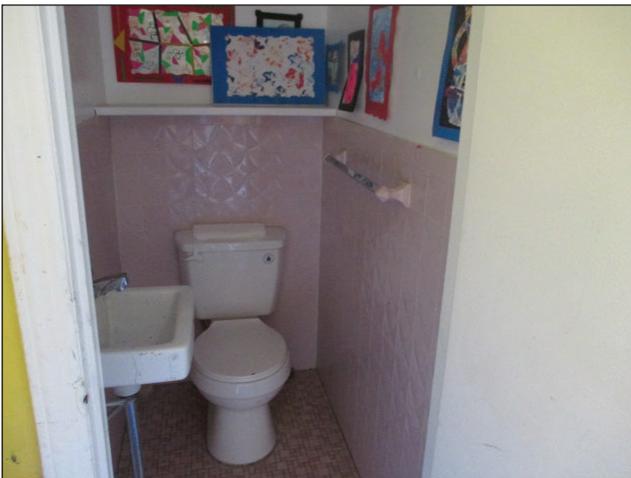
**Image 22:** Example of interior bathroom which is not ADA compliant.

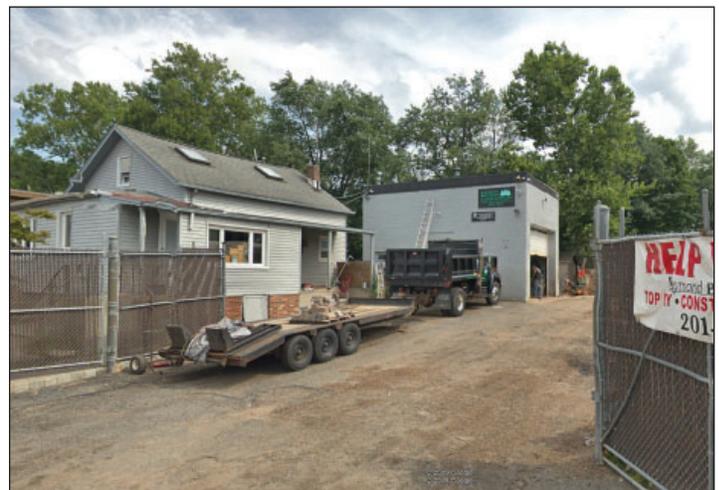
**Image 2:** Existing buildings and shed at the rear with sediment and gravel over the existing asphalt drive aisle.

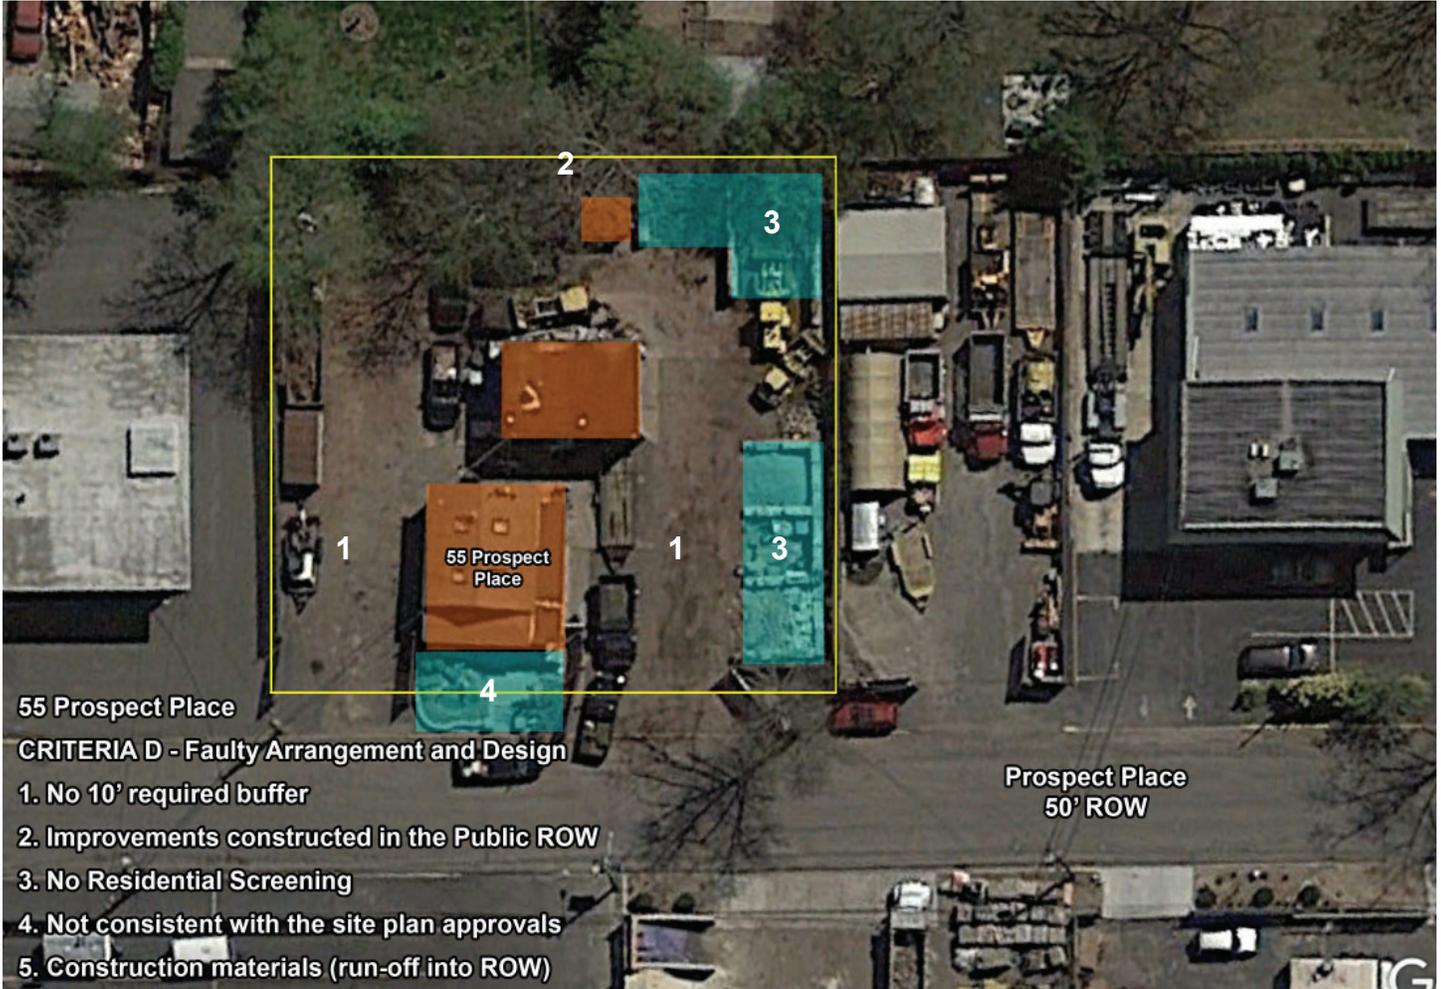
Image 3: Google Aerial Map depicting the site, location of improvements in the public right of way, open construction bins were parking was identified in the site plan application, lack of required residential screening and maneuvering area between the buildings and various other improvements.

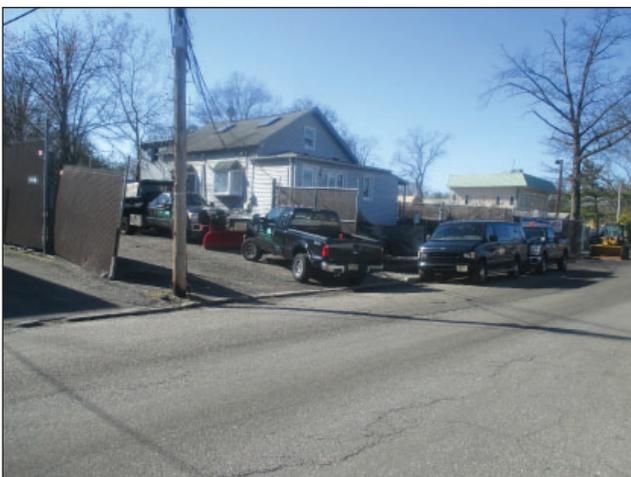
**Image 7:** East drive with grades to the Prospect Place and commercial vehicle in the drive.

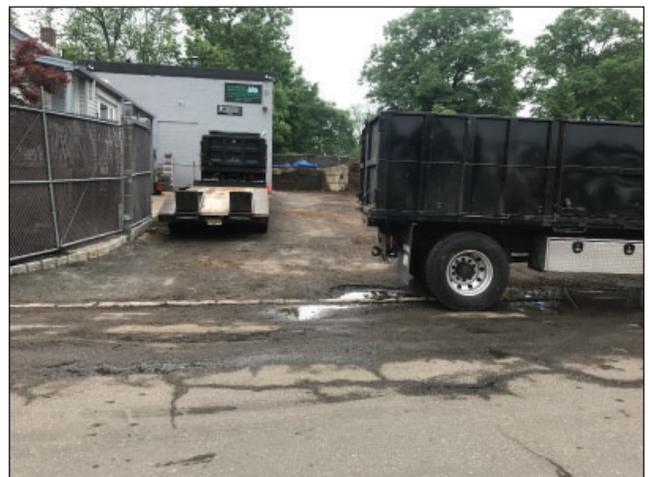
**Image 8:** West driveway on Prospect Place, with large commercial vehicle parked. Run-off with sediment and debris from property into public right of way.

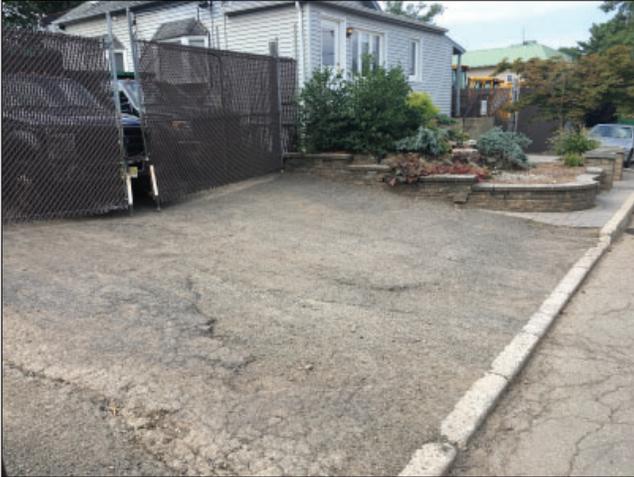
**Image 9:** East drive with grades down to the Prospect Place depicting sediment and gravel along public right of way. No sidewalks or lighting.

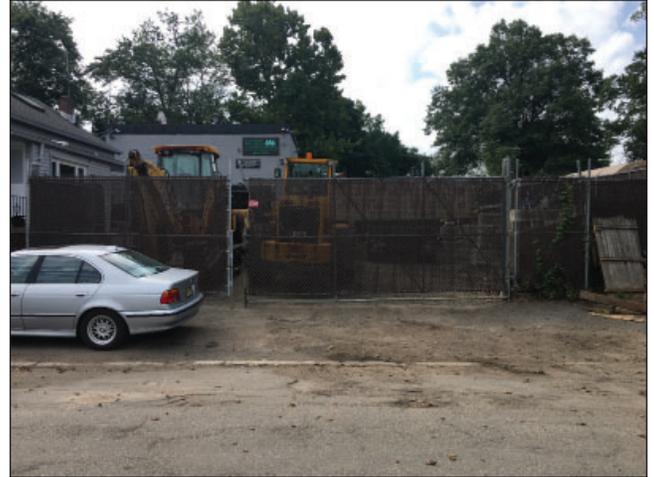
**Image 10:** West driveway on Prospect Place, with gravel and sediment from property in public right of way.

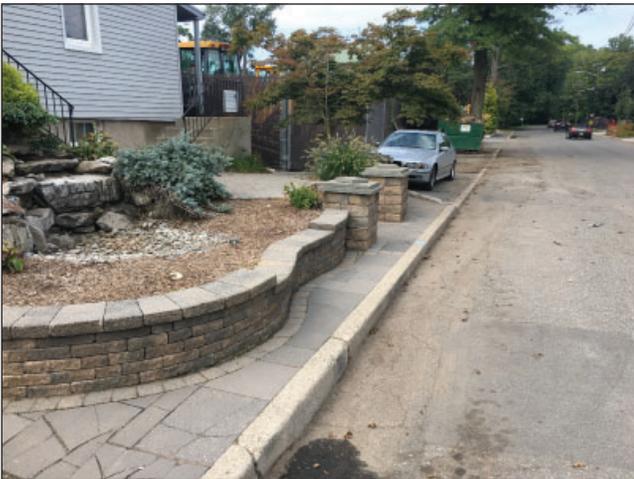
**Image 11:** No compliant sidewalk width in front of the building.

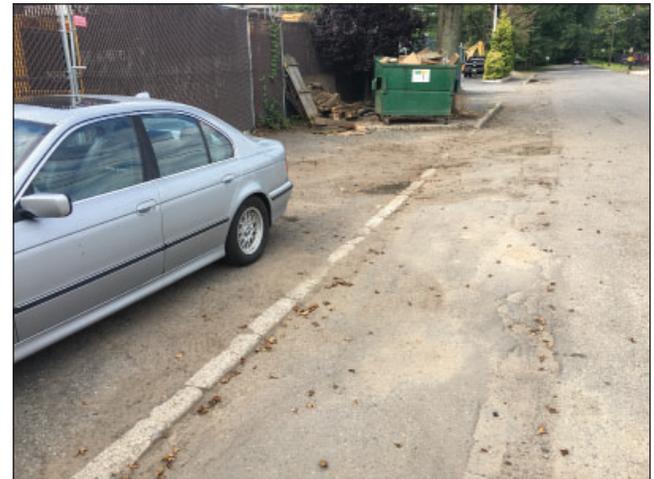
**Image 12:** West driveway on Prospect Place, with gravel and sediment from property in public right of way.

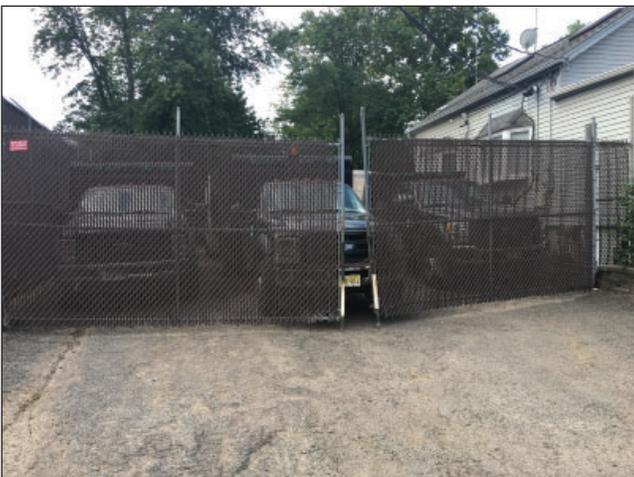
**Image 13:** East driveway entrance.

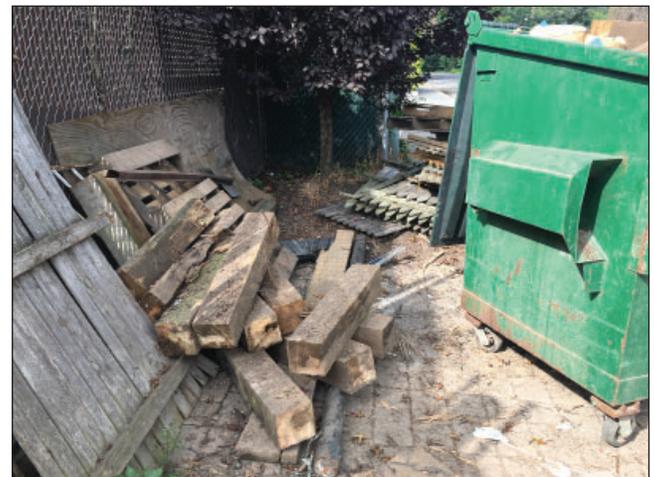
**Image 14:** West driveway on Prospect Place, with debris within the public right of way.

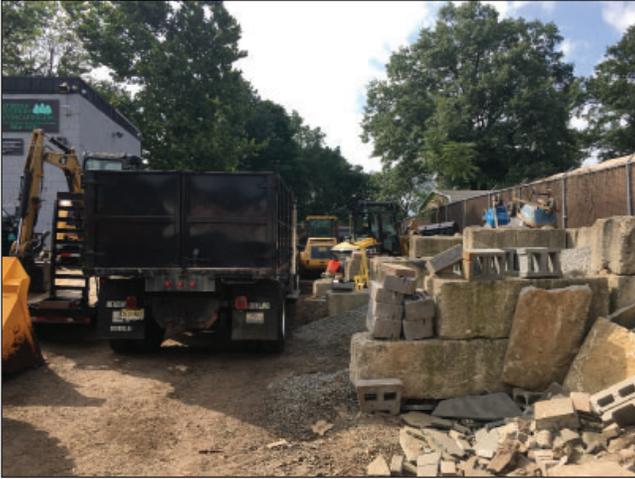
**Image 15:** West driveway entrance with landscape and hardscape materials in concrete areas, depicting sediment and gravel and no control measures.

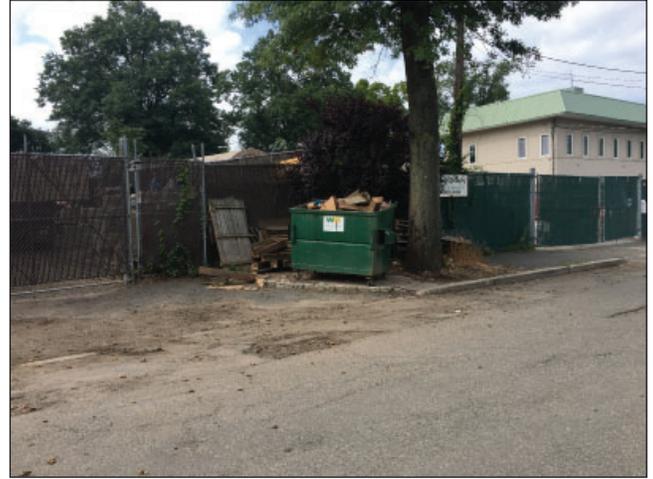
**Image 16:** West driveway on Prospect Place, with trash bin and debris in the public right of way.

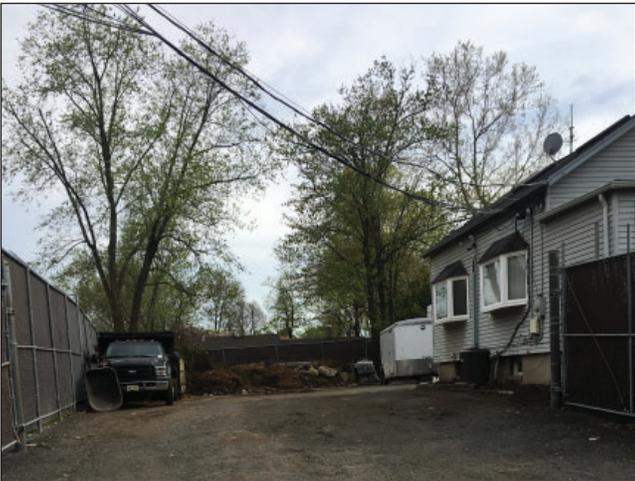
**Image 17:** Images depicting lack of 10 foot fence or screening from residential zone.

Access to the property was requested but was not granted. During several site visits as well as reviewing GIS and aerial photography, the required six foot buffer along the rear portion of the property does not exist. Building Department records did not provide any information pertaining to the removal or replacement of the required screening with fencing as identified on Block 1207 Lot 9. Along the front and of the property there is an approximately six foot chain linked fence. The sides of the property include fencing of varying heights.

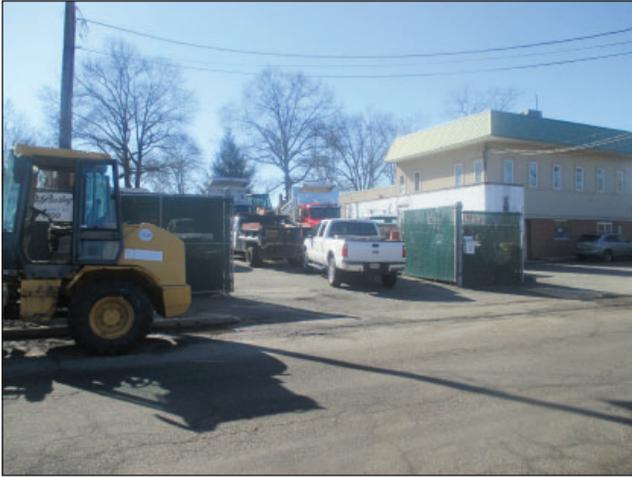
**Image 2:** Driveway entrance with commercial vehicles in the public right of way and sediment in the public street.

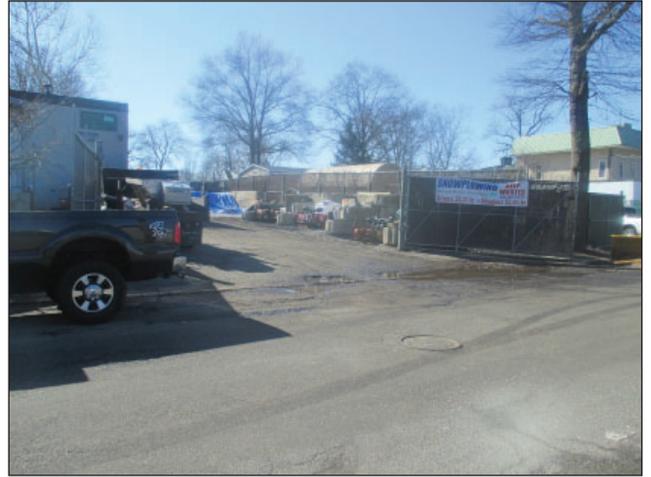
The property has grading that slopes from the rear of the property towards Prospect Place. There was no site lighting (adequate) observed on the property. The impervious surface drains directly onto the public right of way and into Prospect Street. Sediment, gravel and debris were observed in the public right of way and along the street at the driveway entrance to this property.

**Image 3:** Driveway entrance with sediment and water run-off from the property into the public right of way.

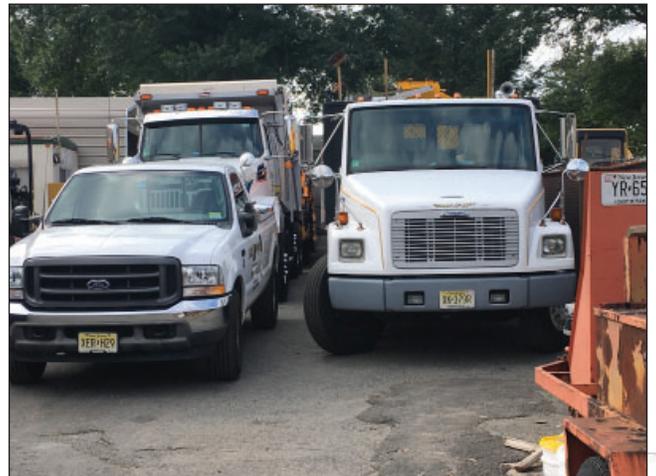
**Image 5:** Commercial vehicles backed into the property.

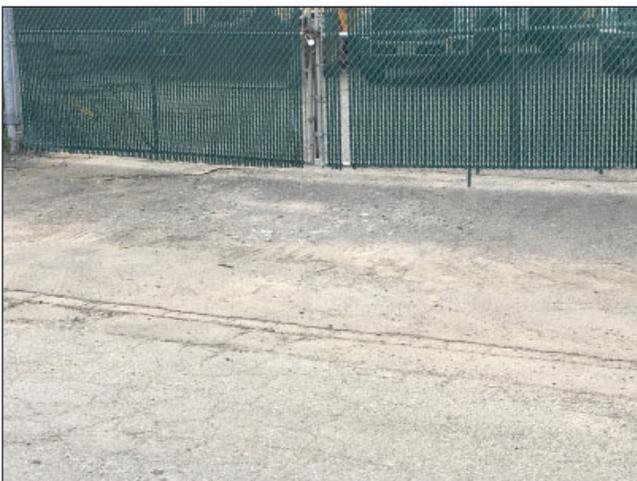
**Image 6:** Sediment in the public right of way in front of the driveway.

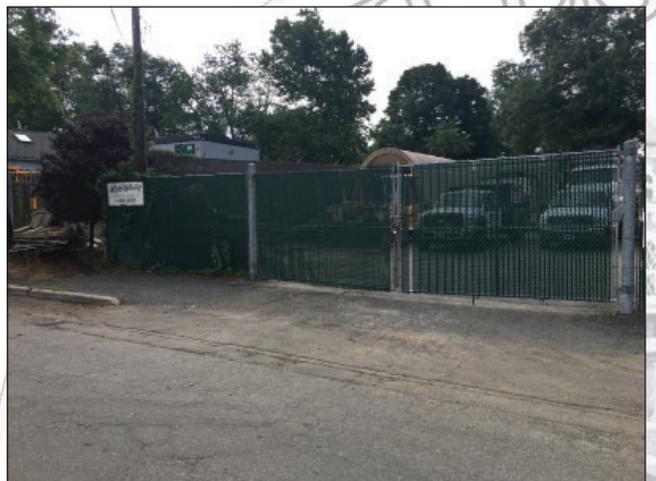
**Image 7:** Sediment in the public right of way in front of the driveway. Commercial vehicles parked facing public street.

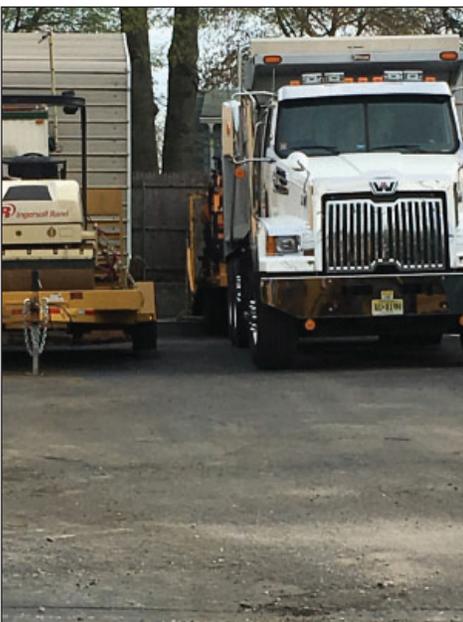
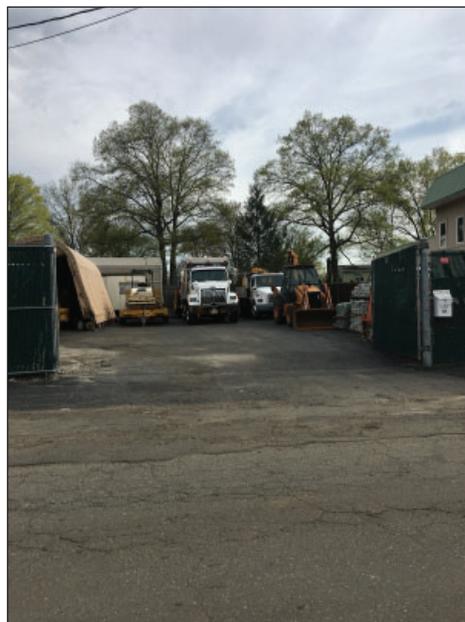
**Image 9:** Image depicting the lack of screening from the residential zone located to the rear of the property.

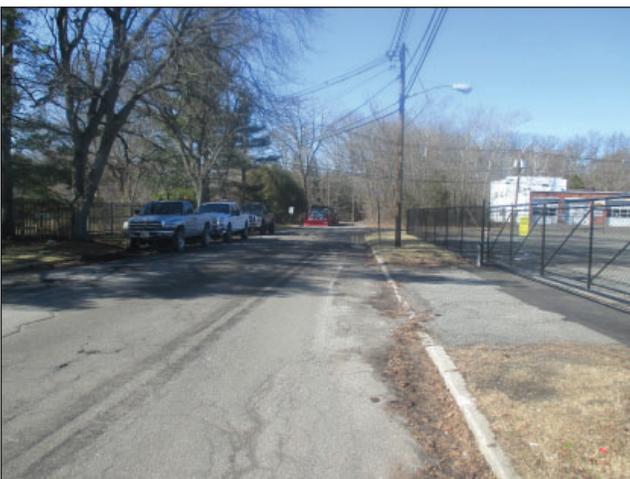
**Image 2:** View along Prospect Place.

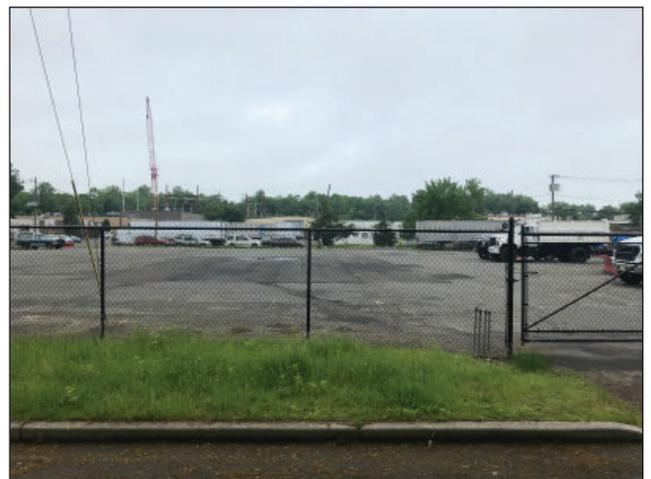
**Image 3:** Asphalt parking area during the week with limited vehicles.

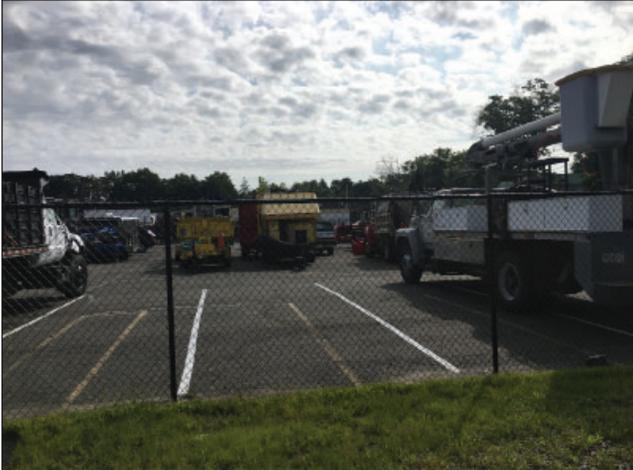
**Image 4:** Asphalt parking area with commercial vehicles on weekend.

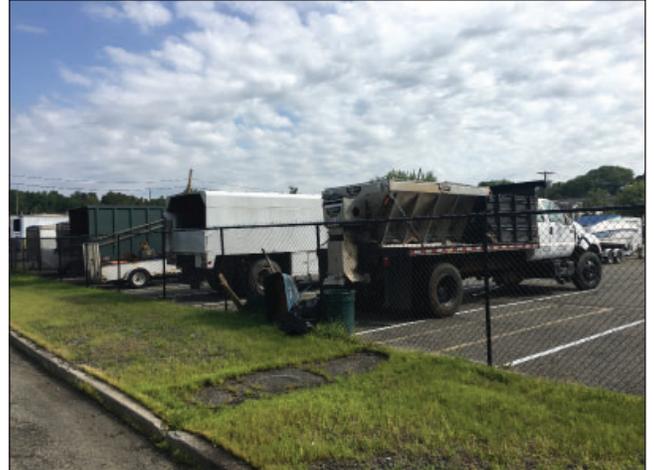
**Image 5:** Sediment and gravel run-off from asphalt parking through the public right of way along Prospect Place.

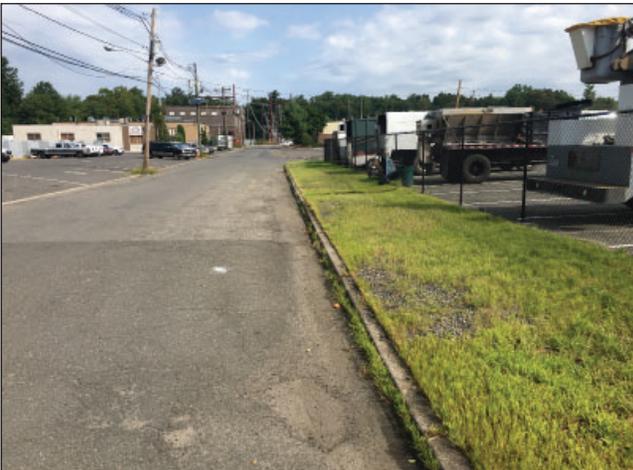
**Image 6:** Sediment and gravel run-off from asphalt parking through the public right of way along Piermont Avenue.

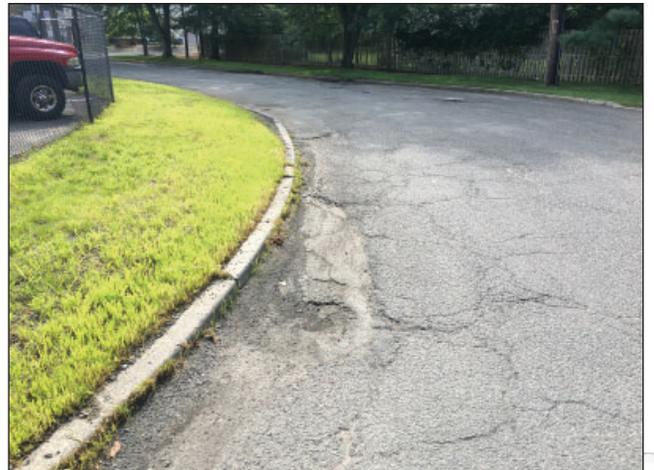
**Image 7:** Sediment and gravel run-off from asphalt parking through the public right of way along Prospect Place.

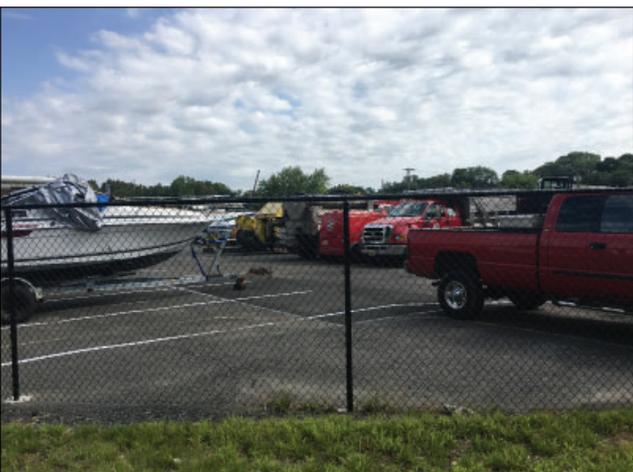
**Image 8:** Asphalt parking area with boats and commercial vehicles on weekend.

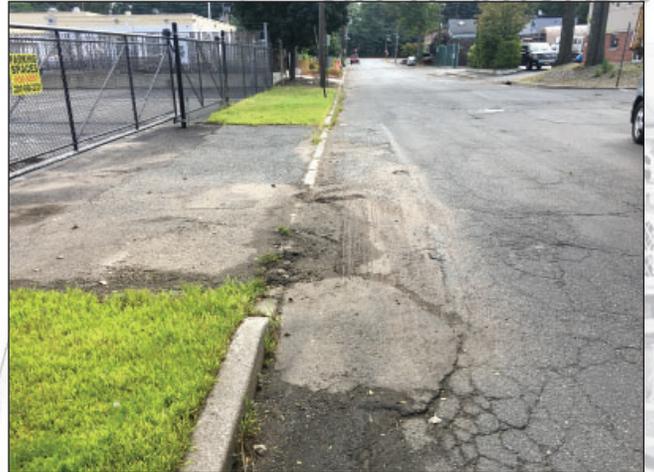
**Image 9:** Sediment and gravel run-off from asphalt parking along the driveway entrance on Piermont Avenue.

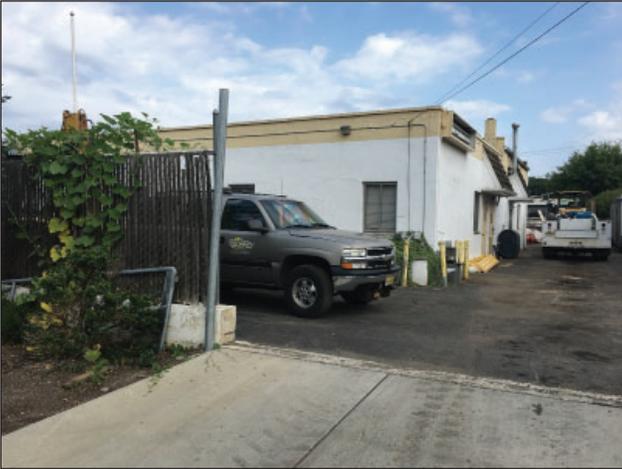
**Image 1:** Driveway entrance with existing one story building.

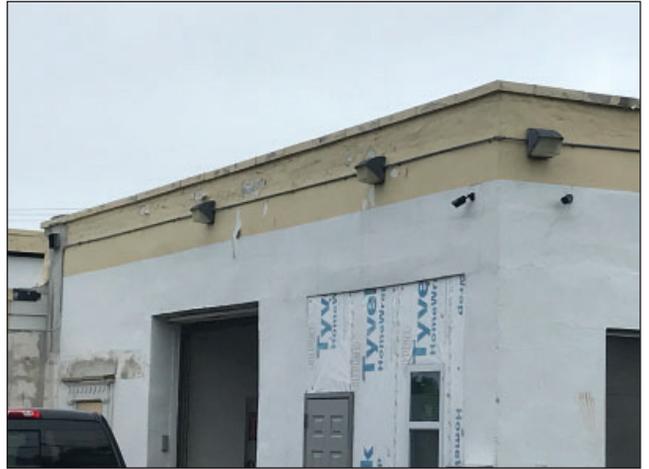
Downspouts for the roof run directly onto the asphalt with no visible storm-water management measures. The buildings appear to be in poor condition evidenced by the presence of Tyvek insulation along the exterior facade as well as visible damage to multiple areas along the facade of the building. Access to the property was requested but was not granted.

**Image 2:** Existing one story building facade from Prospect Place depicting Tyvek insulation exposed.

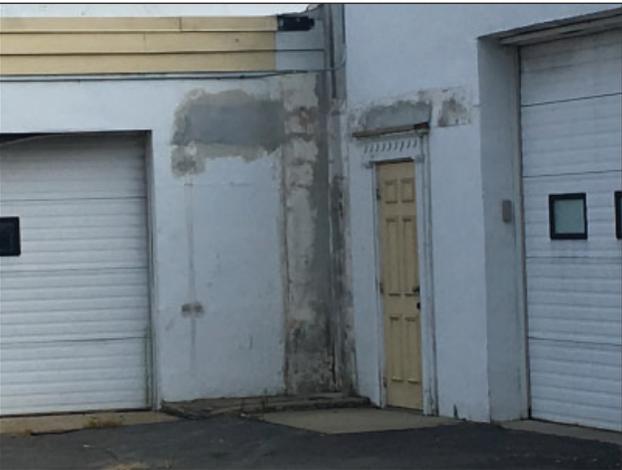
**Image 3:** Driveway entrance at Prospect Place depicting facade repairs.

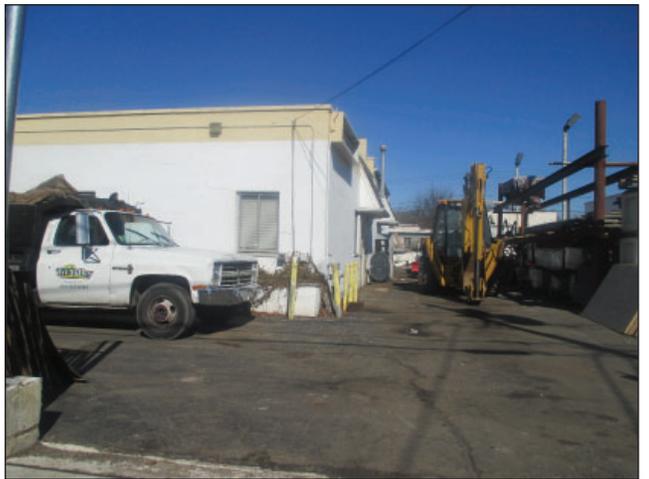
**Image 4:** Asphalt parking with construction and commercial vehicles.

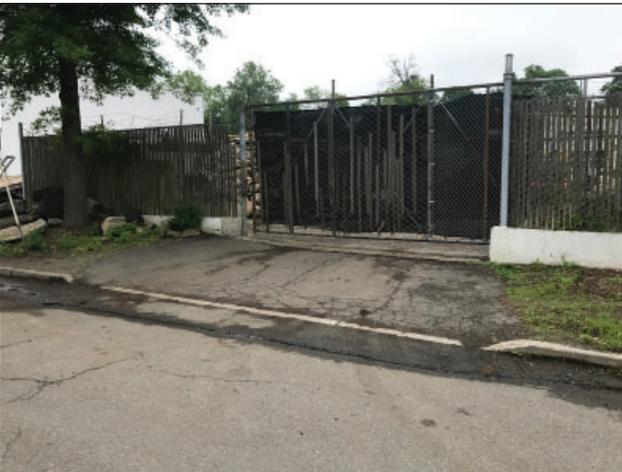
**Image 5:** Driveway entrance with grades to the public right of way. Includes sediment build up in the street.

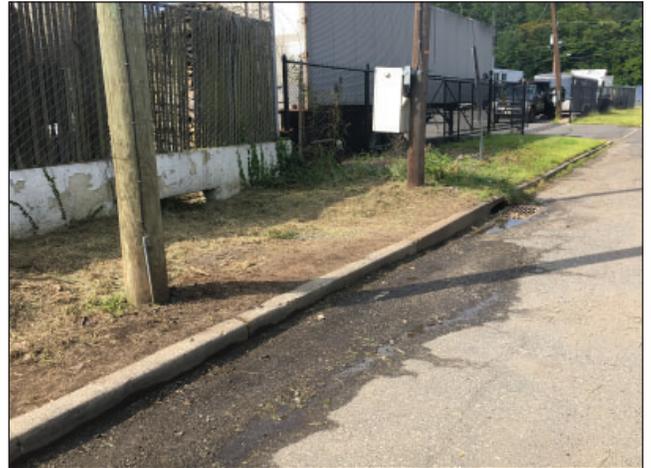
- 3) The property includes large areas of landscape and hardscape materials sectioned off with concrete barriers that are located on the asphalt / gravel lot. Along Piermont Avenue, a portion at the base of barrier has been removed to allow run-off from the site into the public right of way with no storm water measures located on the site. During rain events there are no control measures to prevent the raw materials from going into the public right of way and into the storm water system. This condition is detrimental to the safety, health and welfare of the community in that run-off is being drained into the storm water system without any control measures.

**Image 8:** Piermont Avenue frontage with spillway at landscape/hardscape bins to allow run off from asphalt area to the storm water system in the public right of way.

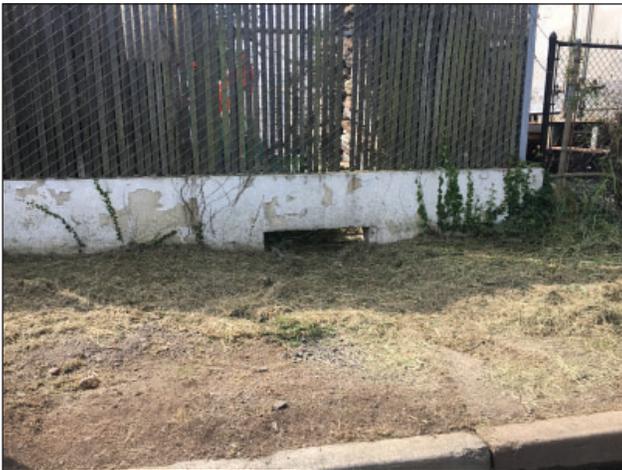
**Image 9:** Piermont Avenue frontage with spillway at landscape/hardscape bins to allow run off from asphalt area to the storm water system in the public right of way.

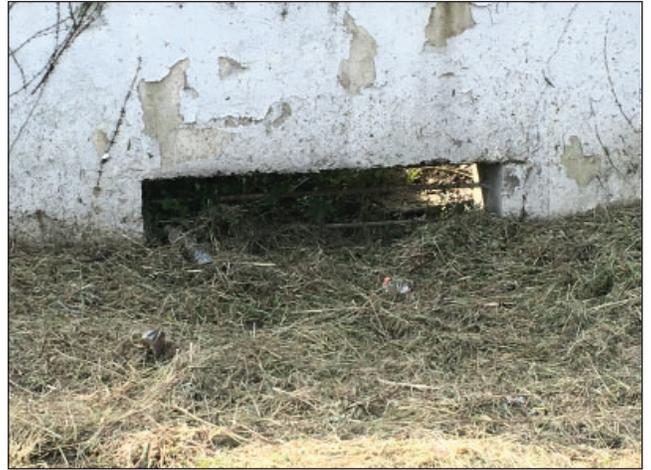
**Image 10:** Piermont Avenue frontage with spillway at landscape/hardscape bins to allow run off from asphalt area to the storm water system in the public right of way.

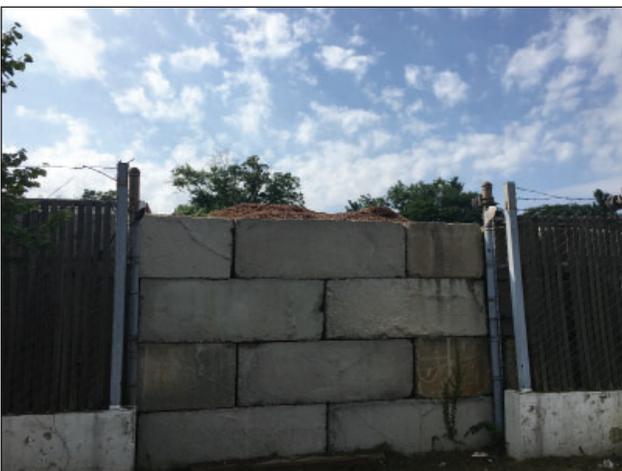
**Image 11:** Piermont Avenue frontage with masonry wall and raw materials coming over the top.

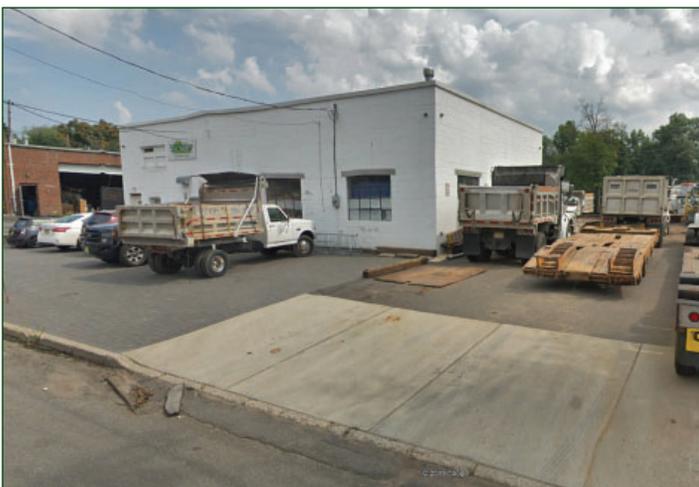
**Image 2:** Head in parking along Piermont Avenue with no enough depth to allow vehicles to maneuver within the right of way with lack of lighting for the area.

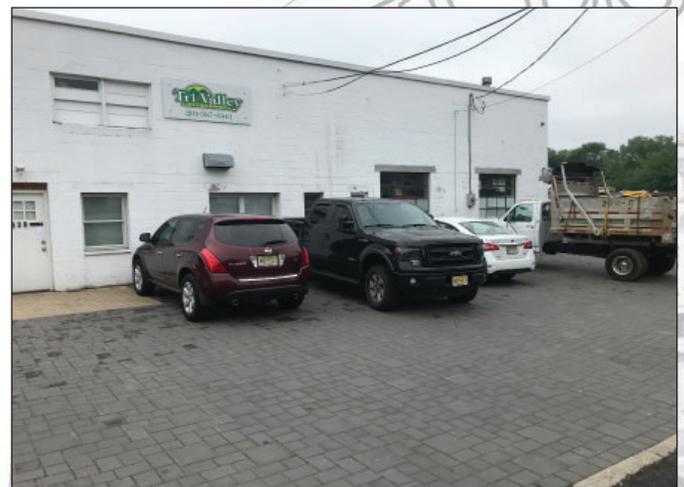
**Image 3:** Head in parking along Piermont Avenue with no enough depth to allow vehicles to maneuver within the right of way.
