Report of  
**Preliminary Investigation for  
Determination of an Area in Need of Redevelopment  
without Condemnation**

Block: 1207, Lots: 8, 9 10 & 11; Block: 1208, Lots: 1, 2, 3, 4 & 5; Block: 1209, Lots: 2, 3, 4, 5 & 6;  
Block: 1210, Lots: 6, 7, 8, 9, 10 & 11; Block: 1211, Lots: 1 & 2; Block: 1212, Lot: 13.

**Prepared By:**  
DMR Architects

**Prepared For:**  
Borough of Hillsdale  
Bergen County, New Jersey

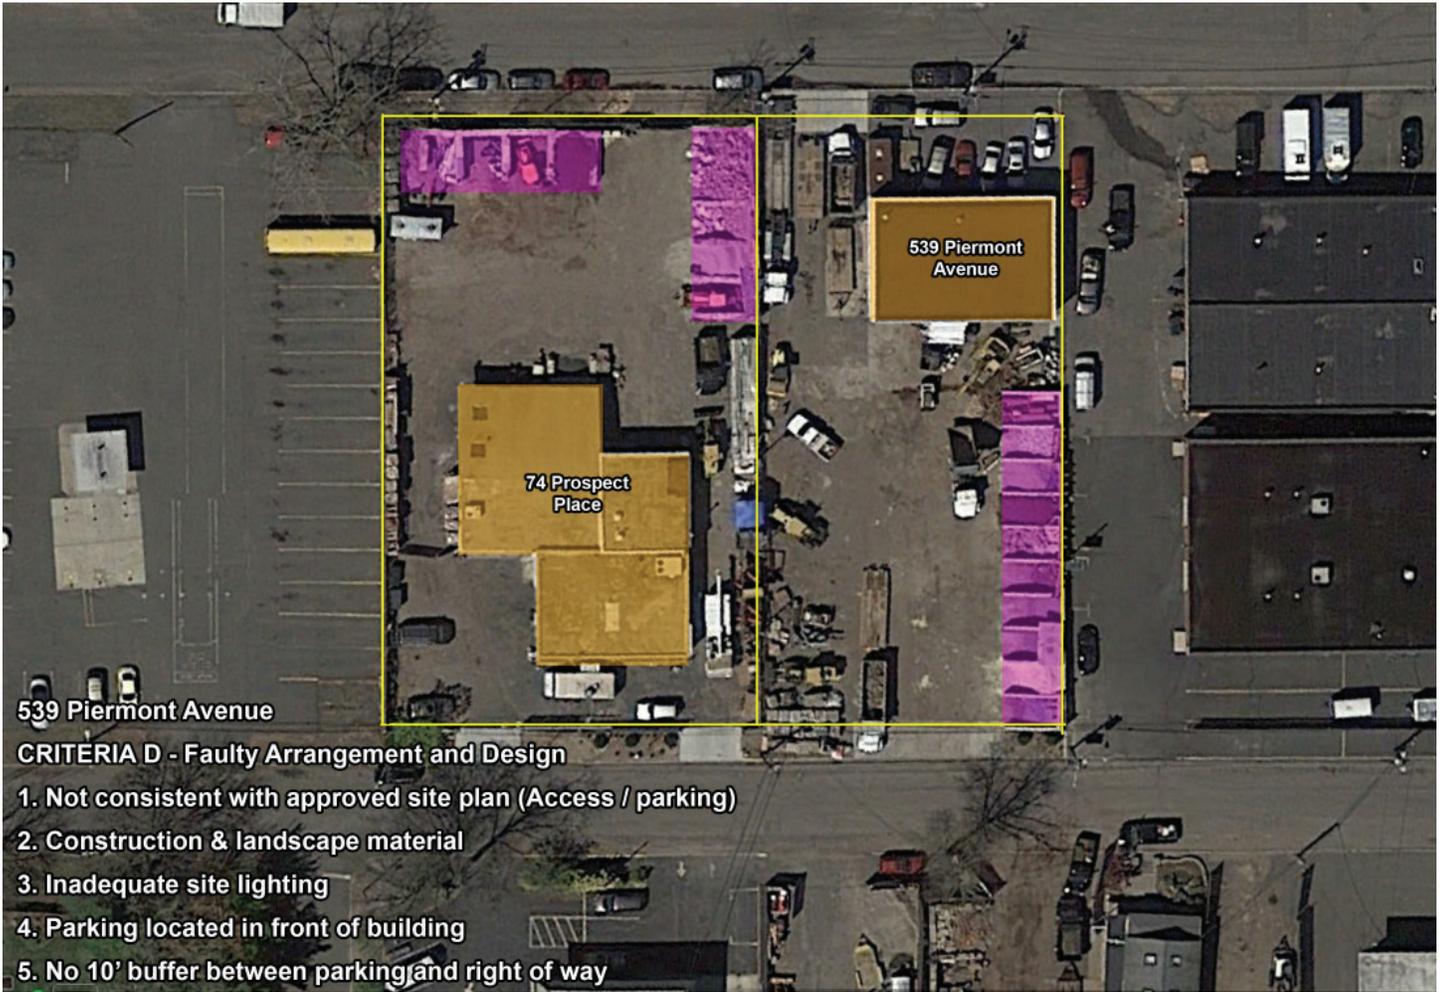
**Image 4:** Head in parking along Piermont Avenue with no enough depth to allow vehicles to maneuver within the right of way.

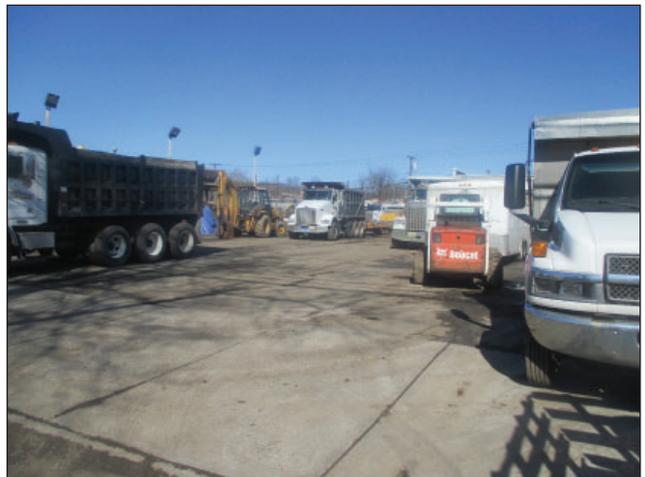
**Image 6:** Concrete area off Prospect Place with truck parking.

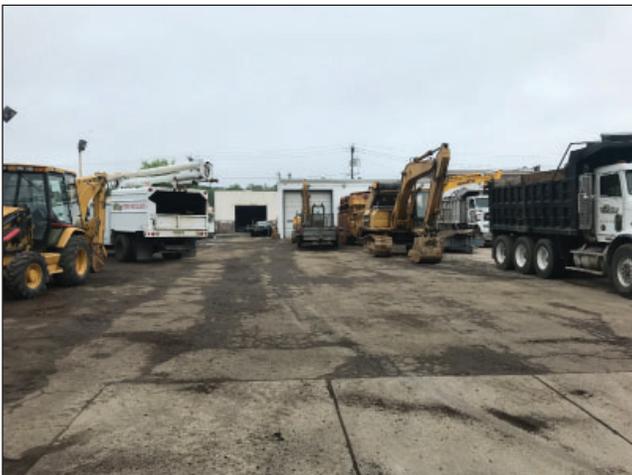
Image 8: Asphalt parking from Prospect Place right of way.

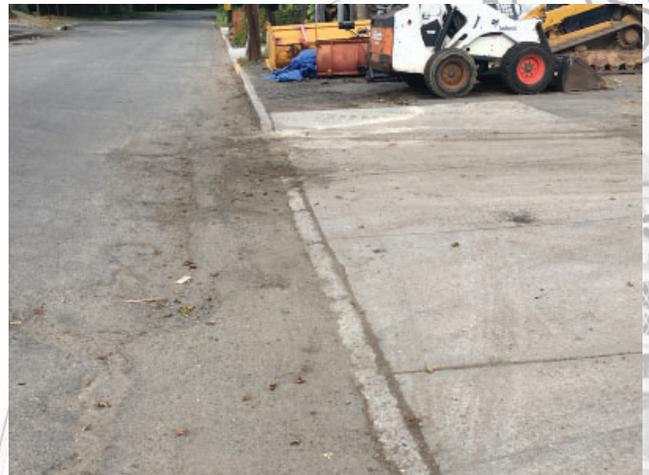
Image 9: Sediment in public right of way on Prospect Place.

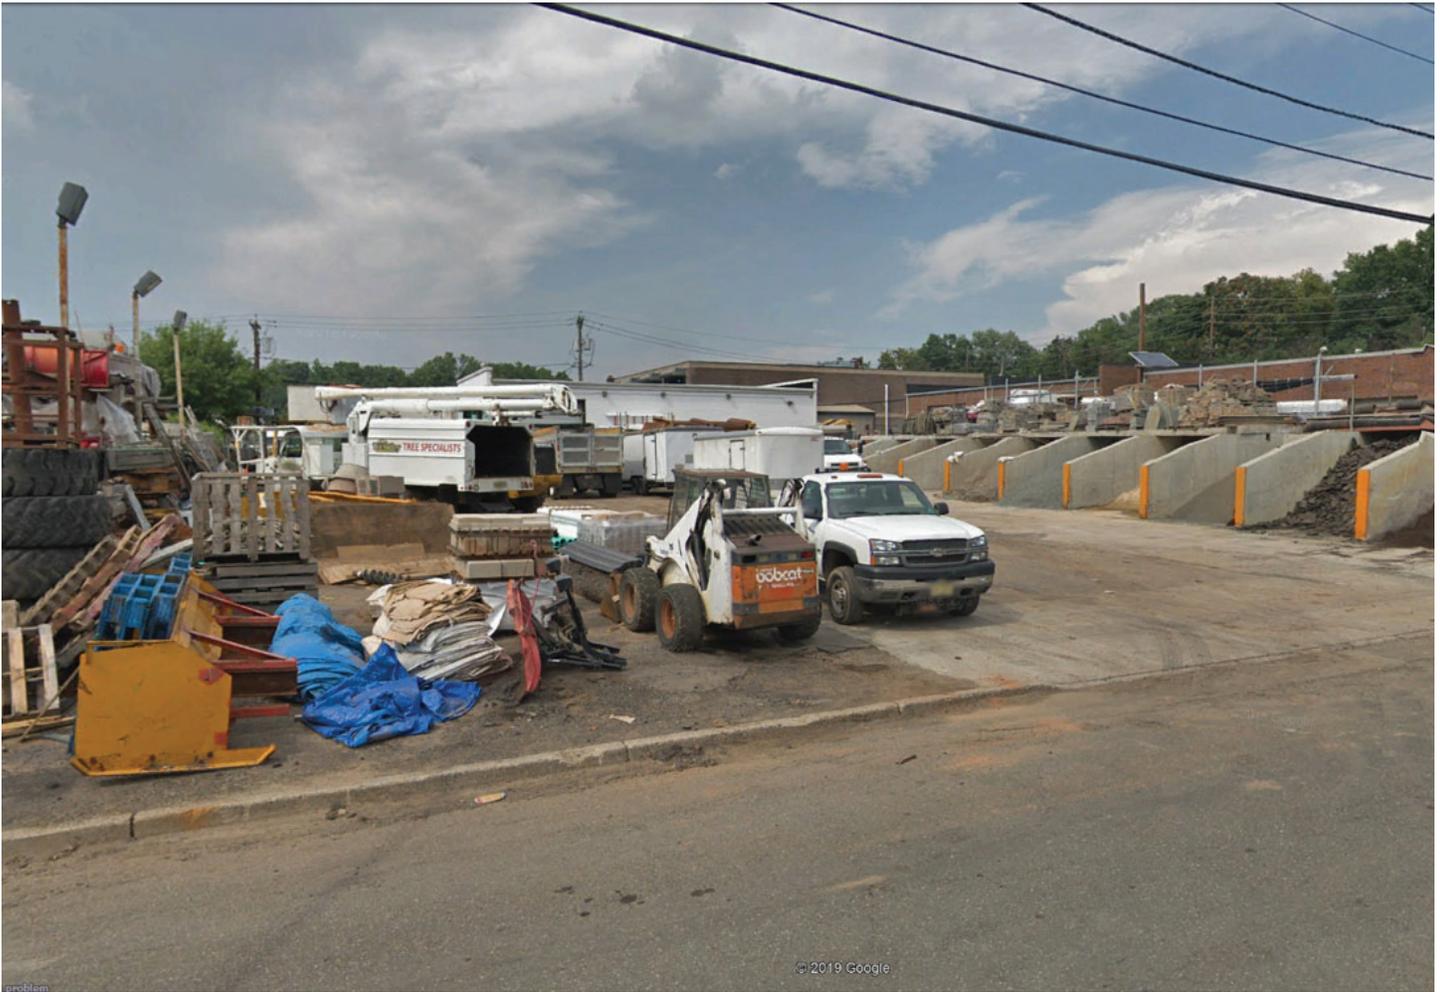
**Image 10:** Construction materials, debris and garbage stored in the public right of way. Concrete barrier bins with construction and landscape materials located along the east property line where the site plan has parking identified. Lack of lighting on site.

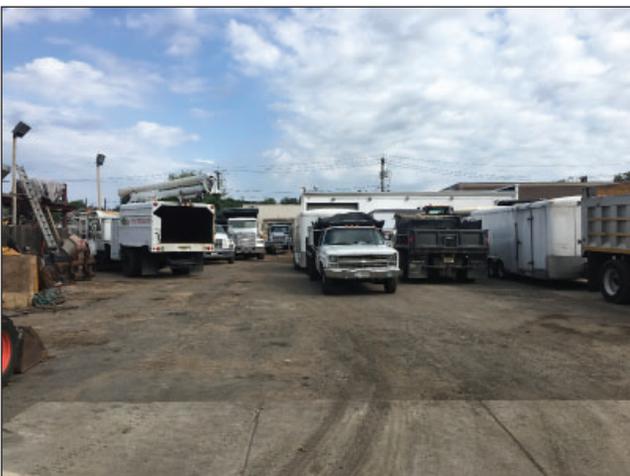
**Image 11:** Prospect Place entrance with commercial vehicles and sediment within the public right of way.

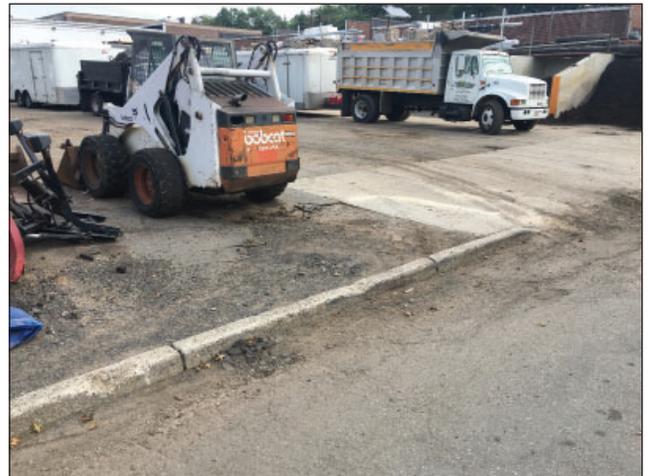
**Image 12:** Landscape bins on asphalt with no visible control measures. Large amount of sediment in the public right of way.

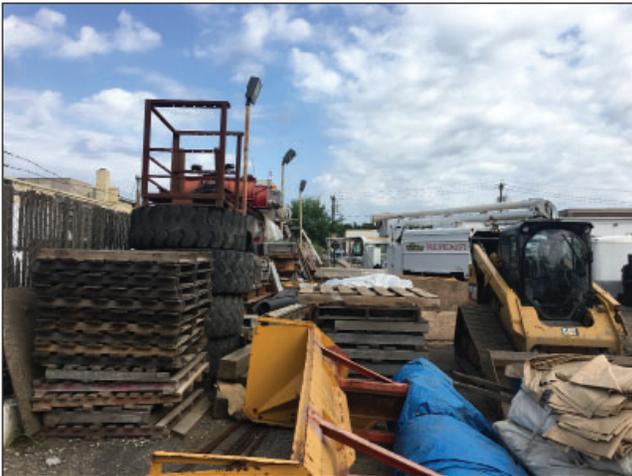
Image 15: Construction materials and debris located on the asphalt parking area.

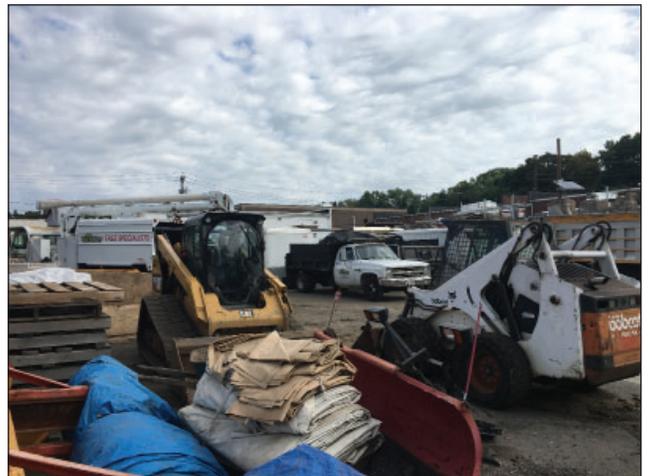
Image 16: Construction materials and debris located on the asphalt parking area.

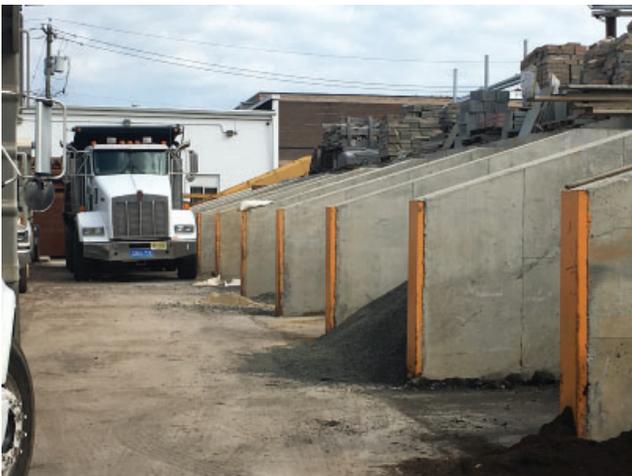
Image 17: Storage areas for landscape materials spilling out onto the asphalt parking area.

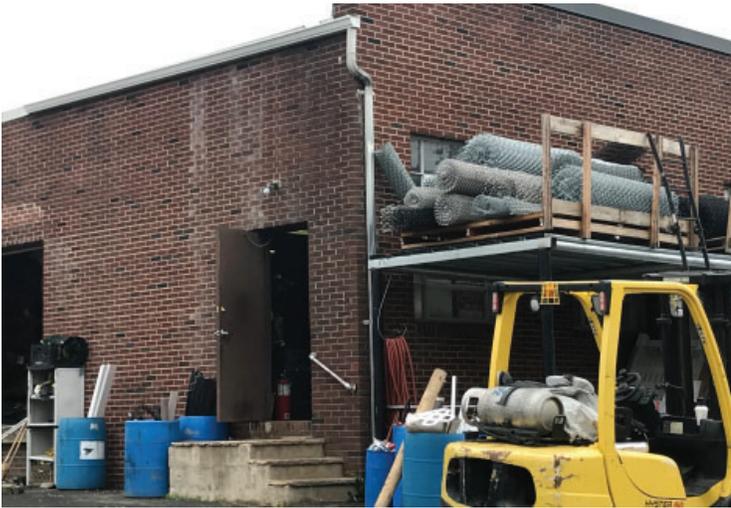
**Image 2:** Rear stairs with lack of handrails and roof leader drain.

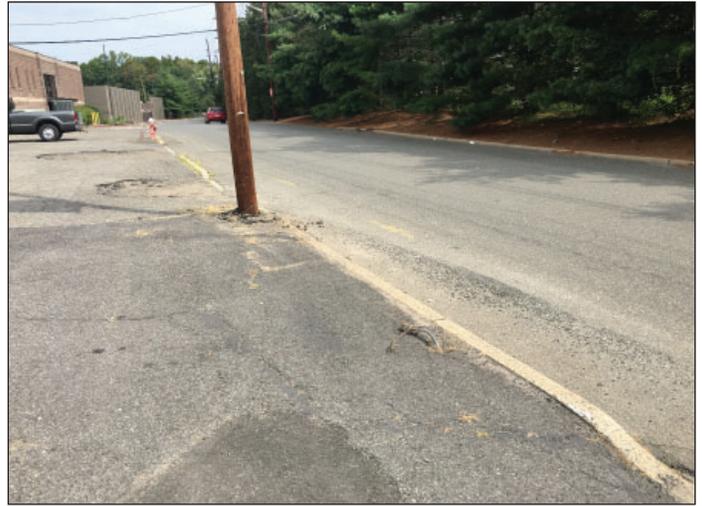
**Image 3:** Utility pole on Patterson Street with no protective measures from asphalt parking area.

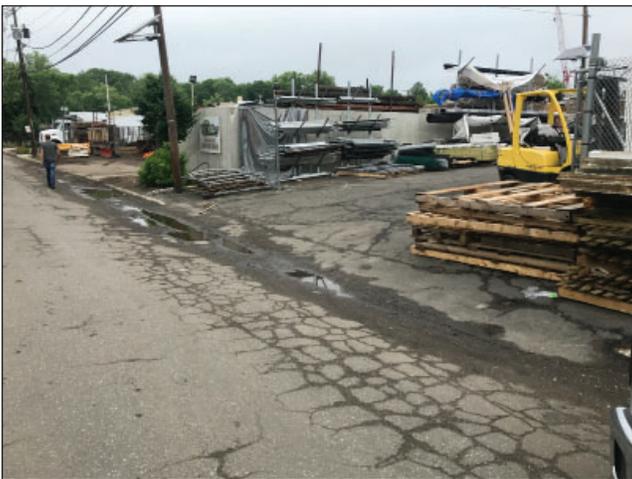
**Image 4:** Construction materials on the asphalt parking area at the rear of the building.

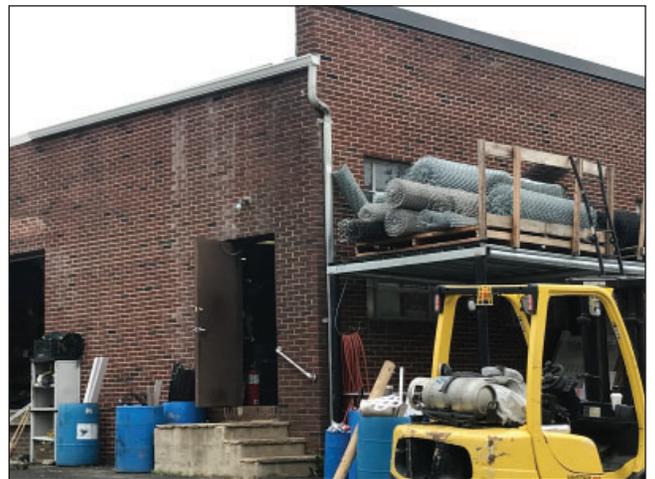
**Image 5:** Rear door with step. No handrails or other protective measures.

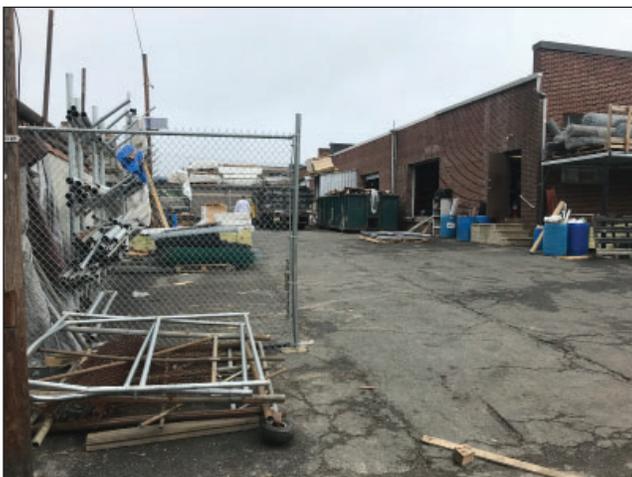
**Image 6:** Construction materials on the asphalt parking area at the rear of the building.

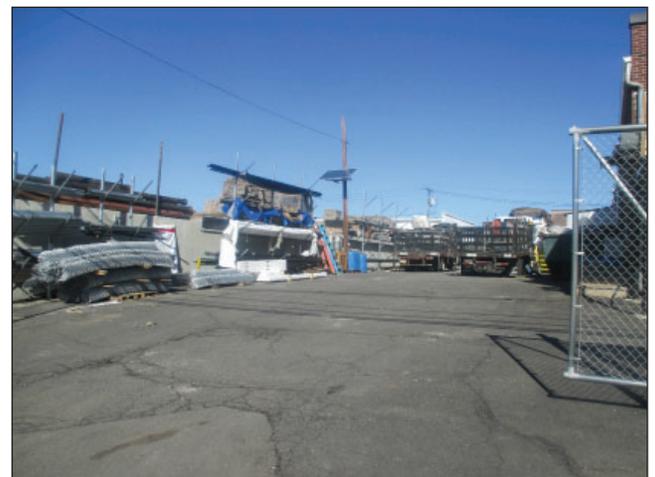
**Image 7:** Construction materials on the asphalt parking area at the rear of the building.

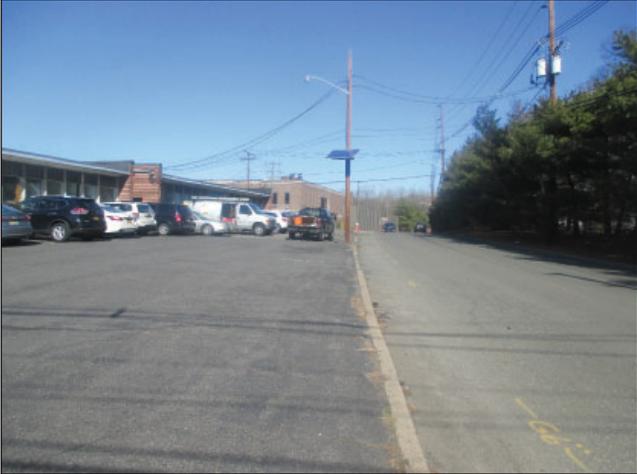
**Image 8:** Head in parking along Patterson Street with utility pole. No sidewalks, buffers or pedestrian safety measures.

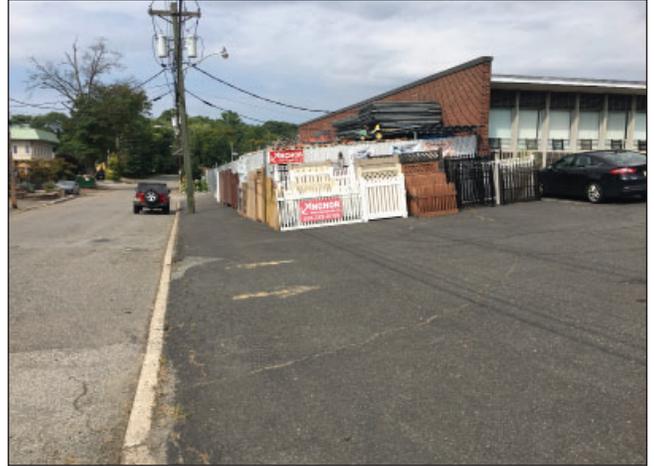
**Image 9:** Side yard along Prospect Place with asphalt and grading toward the public right of way. No sidewalks, lights or other pedestrian safety measures.

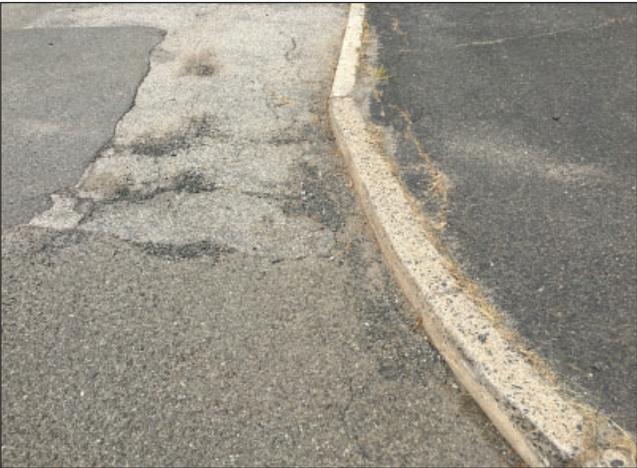
**Image 10:** Parking area at the Patterson Street corner with no pedestrian safety measures.

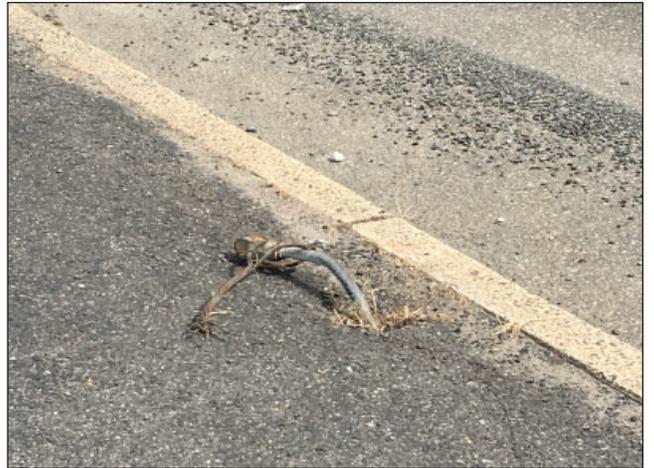
**Image 11:** Previous guy wire destroyed and no longer attached to the utility pole.

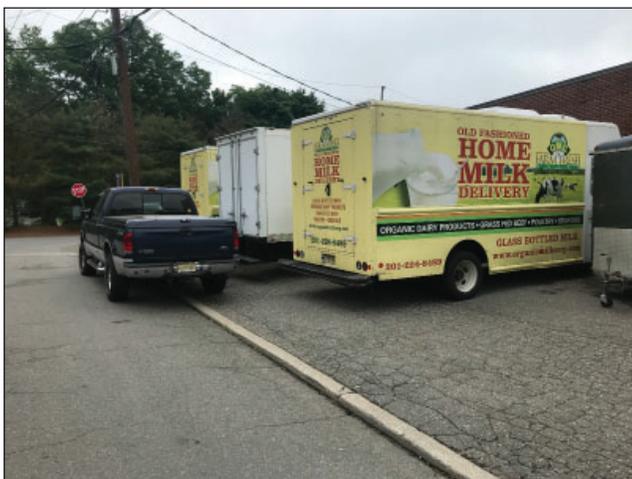
Image 5: Commercial vehicles parked head in along Piermont Avenue within the public right of way.

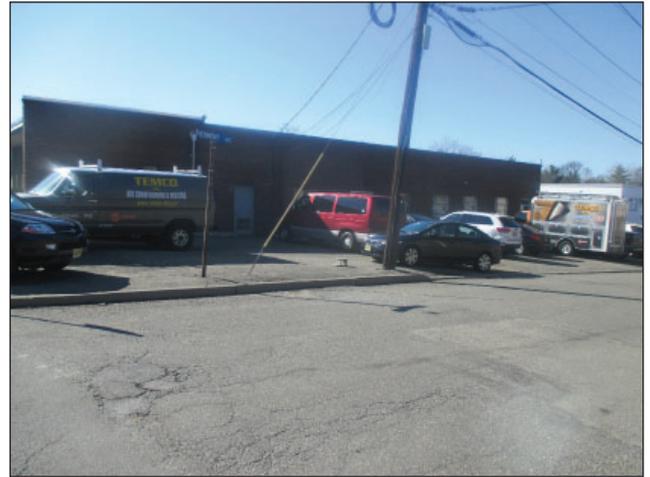
**Image 8:** Parking area along Piermont Avenue with vehicles in the public right of way. No sidewalks or pedestrian safety measures.

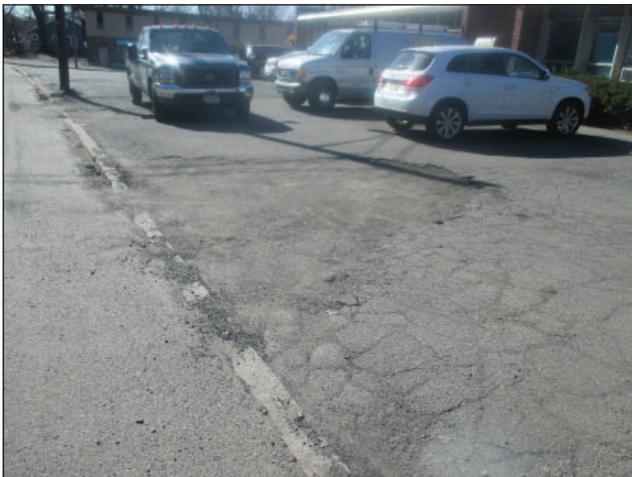
**Image 9:** Sediment and gravel from the property into the public right of way.

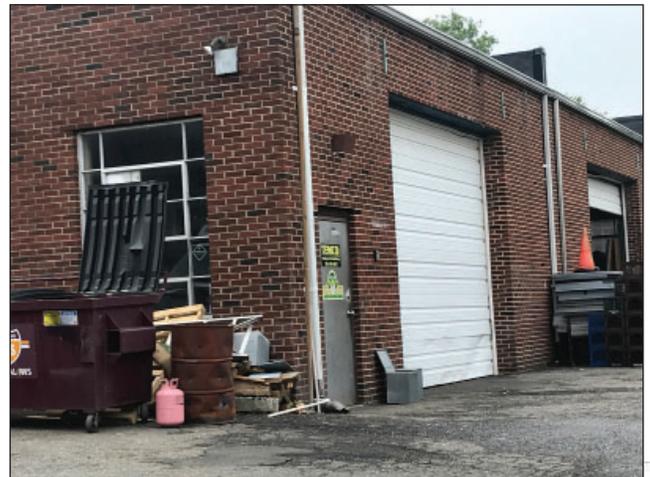
**Image 10:** Roof drain on to asphalt with gravel and sediment.

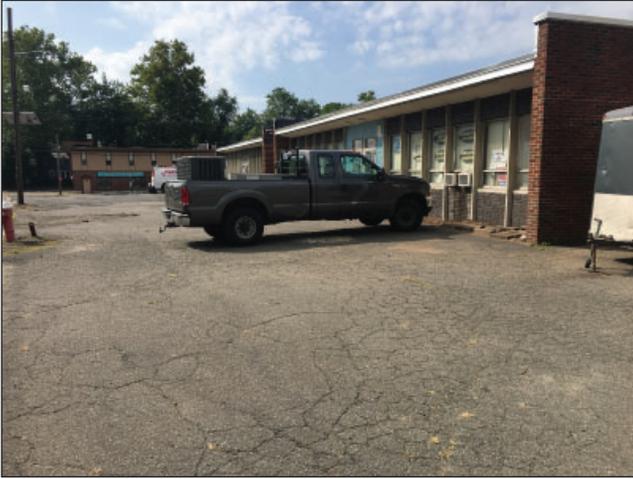
**Image 13:** Head in parking along Patterson Street with hydrant in the background.

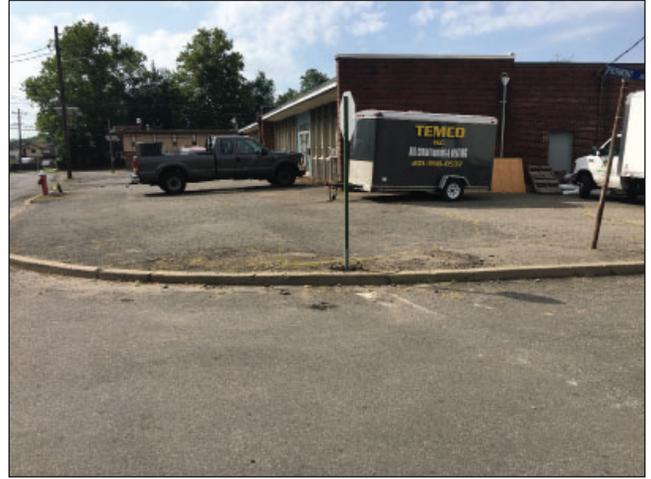
**Image 14:** Asphalt parking between the building to the back of curb with no sidewalk, lighting or other pedestrian safety measures.

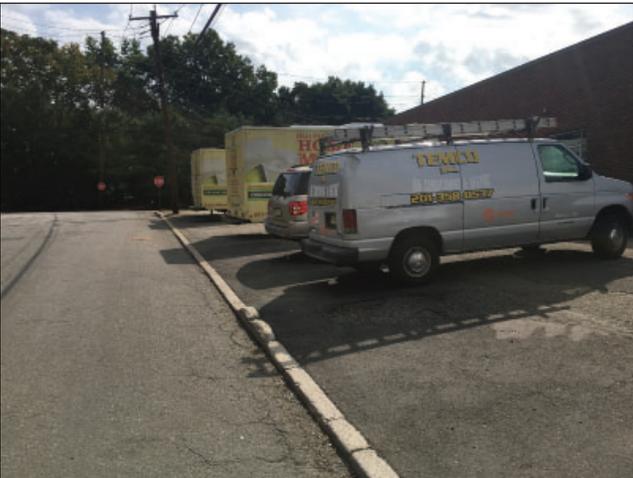
**Image 15:** Head in parking along Piermont Avenue located in the public right of way. No sidewalks, lighting or pedestrian safety measures.

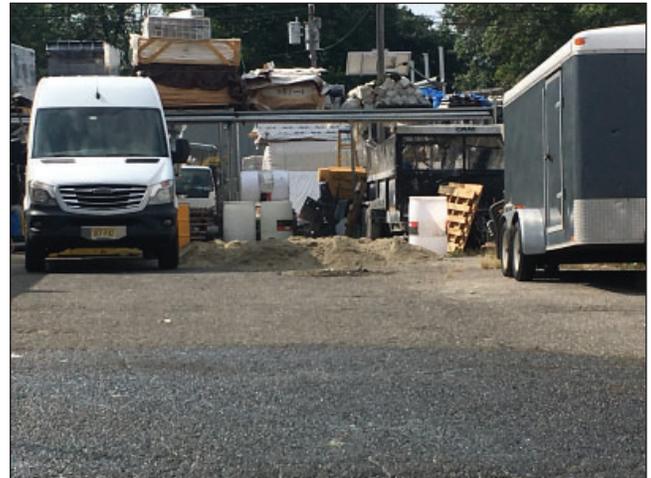
**Image 16:** Asphalt parking with water draining into the public right of way.

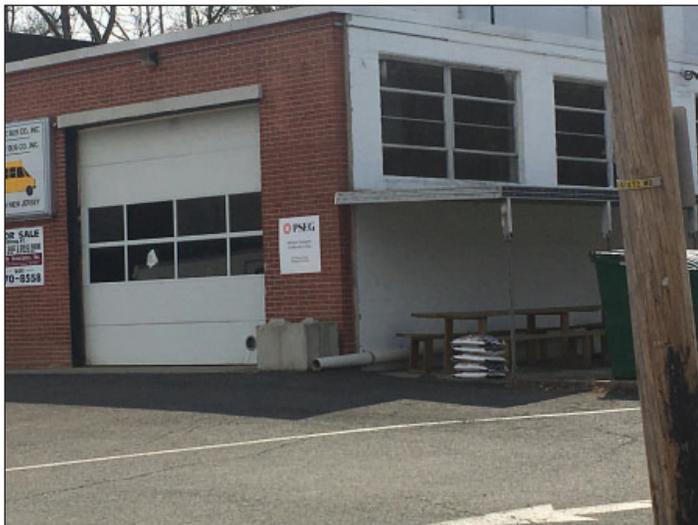
The property slopes from the building towards Prospect Place and drains directly on to the public right of way, causing a safety issue. In addition, this can cause safety concerns during rain and freezing events and create freeze and thaw issues by damaging the existing parking lot.

Image 2: Street view from Prospect Place depicting roof leader drain at the front vehicular access and pedestrian area.

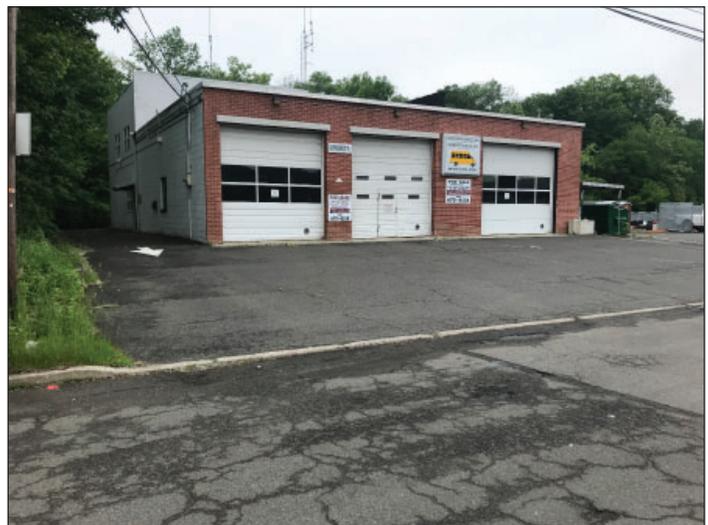
The portion of the property that slopes toward the street includes areas at the curb-line with damage to the asphalt in the street. This condition is most likely caused by freeze / thaw over time due to the fact water from the property runs across the asphalt lot and into the public right of way without any control measures.

Image 3: Street view from Prospect Place depicting drop curb in front of the building and grade change from the property to the street.

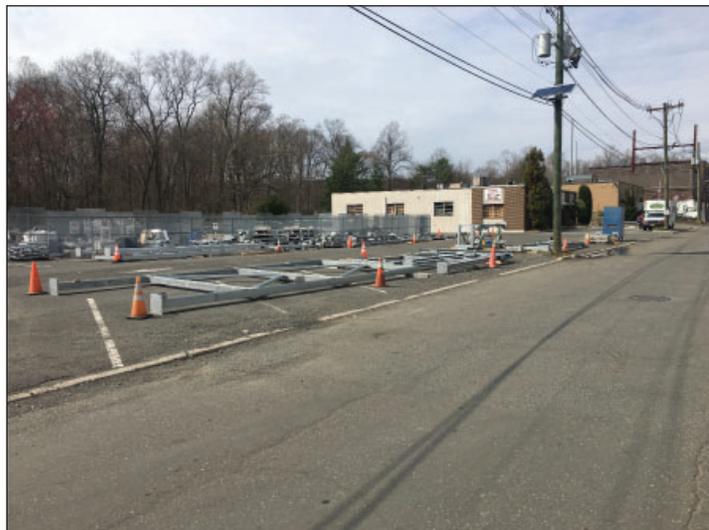
**Image 2:** Street view from Prospect Place depicting lay down area for construction equipment and materials, parking to the back of curb and lack of lighting.

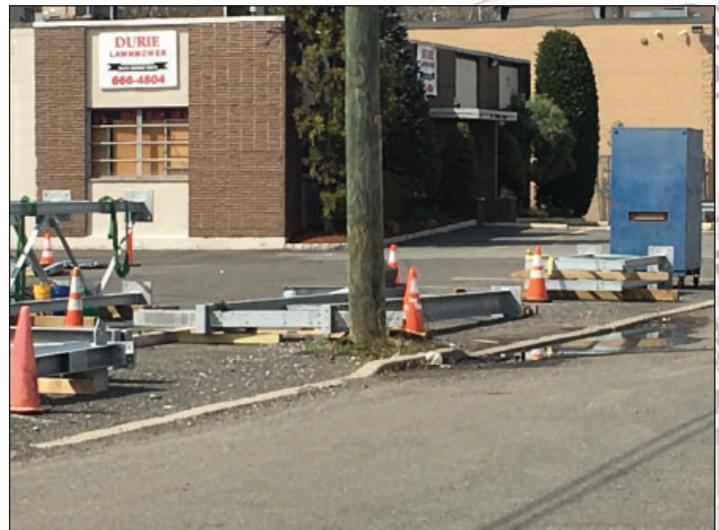
**Image 3:** Street view from Prospect Place depicting lay down area for construction equipment and materials and drop curb.

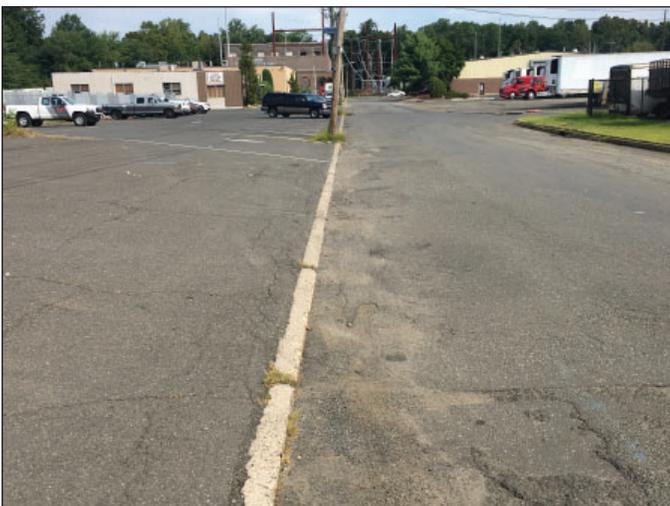
**Image 2:** Street view from Prospect Place depicting parking with drop curb to allow vehicles to exit directly onto the street. No sidewalks, lighting or protective measures for the utility pole or pedestrians.

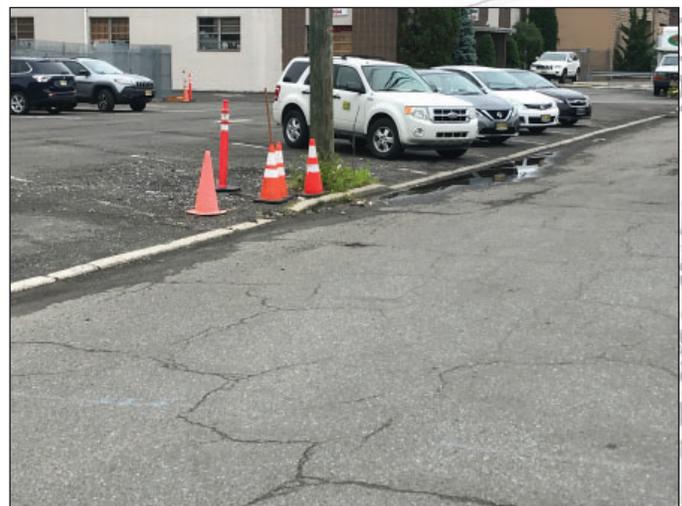
**Image 3:** Street view from Prospect Place depicting parking with drop curb to allow vehicles to exit directly onto the street. No sidewalks, lighting or protective measures for the utility pole or pedestrians.

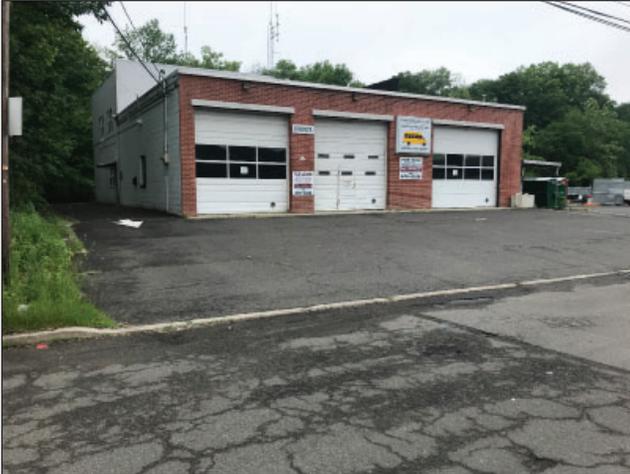
**Image 4:** Garage doors with asphalt parking. Drainage toward the public right of way. Drop curb along the front of the property.

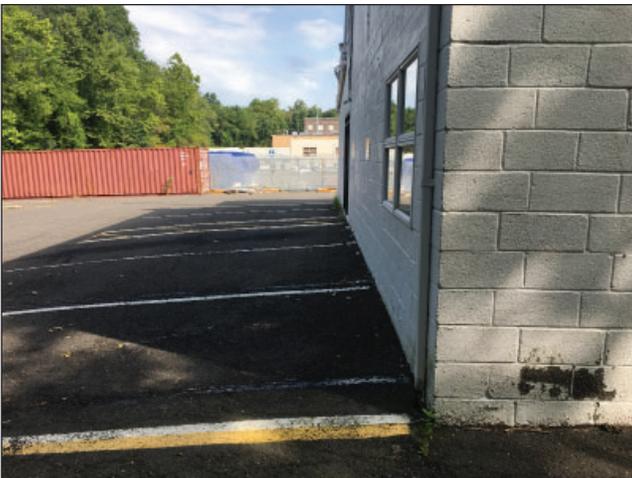
**Image 6:** Rear portion of the building with grades toward the rear of the property. No storm water management control measures.

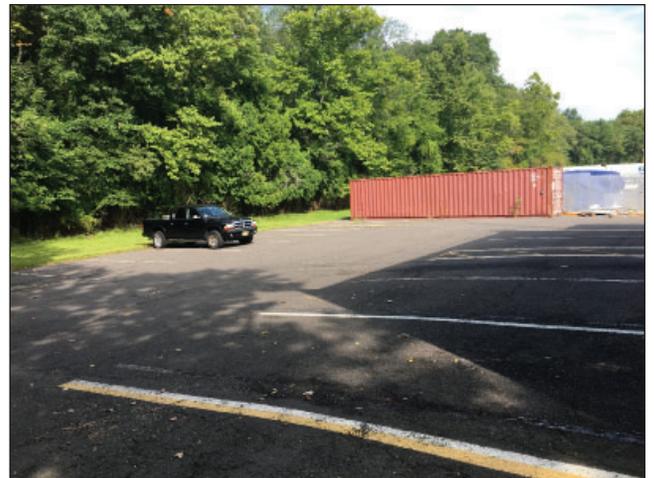
**Image 7:** Rear portion of the building with grades toward the rear of the property. No storm water management control measures.

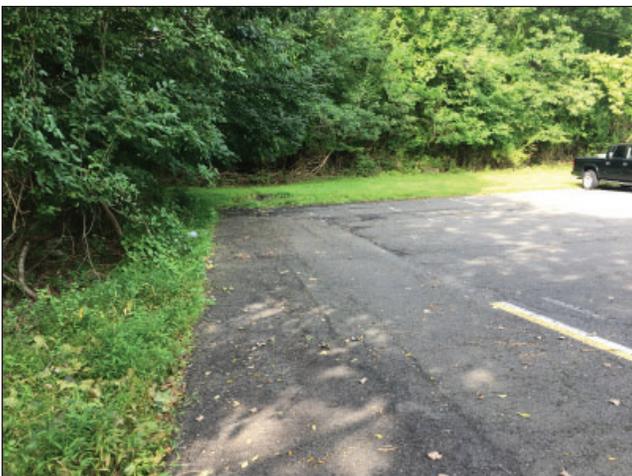
**Image 8:** Rear parking area draining toward the C-1 Waterway with no storm-water control measures.

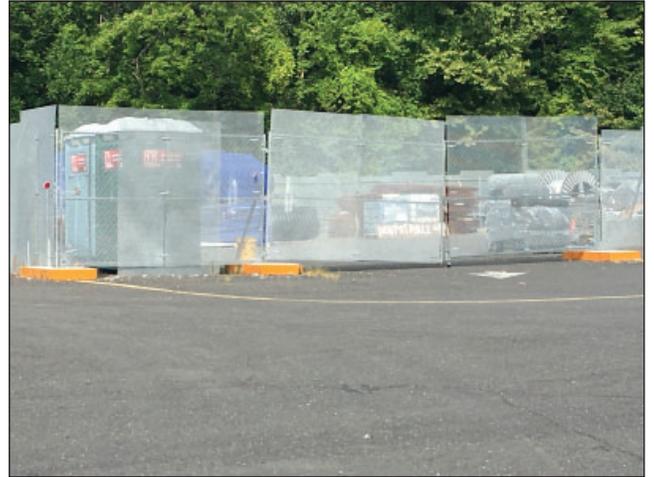
**Image 11:** Construction materials fenced within the parking area. Grades drain water toward the stream in the rear with no visible storm water control measures.

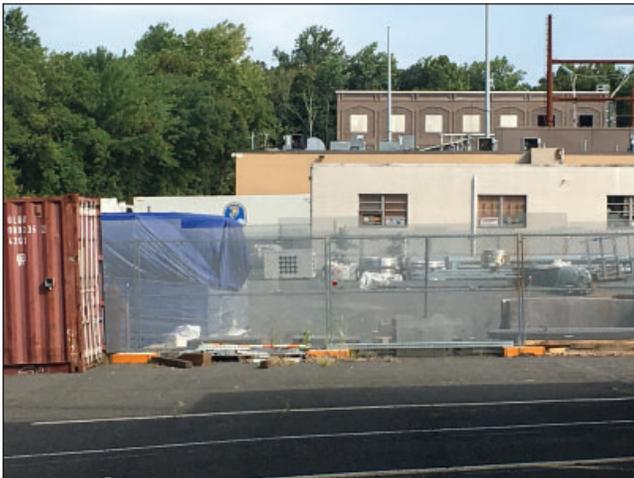
**Image 12:** Construction materials fenced within the parking area. Grades drain water toward the stream in the rear with no visible storm water control measures.

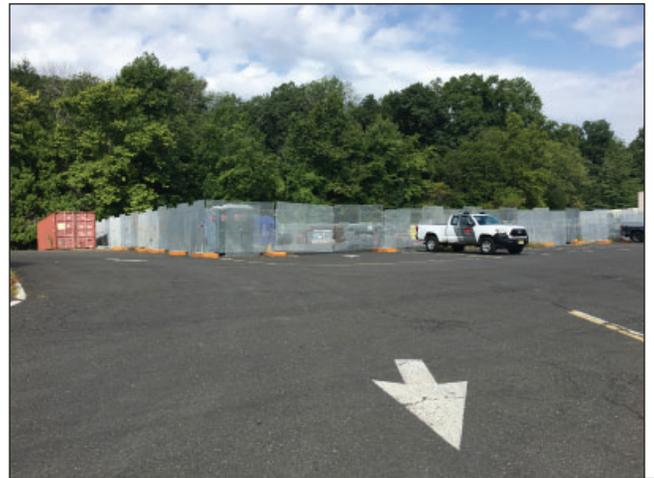
**Image 13:** Construction materials fenced within the parking area. Grades drain water toward the stream in the rear with no visible storm water control measures.

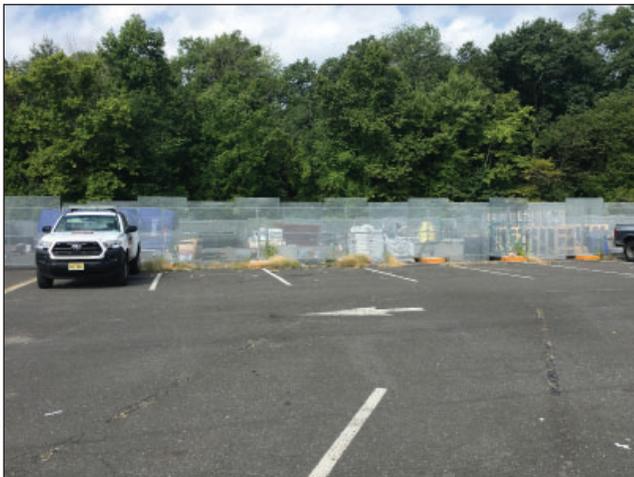
**Image 14:** Construction materials fenced within the parking area. Grades drain water toward the stream in the rear with no visible storm water control measures.

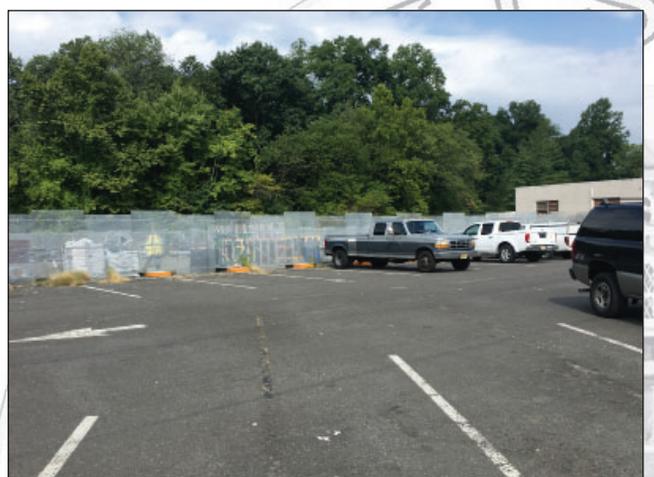
**Image 15:** Construction materials fenced within the parking area. Grades drain water toward the stream in the rear with no visible storm water control measures.

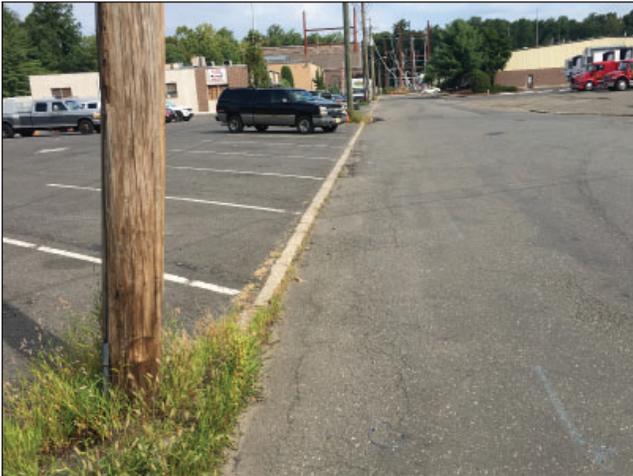
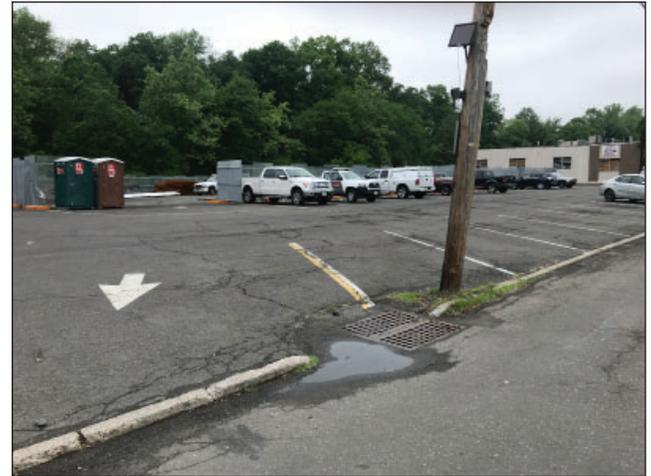
**Image 16:** Parking along Prospect Place with drop curb to allow vehicles to exit directly onto the street. No sidewalks, lighting or protective measures for the utility pole or pedestrians.

**Image 17:** Parking along Prospect Place with drop curb to allow vehicles to exit directly onto the street. No sidewalks, lighting or protective measures for the utility pole or pedestrians.

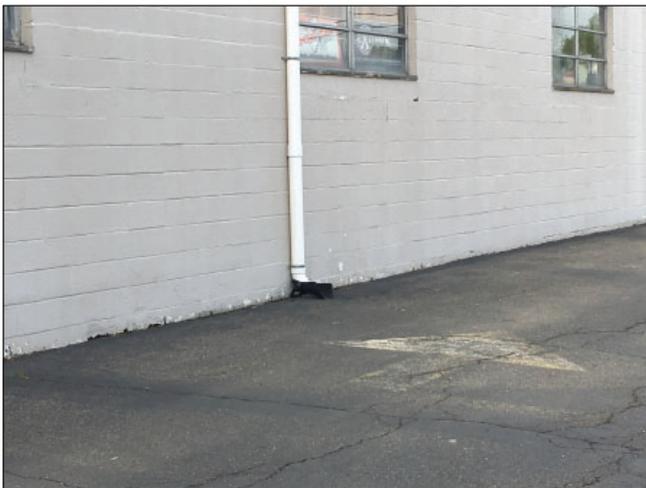
Image 2: Roof leader drain at the south side of the building across the egress drive.

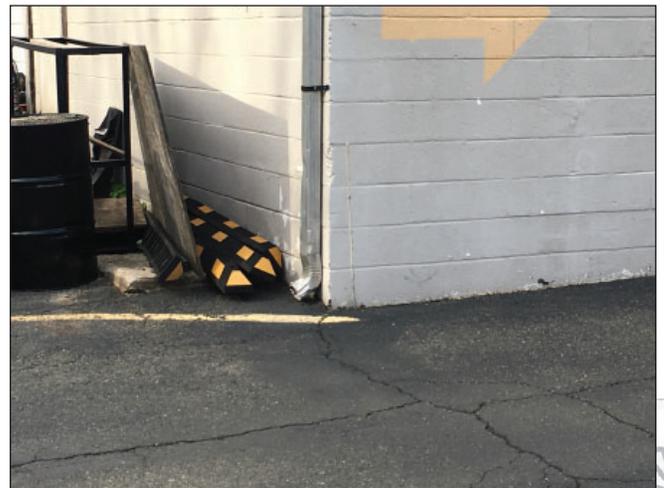
Image 3: Roof leader drain at the west side of the building across the egress drive.

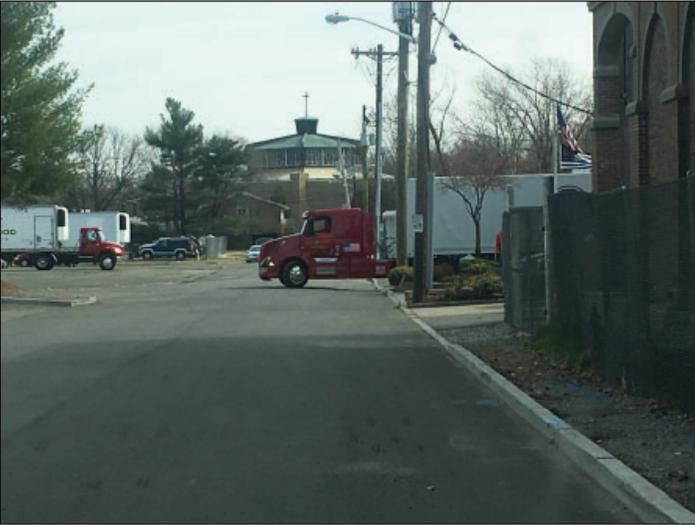
- 1) Per Section 210-60, "Access to truck standing, loading and unloading space shall be provided directly from a public street or alley or from any right-of-way that will not interfere with public convenience and will permit orderly and safe movement of truck vehicles". During several site visits, commercial trucks were observed backing out of the property into the public right of way. This condition creates conflicts with other vehicles within the public right of way, which is detrimental to the safety, health and welfare of the community, as evidenced by the number of violations associated with this property according to the Borough's records. Violations include municipal ordinances, sanitation codes, accidents and noise complaints.

**Image 1:** Series of photographs depicting an 18 wheeler backing into the property from Prospect Place during business hours.

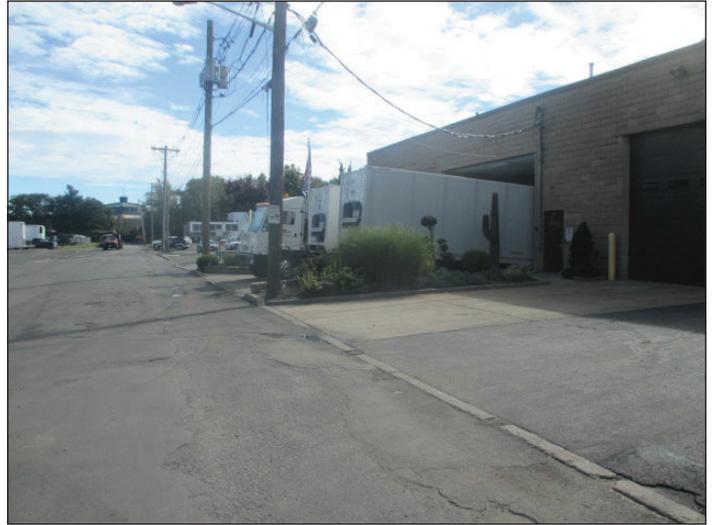
Image 2: Truck cab parked in the public right of way during a delivery.

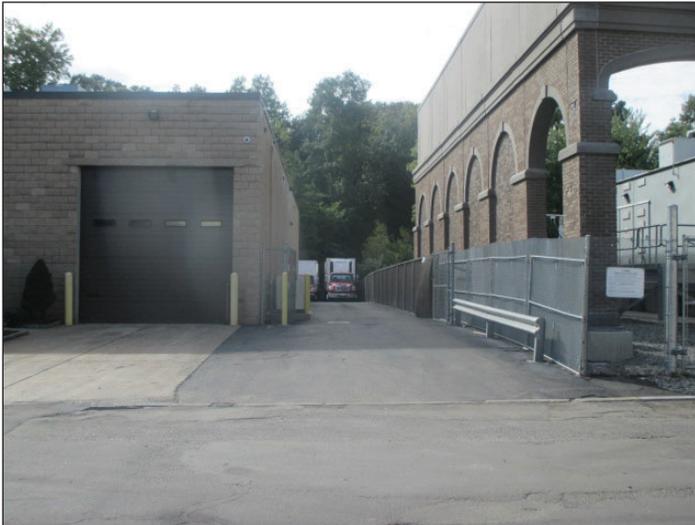
Image 3: Loading dock with truck beds in the public right of way

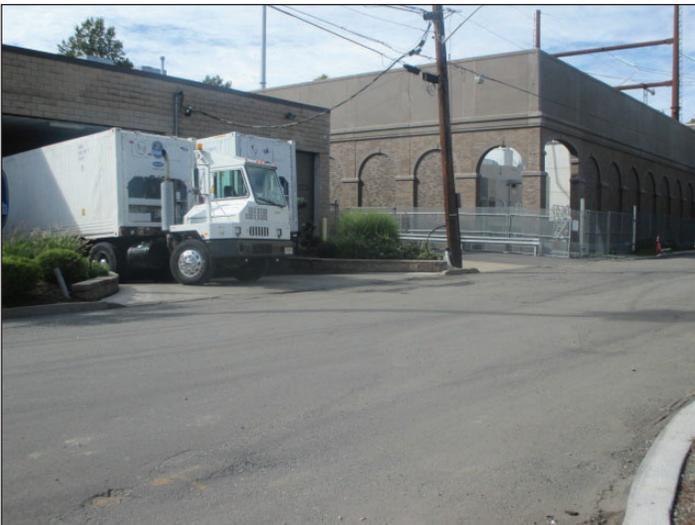
Image 5: Loading dock with truck beds in the public right of way

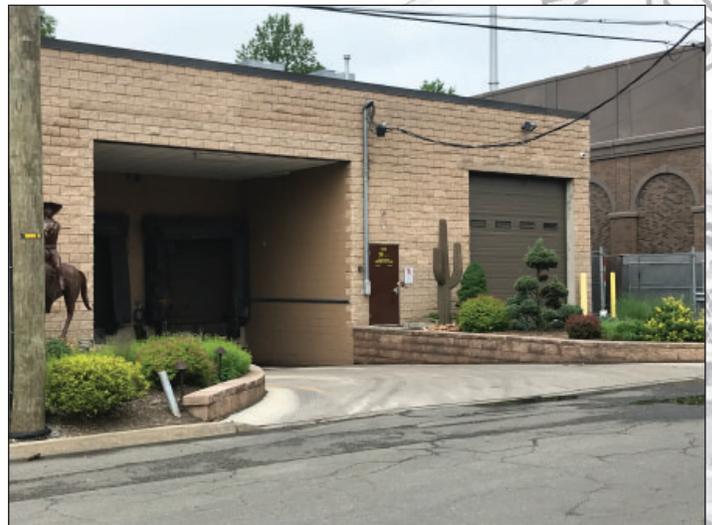
Image 6: Loading dock with truck beds in the public right of way

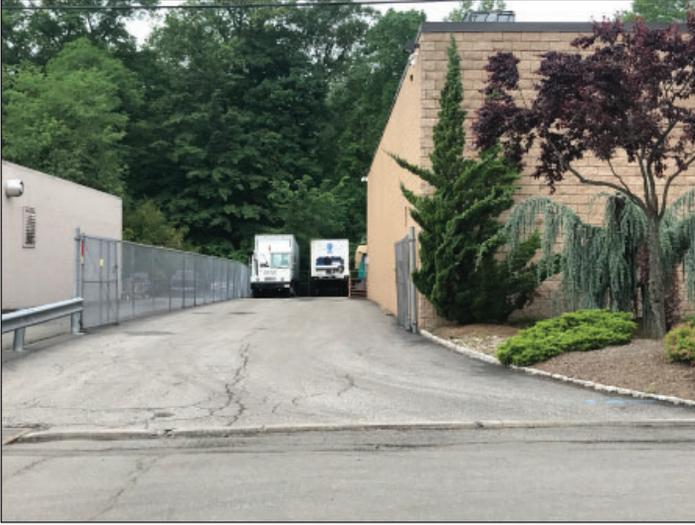
Image 7: Loading dock at the front of the building which requires trucks to back into the public right of way and block the street during loading and unloading.

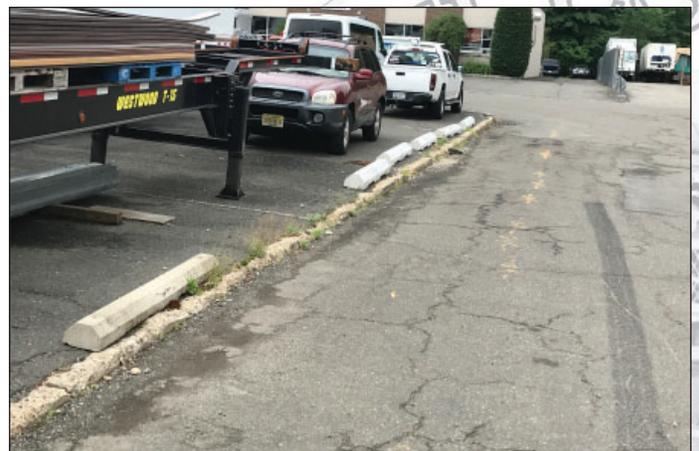
- 4) In addition, there is a lack of access management given asphalt is located up to the existing curb, which allows vehicles to enter and exit the property along it's entire length. This condition represents a faulty arrangement and design that is dangerous to the health, safety and welfare of other vehicles in the public right of way. This is further exacerbated by the lack of lighting on the property.

Image 2: Street view depicting impervious area with drop curb, lack of lighting, striping, sidewalks and access management.

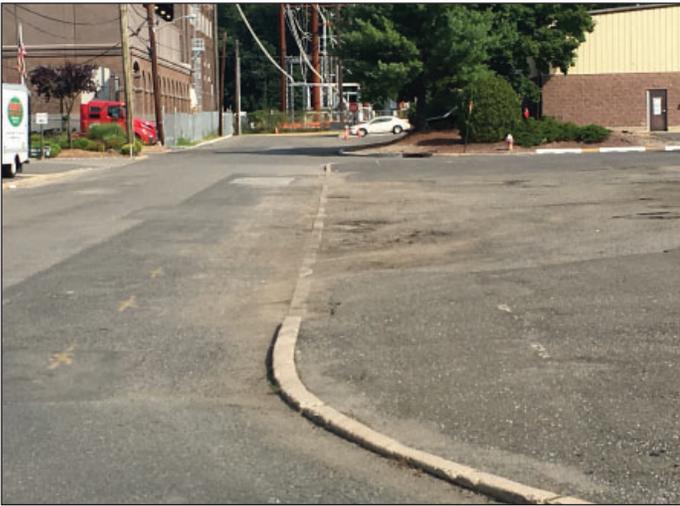
- 1) The lot includes asphalt parking to the back of curb, which violates the requirements of the Hillsdale Zoning Ordinance (Section 310-58) which states, "Parking areas shall not be closer than 10 feet from any street line". This creates a dangerous condition by having vehicles parked in the public right of way with no sidewalks, buffers or any other pedestrian safety measures, which is detrimental to the safety, health and welfare of the community.

Image 3: Street view depicting vehicles parked in the public right of way, lack of required 10-foot buffer, lack of light and other pedestrian safety measures.

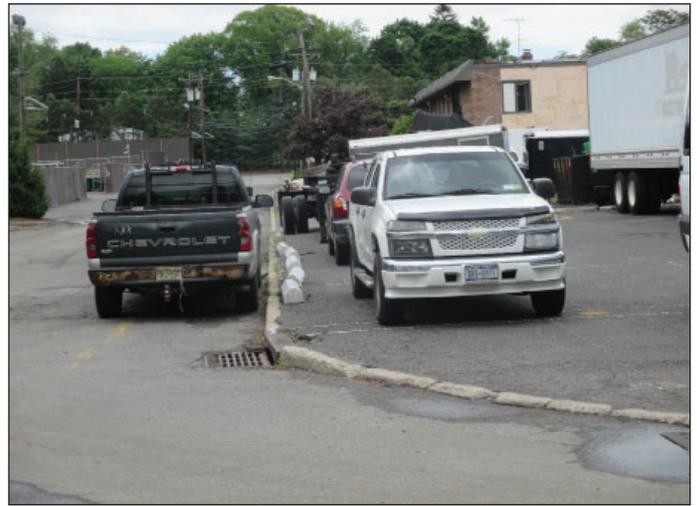
**Image 4:** Street view depicting drop curb, lack of 10 foot buffer, lighting, striping and access management.
