Report of  
**Preliminary Investigation for  
Determination of an Area in Need of Redevelopment  
without Condemnation**

Block: 1207, Lots: 8, 9 10 & 11; Block: 1208, Lots: 1, 2, 3, 4 & 5; Block: 1209, Lots: 2, 3, 4, 5 & 6;  
Block: 1210, Lots: 6, 7, 8, 9, 10 & 11; Block: 1211, Lots: 1 & 2; Block: 1212, Lot: 13.

**Prepared By:**  
DMR Architects

**Prepared For:**  
Borough of Hillsdale  
Bergen County, New Jersey

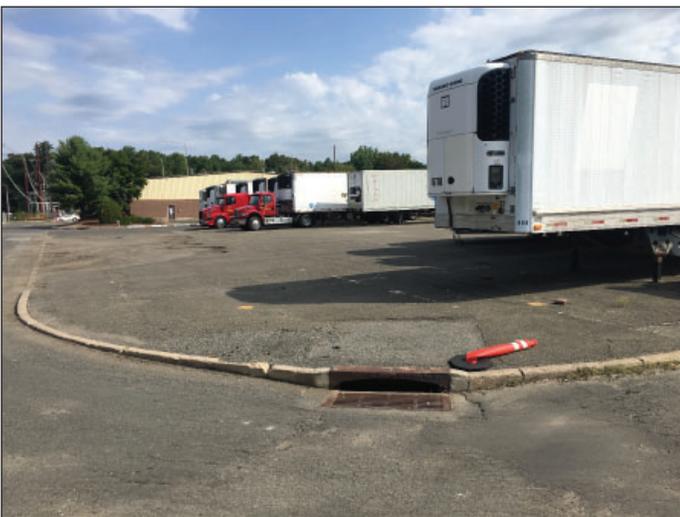
**Image 5:** Street view depicting drop curb, lack of 10 foot buffer, lighting, striping and access management.

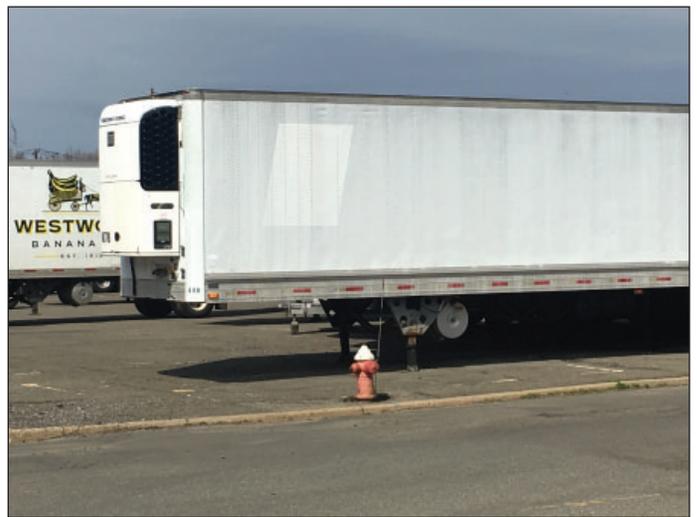
**Image 6:** Street view depicting drop curb, lack of 10 foot buffer, lighting, striping and access management.

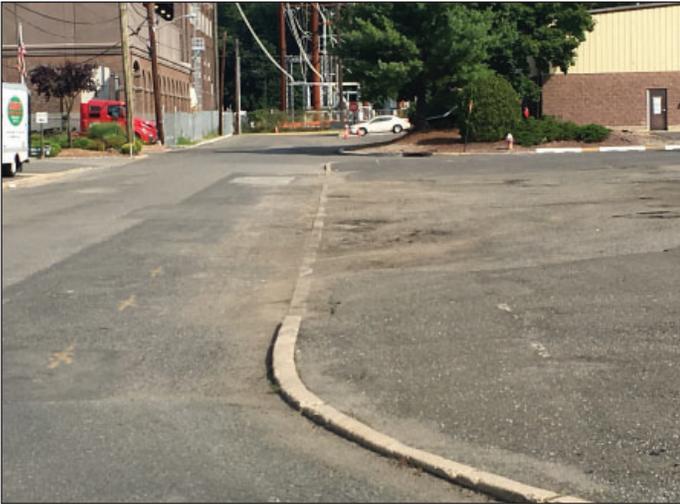
Image 3: Street view depicting vehicles parked in the public right of way, lack of required 10' buffer, lack of light and other pedestrian safety measures.

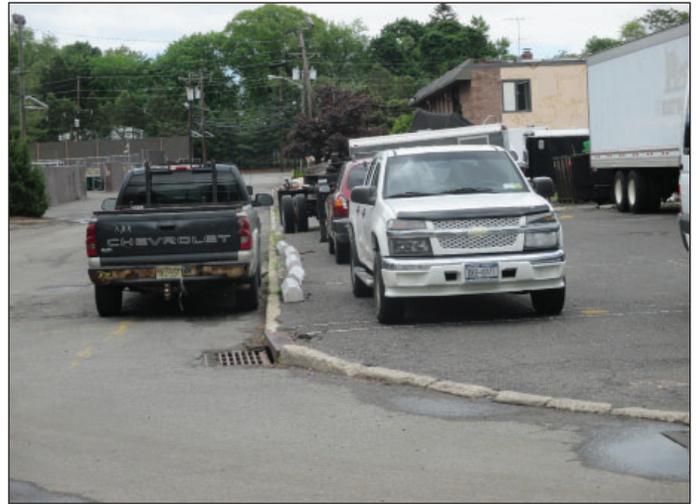
**Image 4:** Street view depicting drop curb, lack of 10 foot buffer, lighting, striping and access management.

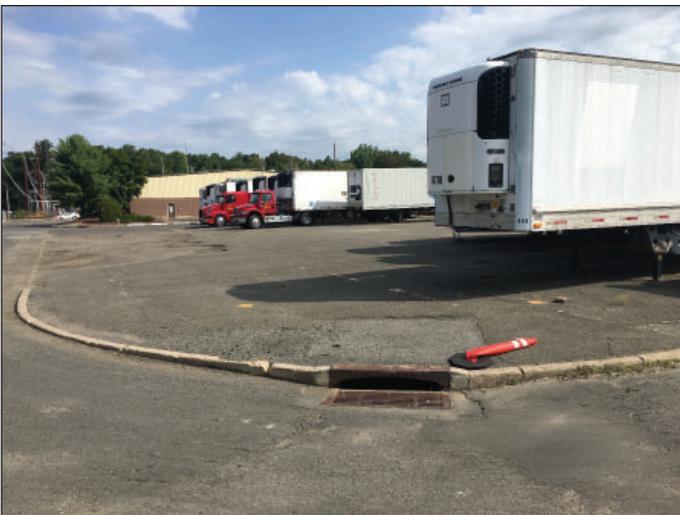
**Image 5:** Street view depicting drop curb, lack of 10 foot buffer, lighting, striping and access management.

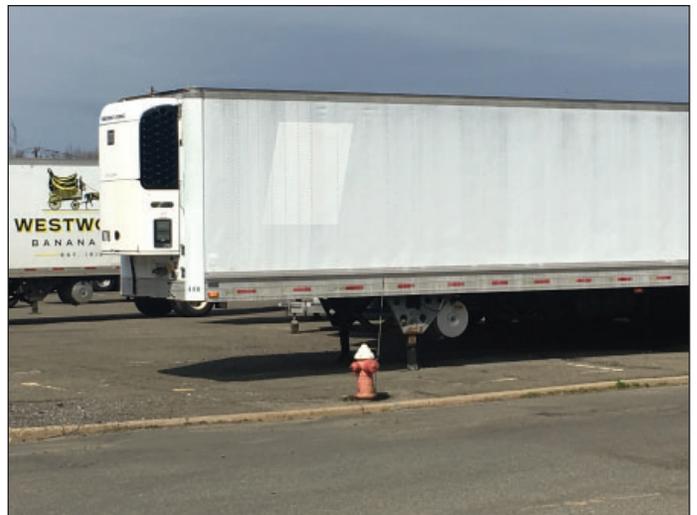
**Image 6:** Street view depicting drop curb, lack of 10 foot buffer, lighting, striping and access management.

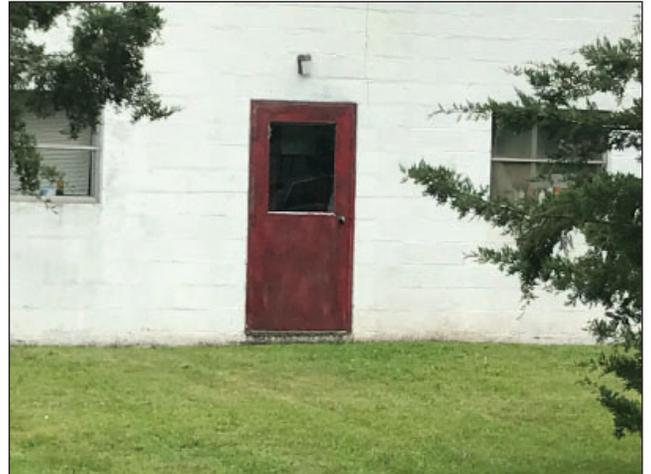
Image 2: Front entrance with no pedestrian access

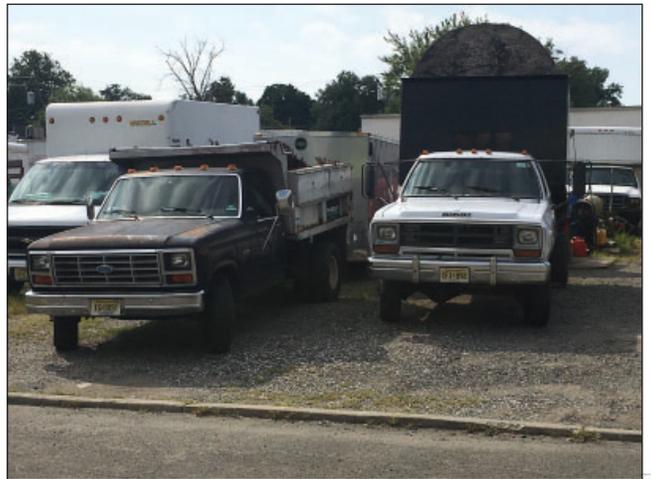
Image 4: Parking area to the back of curb at Brookside Place.

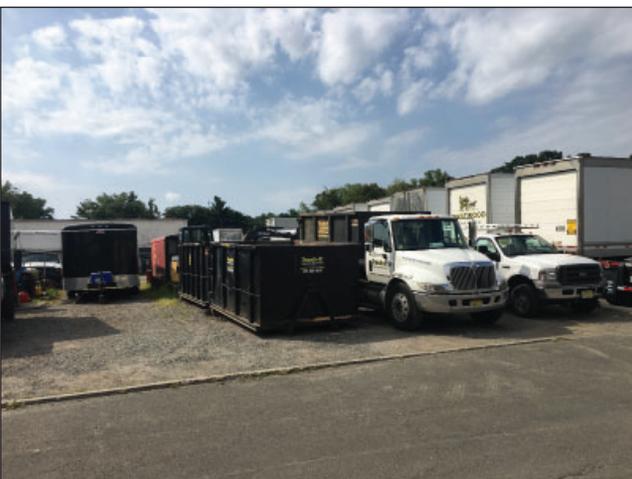
Image 5: Parking area to the back of curb at Brookside Place.

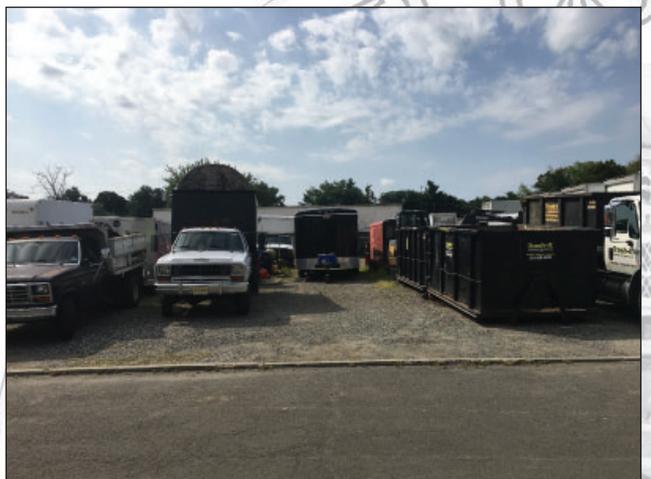
Image 6: Parking area to the back of curb at Brookside Place.

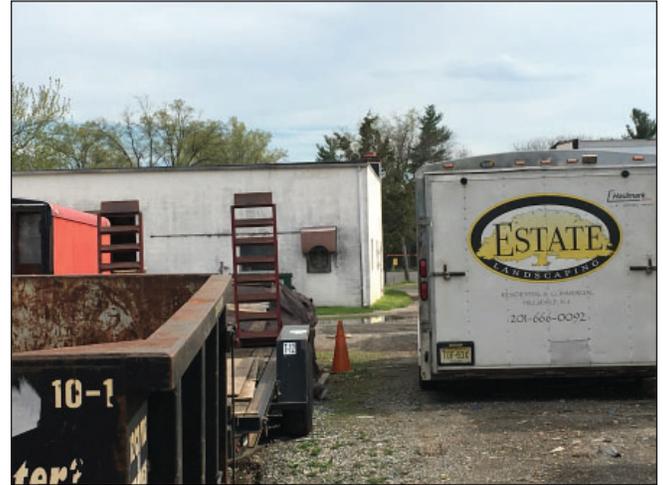
**Image 8:** Vehicles parked at the rear portion of the property along Brookside Place.

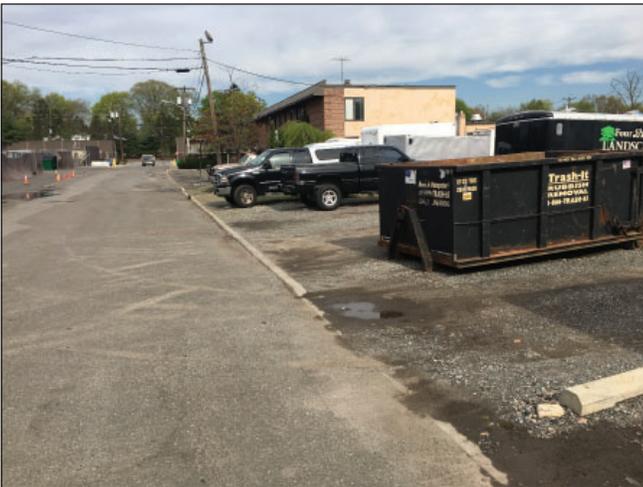
**Image 9:** Parking area to the back of curb along Brookside Place.

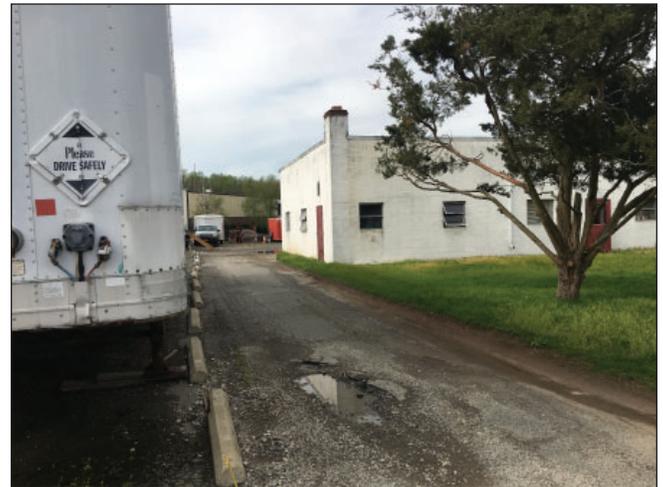
**Image 10:** Drive along west side of the building.

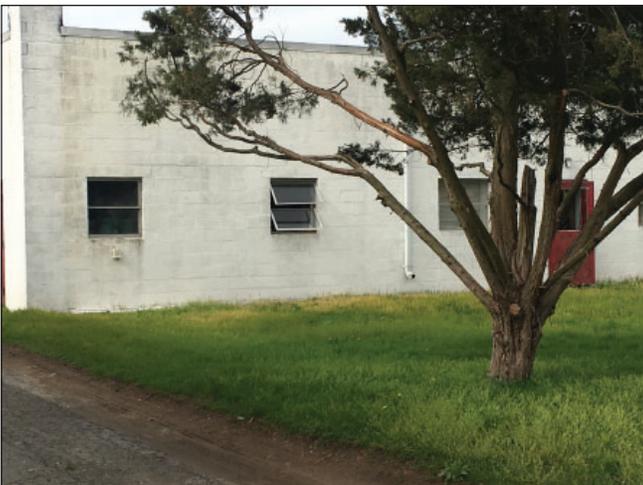
**Image 11:** Front facade of the building from Piermont Avenue.

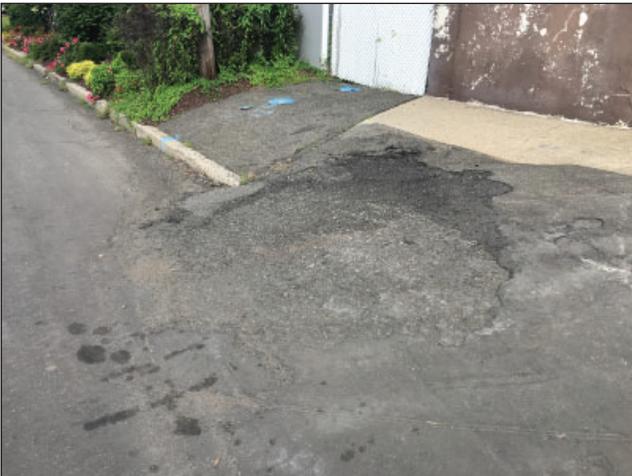
**Image 3:** Building at west edge of property depicting grades along edge of property.

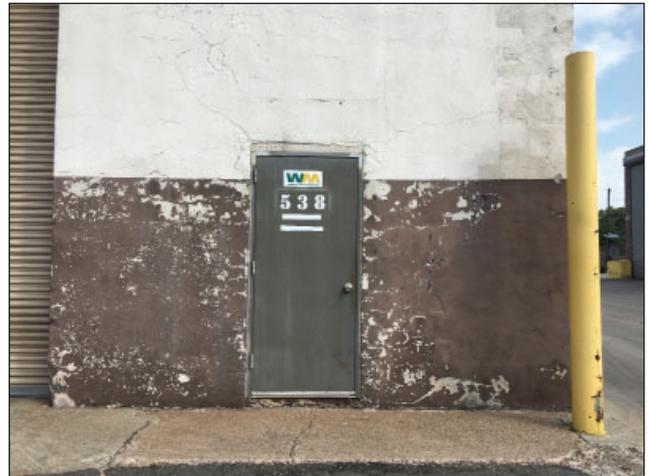
**Image 4:** Door from building without light depicting door threshold off concrete area..

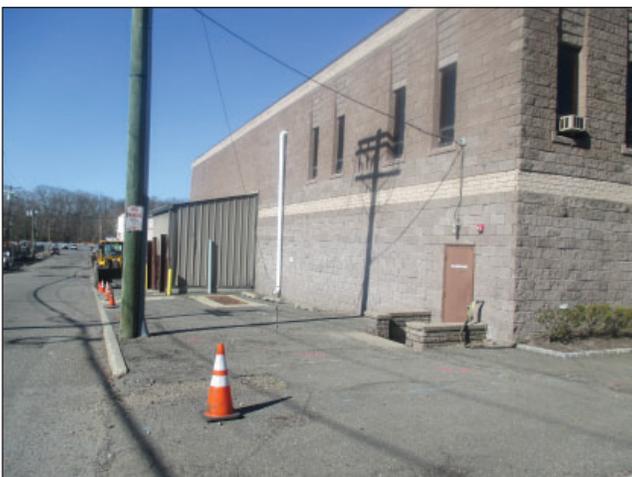
**Image 12:** Two story building roof drain onto the parking area along Piermont Avenue.

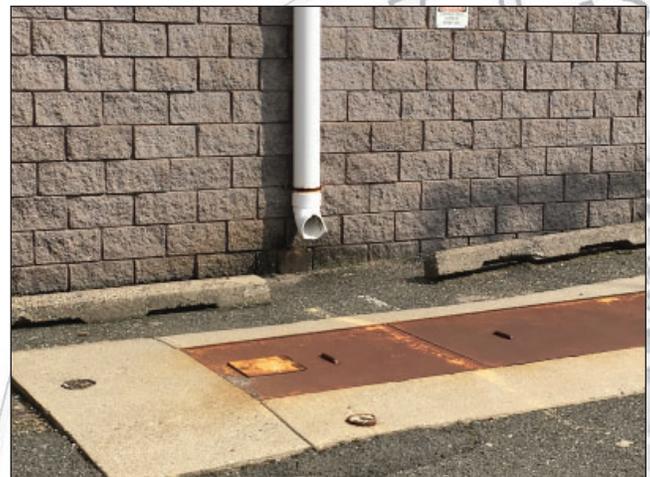
Image 13: Building along Piermont Avenue with asphalt and concrete depicting grading toward the public right of way with metal shed.

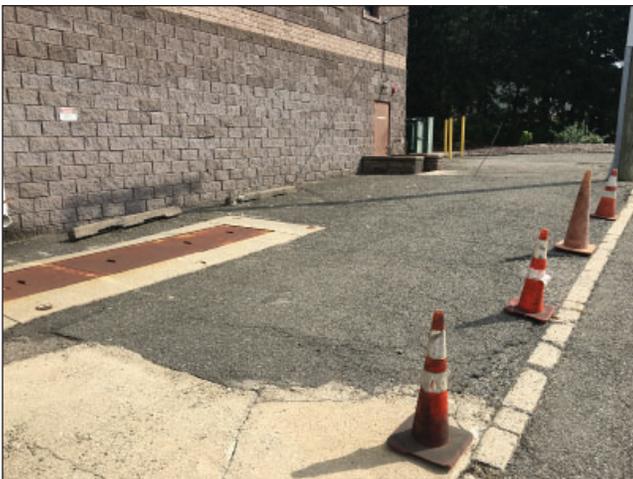
Image 16: Patterson Street facing north depicting parking along the building. Includes significant amount of sediment and debris draining into the public right of way.

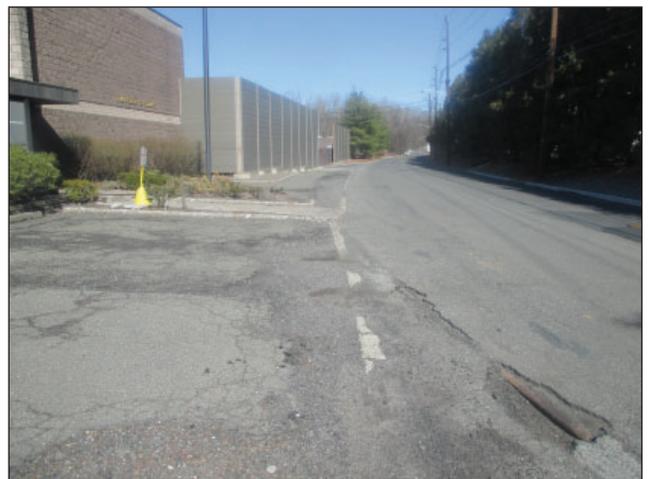
Image 17: Patterson Street facing north depicting parking along the building. Includes significant amount of sediment and debris draining into the public right of way.

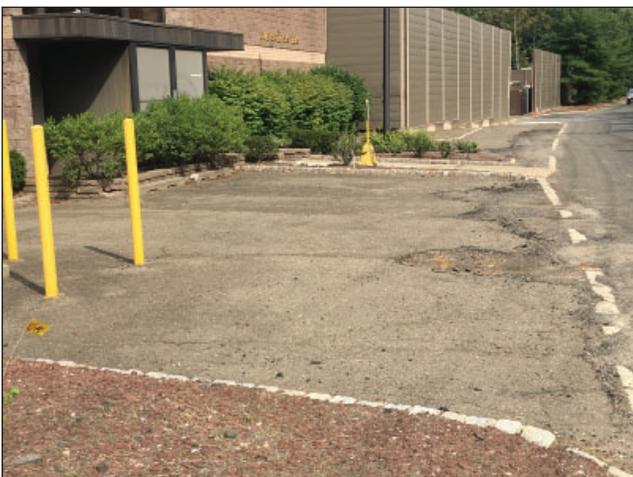
Image 18: Patterson Street facing north depicting parking along the building. Includes significant amount of sediment and debris draining into the public right of way.

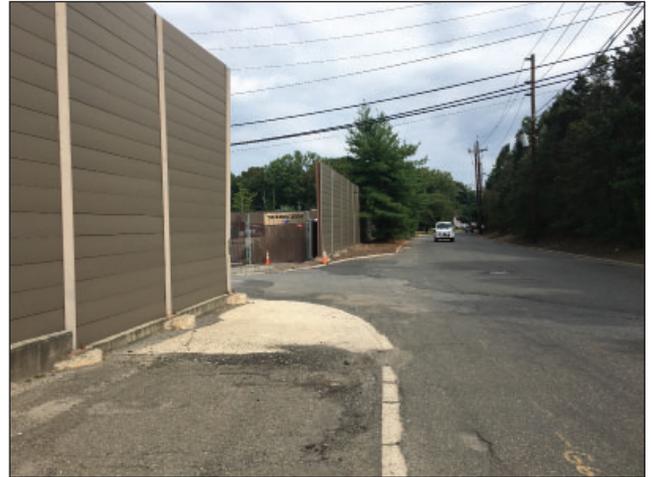
Image 21: Large wall along Patterson Street which does not provide adequate area for a sidewalk at the corner of Brookside Place.

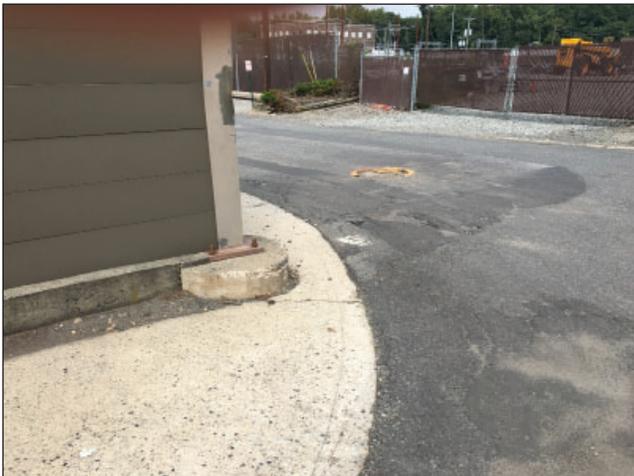
Image 22: Large wall along Patterson Street depicting asphalt area in front and a small turn around area adjacent to the front entrance with insufficient room to maneuver outside of the right of way.

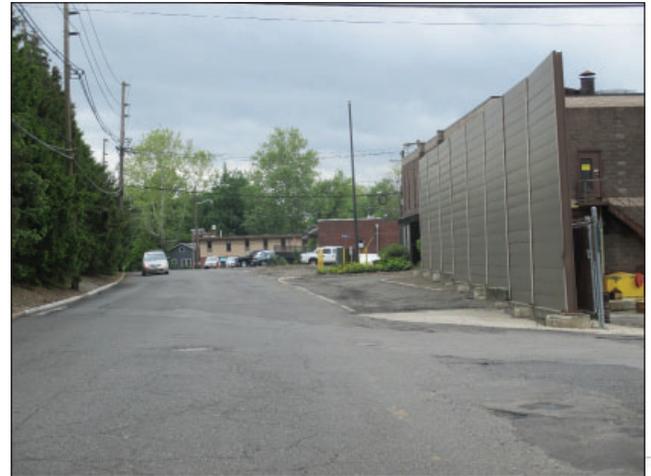
Image 23: View of Patterson Street from the driver position legally stopped at the corner, depicting limited view of on-coming traffic.

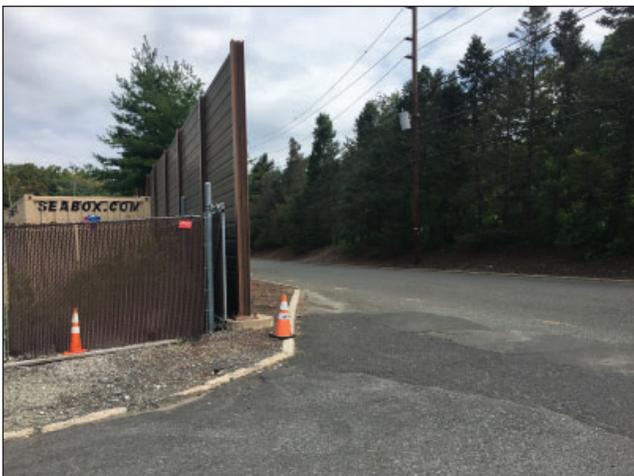
Image 24: View of Patterson Street from the driver position legally stopped at the corner, depicting limited view of on-coming traffic with stop sign attached to bollard.

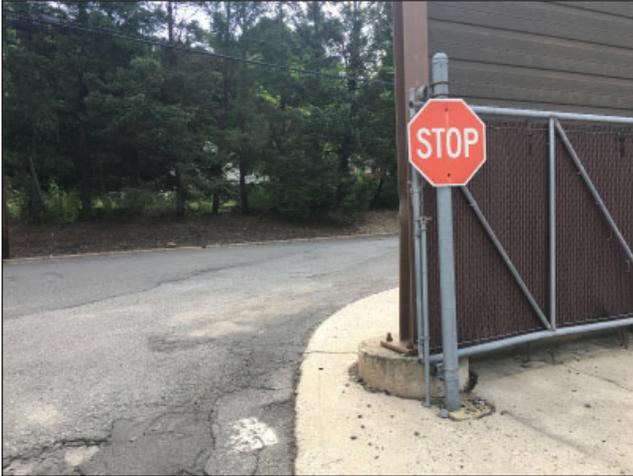
Image 26: View from Brookside Place across impervious lot to the building depicting roof drain.

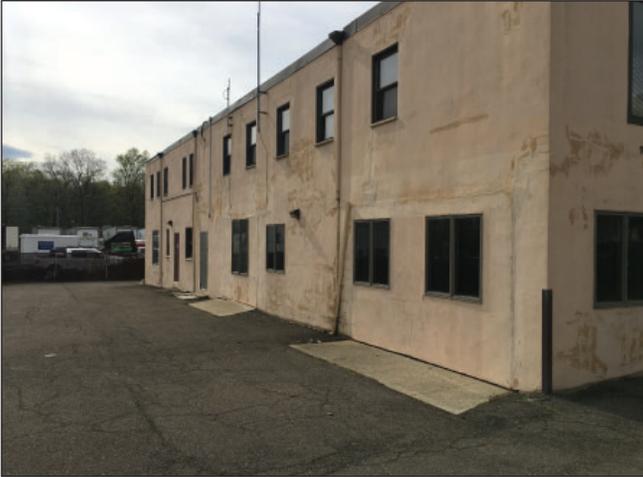
**Image 2:** View of the rear facade and parking area depicting the roof leader drains directly onto the asphalt, doorways raised above the parking area.

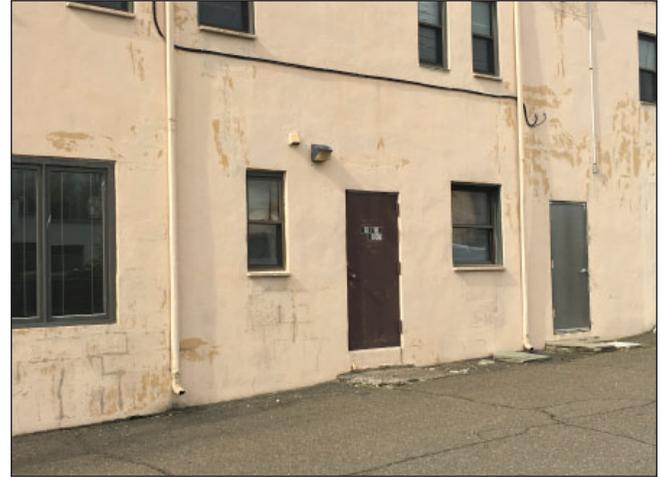
**Image 3:** View of the rear facade and parking area depicting the roof leader drains directly onto the asphalt, doorways raised above the parking area.

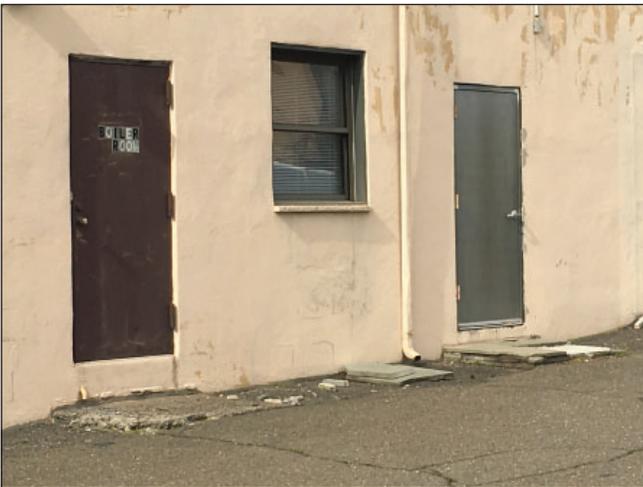
**Image 4:** View of the rear facade and parking area depicting the roof leader drains directly onto the asphalt, doorways raised above the parking area.

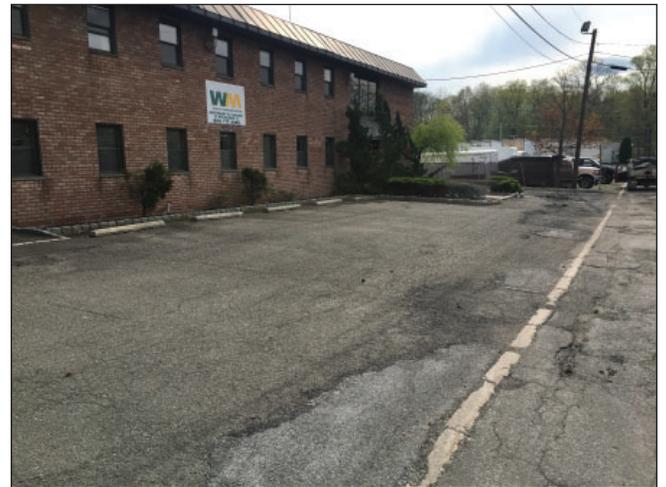
**Image 5:** View of asphalt parking and building along Brookside Avenue with no access control measures, sidewalks or other pedestrian safety measures.

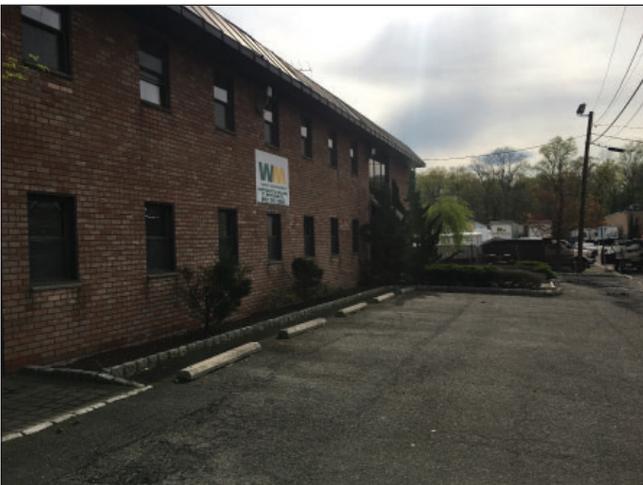
**Image 6:** View of asphalt parking and building along Brookside Avenue with no access control measures, sidewalks or other pedestrian safety measures.

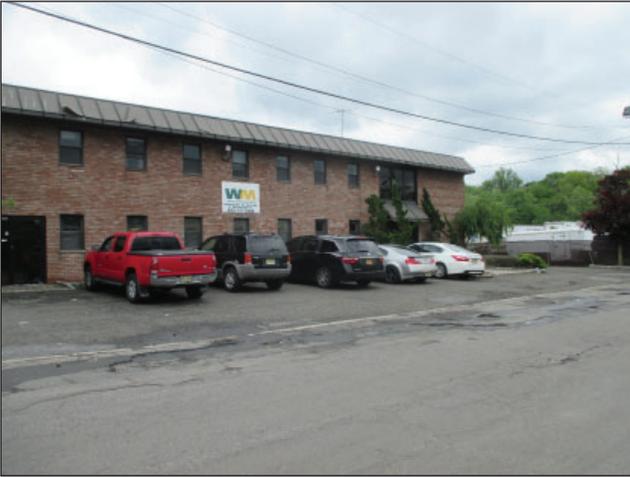
**Image 8:** View of asphalt parking with head in parking and no area for vehicles to maneuver within the property.

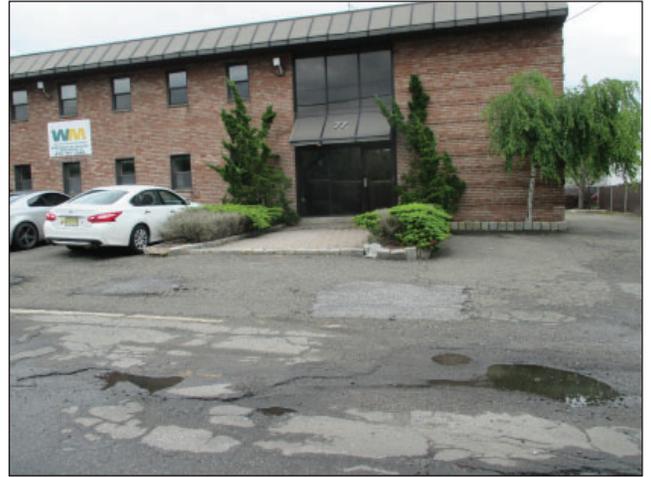
**Image 9:** View of asphalt parking and grading toward the public right of way with no access control measures.

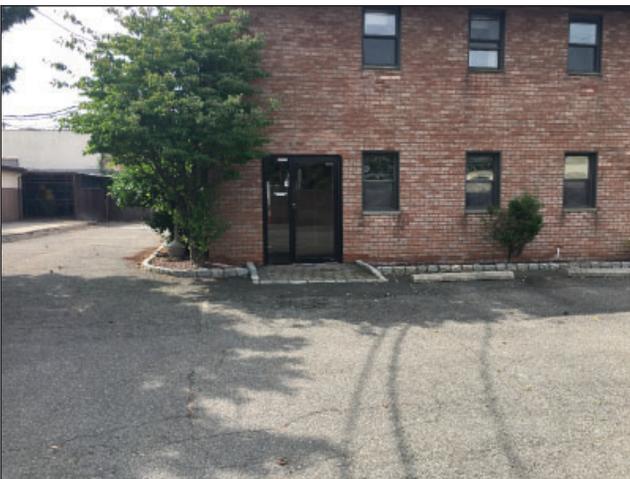
**Image 10:** View from Brookside Place across impervious lot to the building.

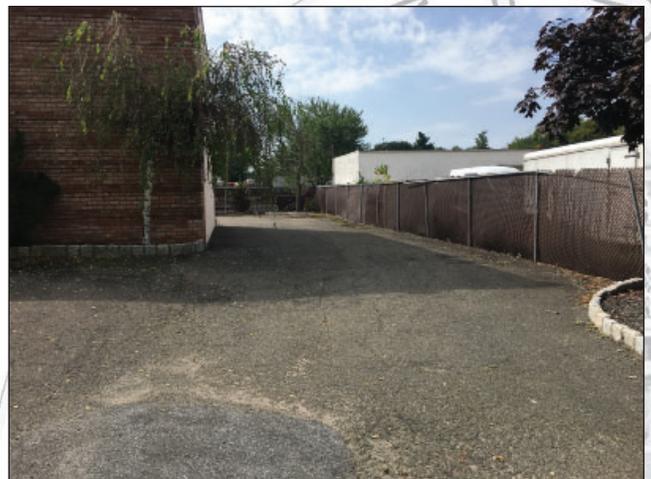
**Image 13:** View of driveway along the side of the building.

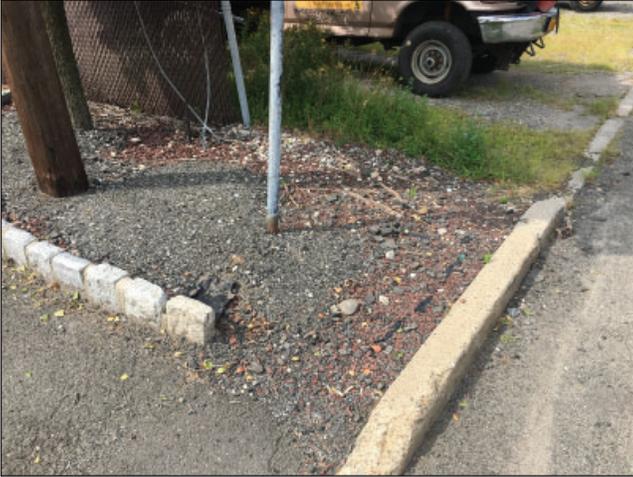
**Image 14:** View of corner property with sediment in the public right of way.

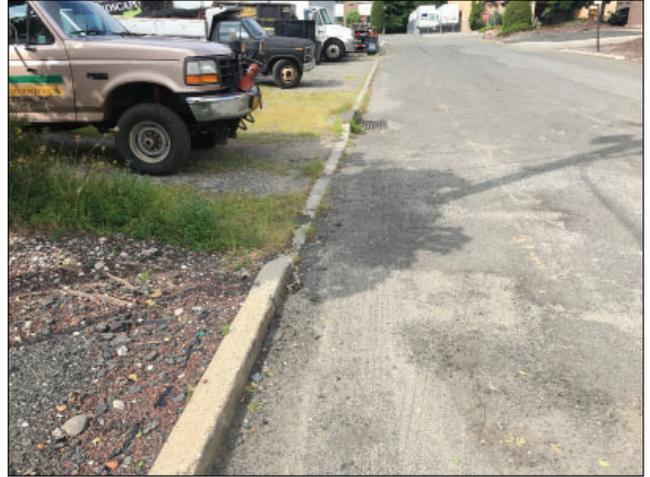
**Image 15:** View of corner property with sediment in the public right of way.

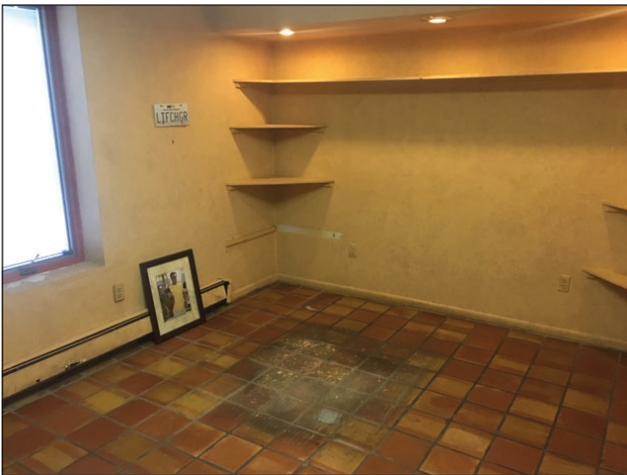
**Image 16:** Interior empty office

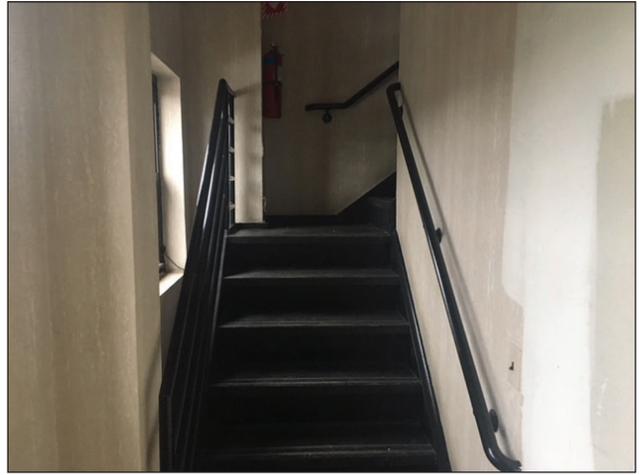
**Image 17:** View of interior stairs

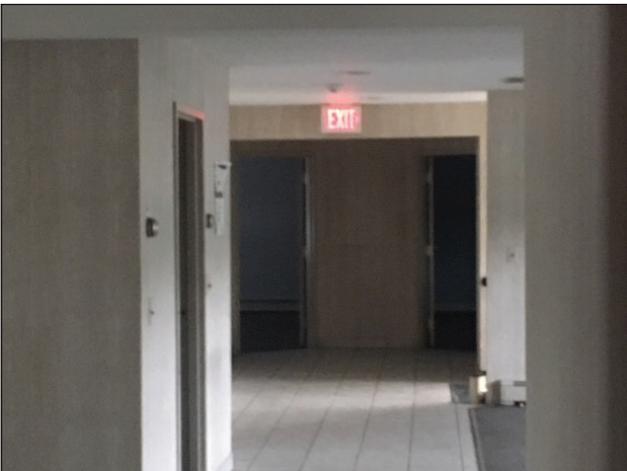
**Image 18:** View of empty interior hallway

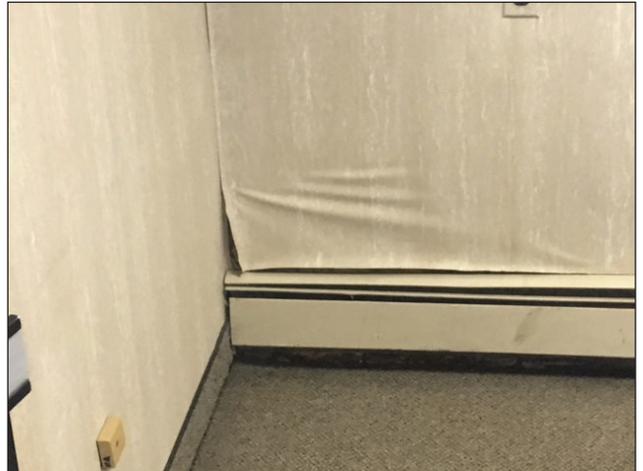
**Image 19:** View of interior office

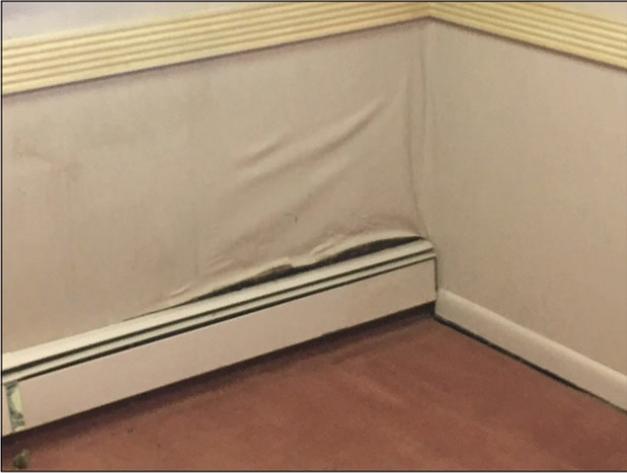
Image 20: Interior empty office

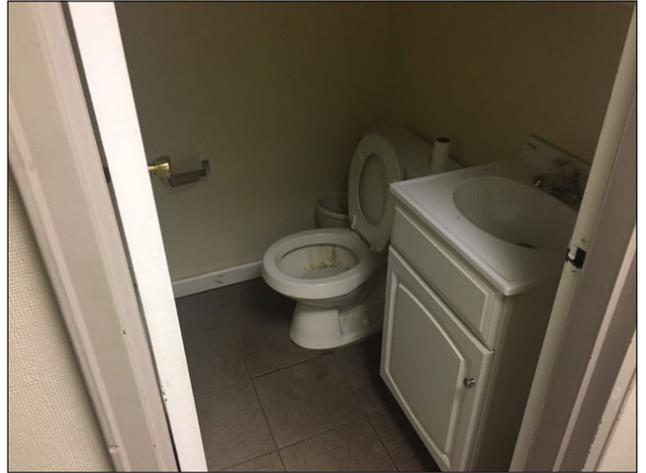
Image 21: View of bathroom.

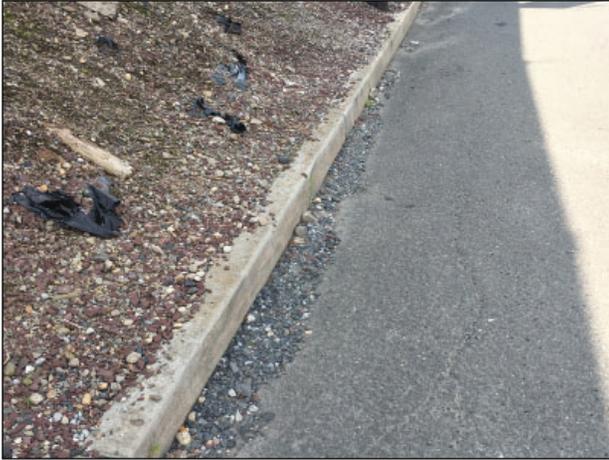
**Image 5:** View of wall on Knickerbocker Avenue with sediment and debris falling into the public right of way and street.

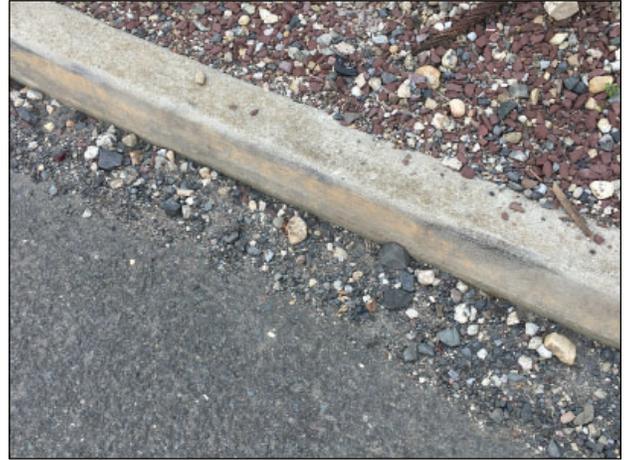
**Image 6:** View of wall on Knickerbocker Avenue with sediment and debris falling into the public right of way and street.

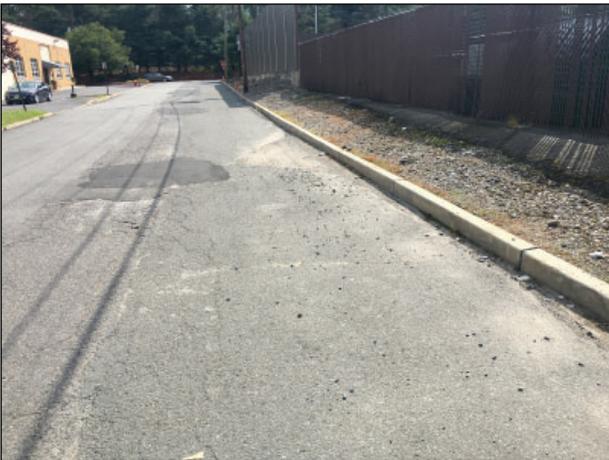
**Image 7:** View of wall on Knickerbocker Avenue with sediment and debris falling into the public right of way and street.

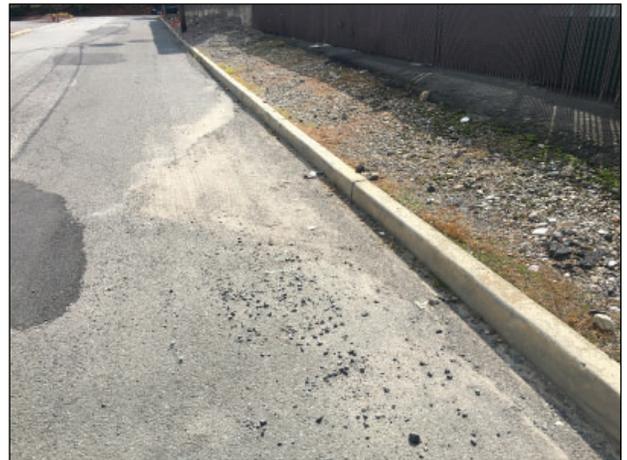
**Image 8:** View of wall on Knickerbocker Avenue with sediment and debris falling into the public right of way and street.

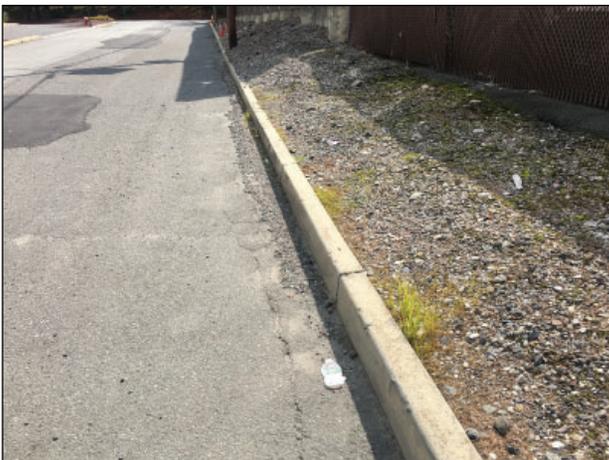
**Image 9:** View of wall on Knickerbocker Avenue with sediment and debris falling into the public right of way and street.

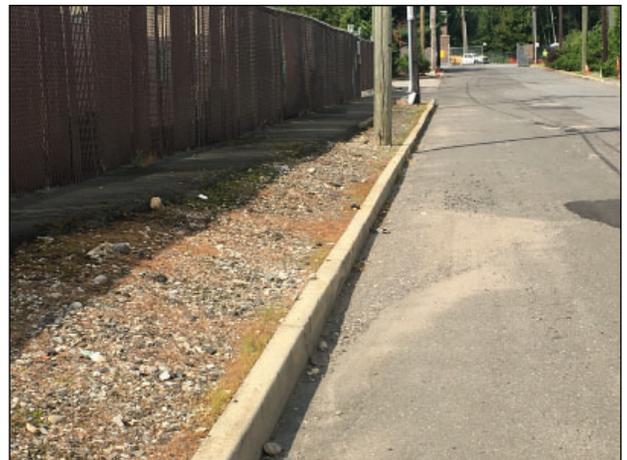
**Image 10:** View of wall on Knickerbocker Avenue with sediment and debris falling into the public right of way and street.

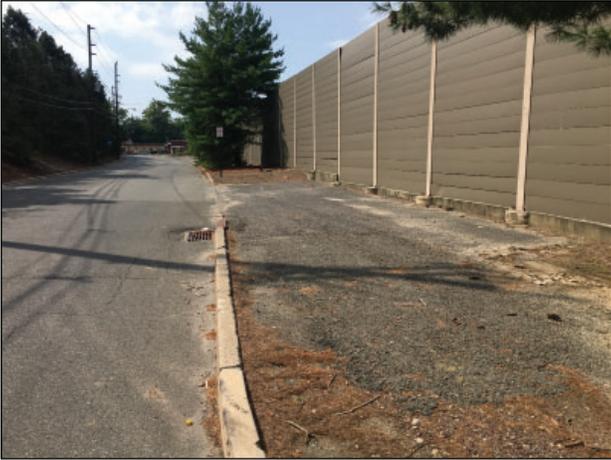
**Image 11:** View of wall on Patterson Street with no sidewalks, street lights and includes asphalt parking areas.

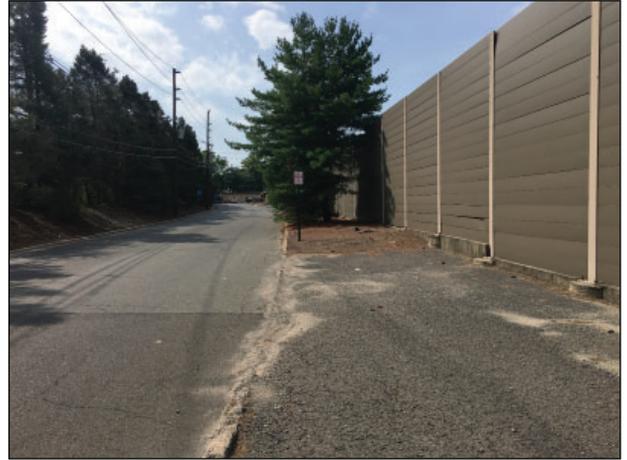
**Image 12:** View of wall on Patterson Street with no sidewalks, street lights and includes asphalt parking areas.

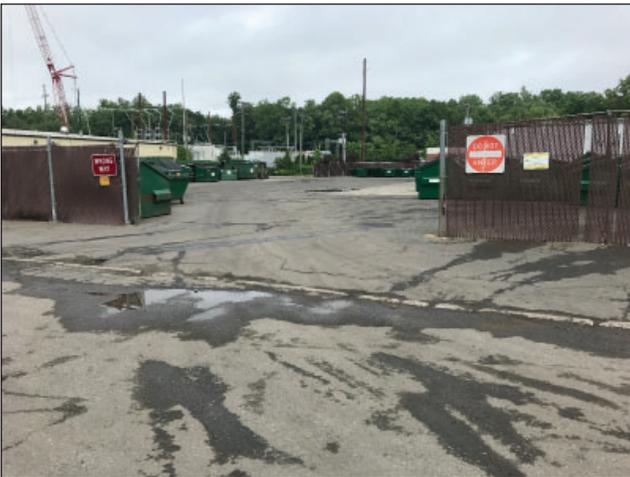
**Image 13:** View along Brookside Place.

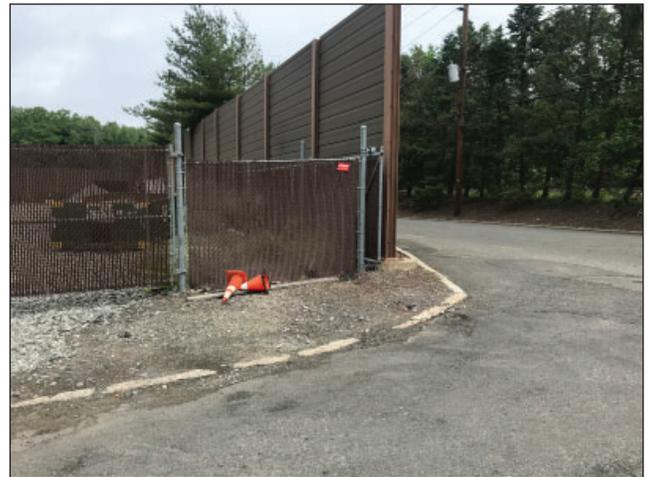
The stop sign and line at Knickerbocker Avenue on the south side is located approximately 5 feet in front of the wall, which would impede visibility for someone trying to turn onto Patterson Street. This condition would require vehicles to pull into the Patterson Street public right of way in order to see oncoming traffic.

**Image 14:** View of wall at the corner of Brookside Place and Patterson Street depicting the wall with limited visibility and no room for a sidewalk

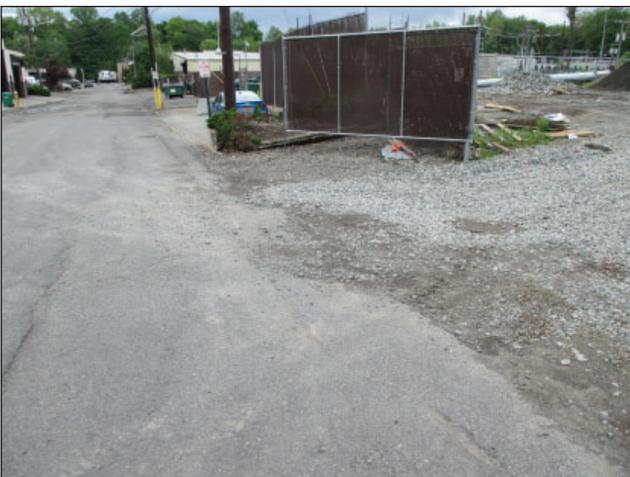
**Image 15:** View along Brookside Place depicting sediment and gravel onto the public right of way.

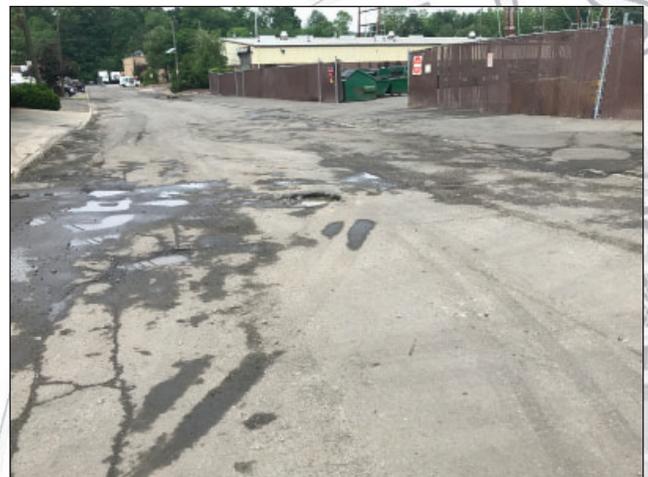
**Image 16:** View down Brookside Place.

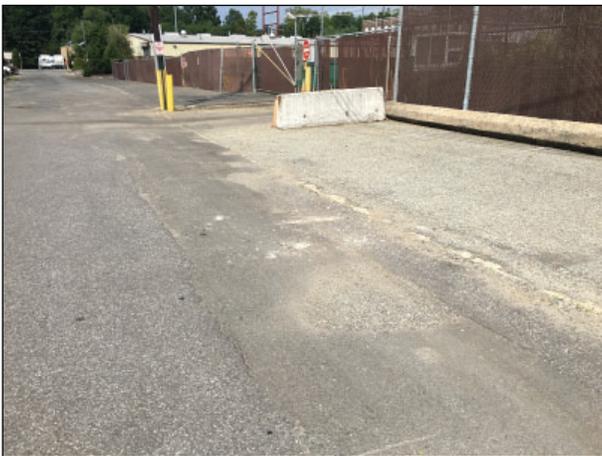
Image 19: View along Brookside Place.

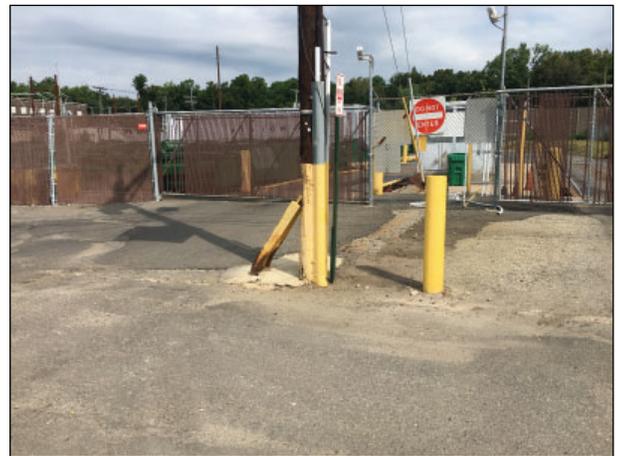
Image 20: View of entrance into the asphalt parking area with damage to utility pole protection.

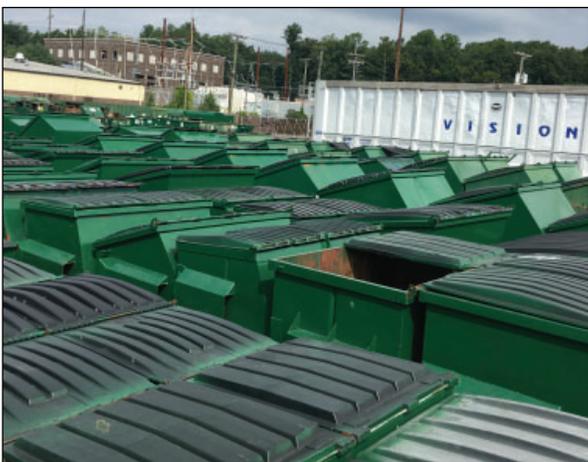
Image 21: View into storage area.

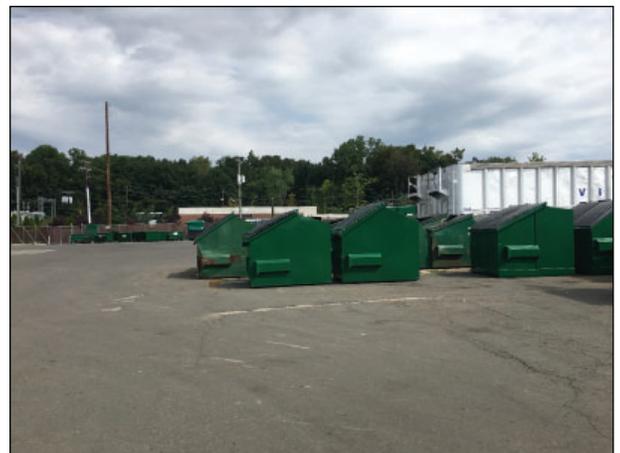
Image 22: View into storage area

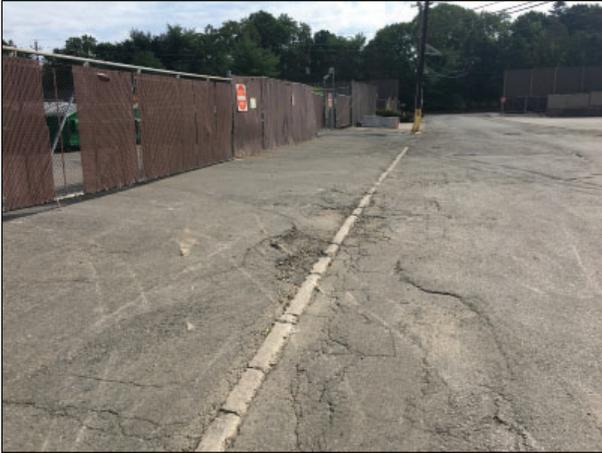
**Image 23:** View along Brookside Place depicting drop curb with lack of sidewalks, street lighting and other pedestrian safety measures.

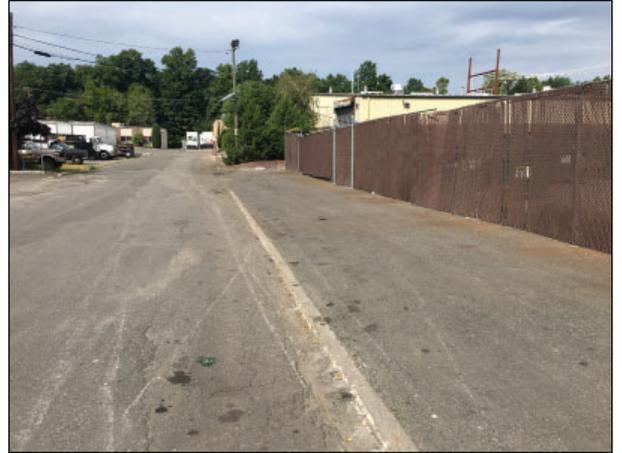
**Image 24:** View along Brookside Place.

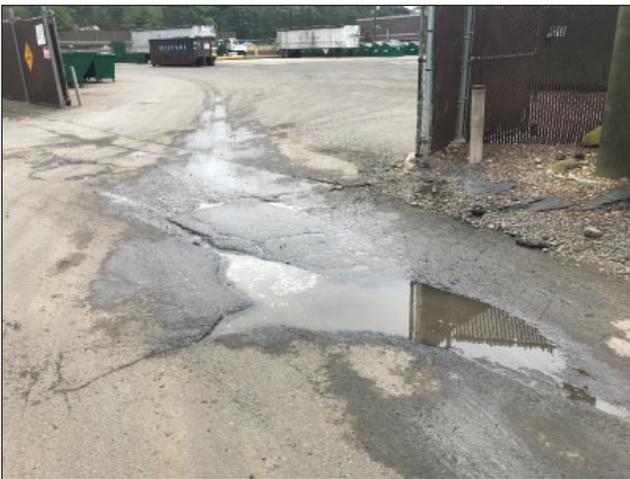
**Image 25:** View of entrance from Knickerbocker Avenue.

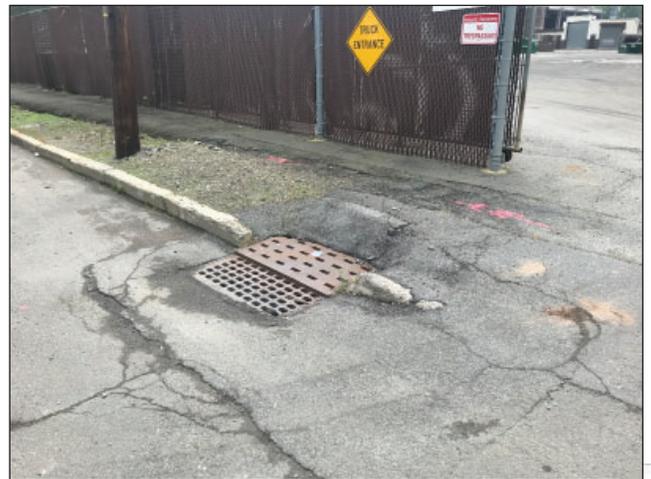
**Image 26:** View of drainage area with severe grading along entrance drive.

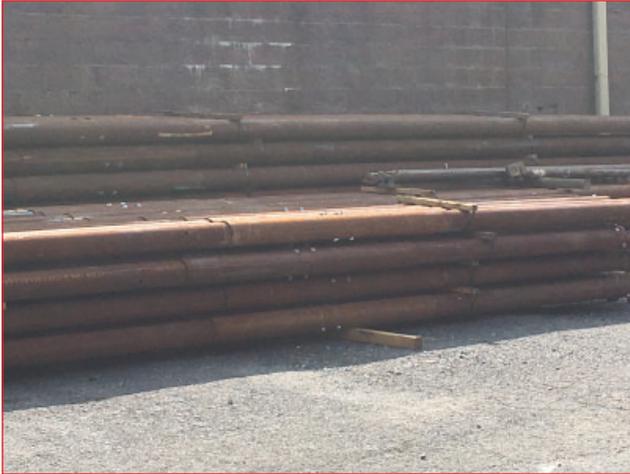
**Image 1:** View of parking area on Prospect Street with rusting construction materials.

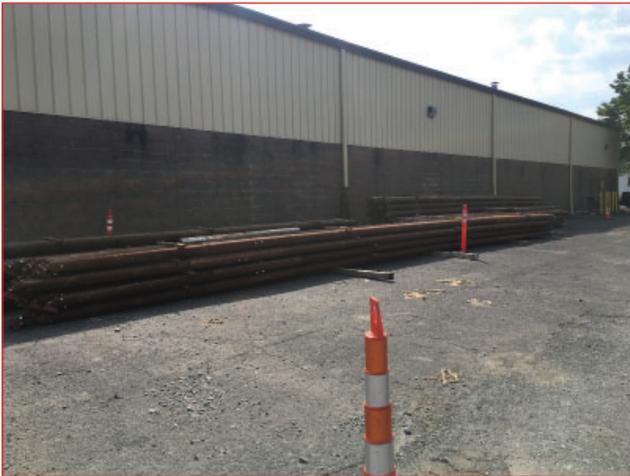
**Image 3:** View of parking area on Prospect Street with rusting construction materials.

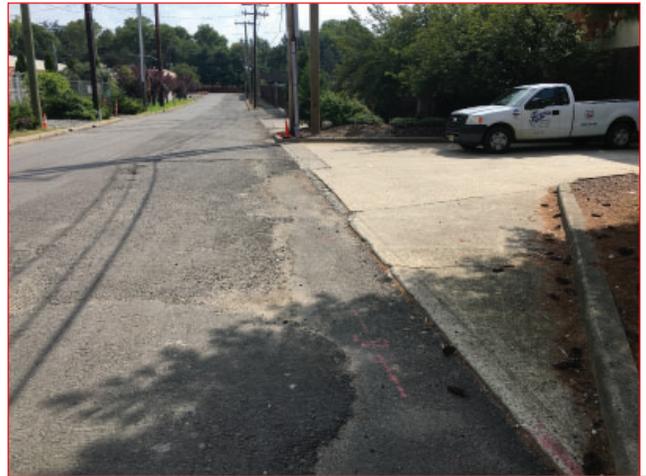
**Image 4:** View of entrance from Knickerbocker Avenue.

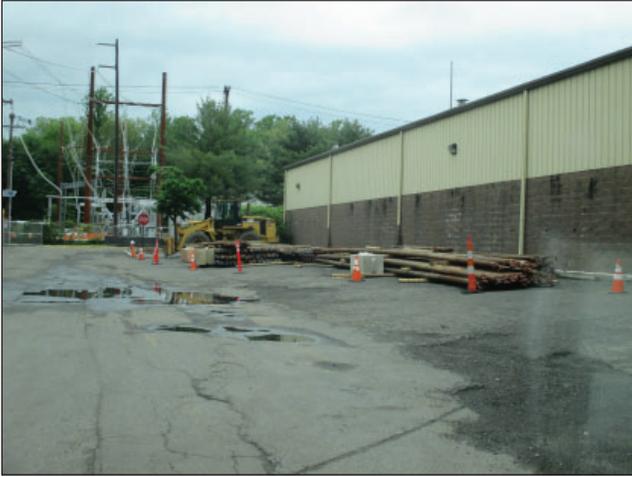
**Image 7:** View of parking area on Prospect Street with rusting construction materials.

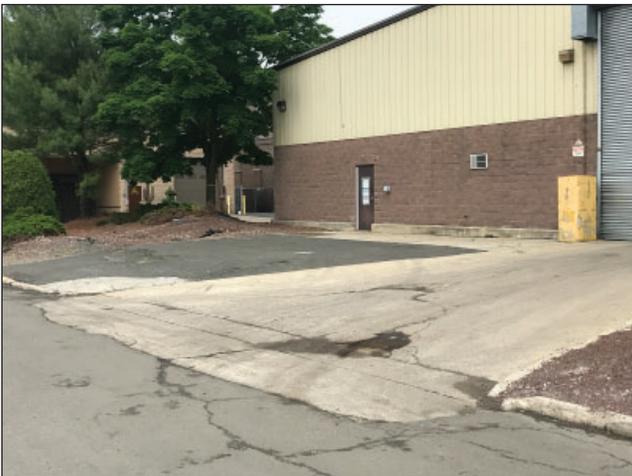
**Image 9:** View of building along Brookside Place depicting grades away from the building with no sidewalks or pedestrian control measures.

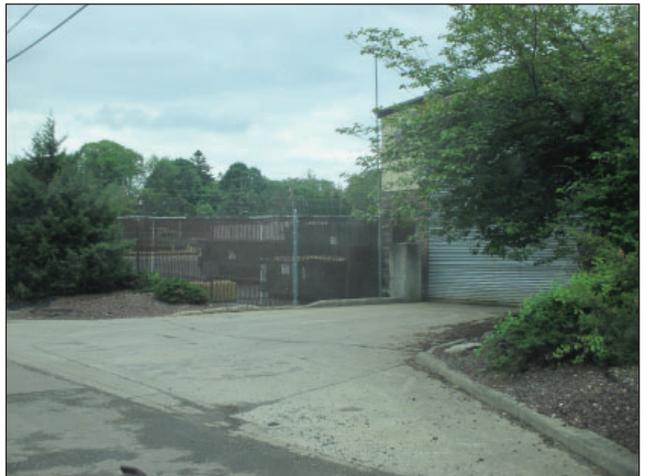
**Image 10:** View of Knickerbocker entrance with no sidewalk or safety lighting.
