Report of  
**Preliminary Investigation for  
Determination of an Area in Need of Redevelopment  
without Condemnation**

Block: 1207, Lots: 8, 9 10 & 11; Block: 1208, Lots: 1, 2, 3, 4 & 5; Block: 1209, Lots: 2, 3, 4, 5 & 6;  
Block: 1210, Lots: 6, 7, 8, 9, 10 & 11; Block: 1211, Lots: 1 & 2; Block: 1212, Lot: 13.

**Prepared By:**  
DMR Architects

**Prepared For:**  
Borough of Hillsdale  
Bergen County, New Jersey

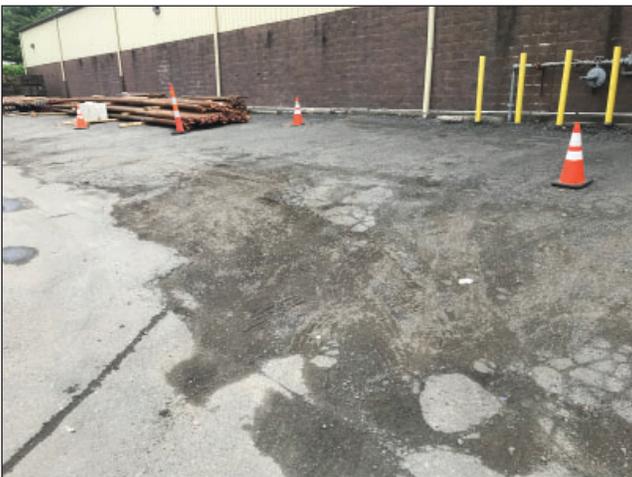
**Image 11:** View of building, roof drains and construction materials along Prospect Place with sediment and gravel in public right of way and parking area.

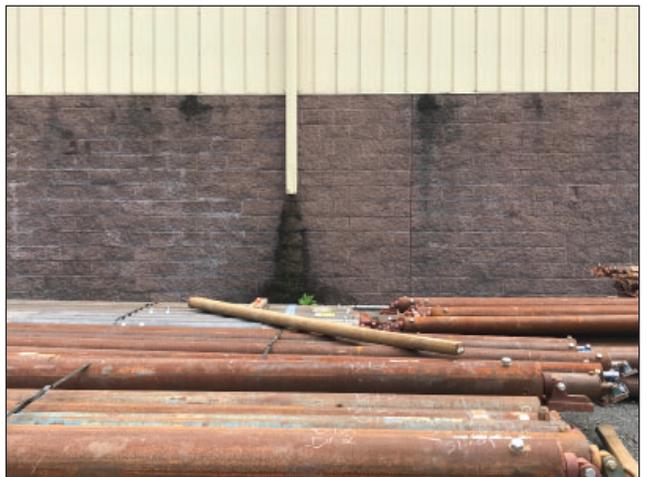
**Image 12:** View roof drains along Prospect Place.
